RE: Nags Head Beach Nourishment Project (CSE 2203)
Final Report – Preliminary Results

This letter summarizes the condition of the beach along Nags Head after nourishment.

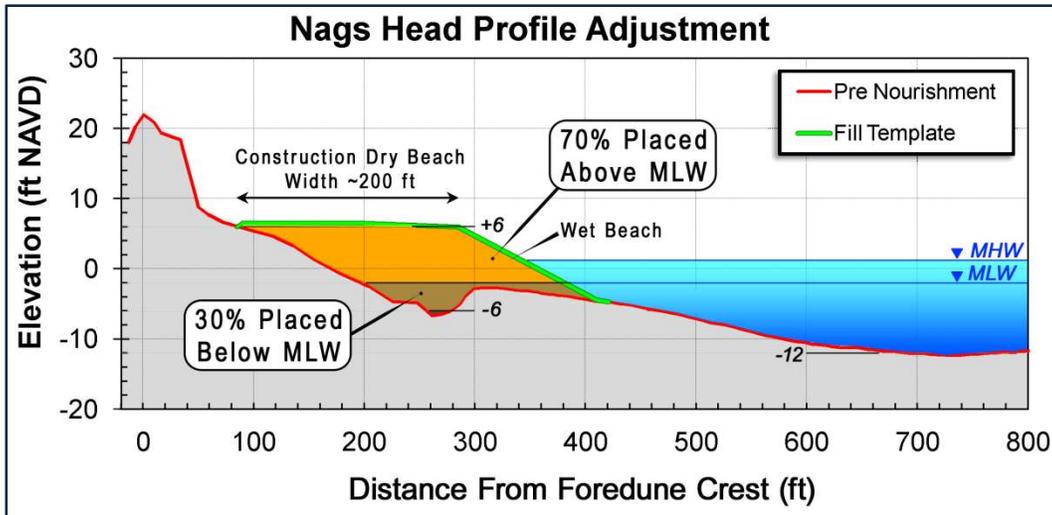
Figure A shows typical cross-sections (“profiles”) of the beach before and after nourishment. The upper diagram shows the initial shape of the nourished beach as sand was pumped into place. The constructed beach averaged more than 200 ft wide, and nearly all the new sand was contained within 400 ft of the foredune. This beach shape allowed the contractor to control the volume placed with the expectation that waves would soon reshape the nourishment into a natural profile.

FIGURE A. Sequence of profiles. [UPPER] Before and fill template. [MIDDLE] Before and post-nourishment. [LOWER] All three profiles with red and green erosion/accretion zones.

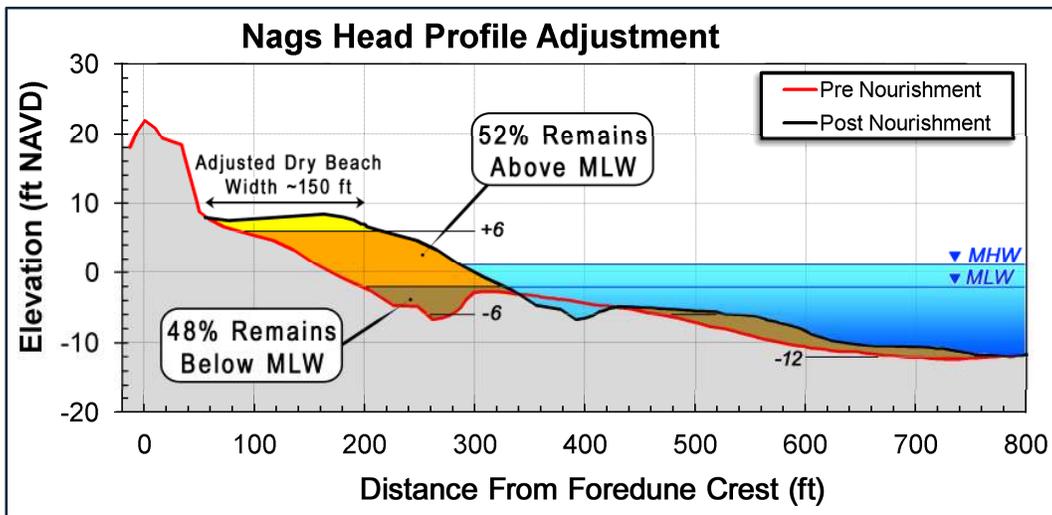
The middle diagram of Figure A shows the profile of the beach after Hurricane *Irene* (27 August) and several fall northeasters. Storm waves pushed some sand higher on the dry-sand beach (note yellow wedge) while at the same time the wet-sand beach receded landward. Thus, the dry beach narrowed by about 25-33 percent. Some sand from the wet beach shifted offshore and formed a bar 400-600 ft from the foredune (note the underwater sand buildup). We determined the limit of significant sand movement since nourishment was the 12-ft depth contour (~800 ft from the foredune).

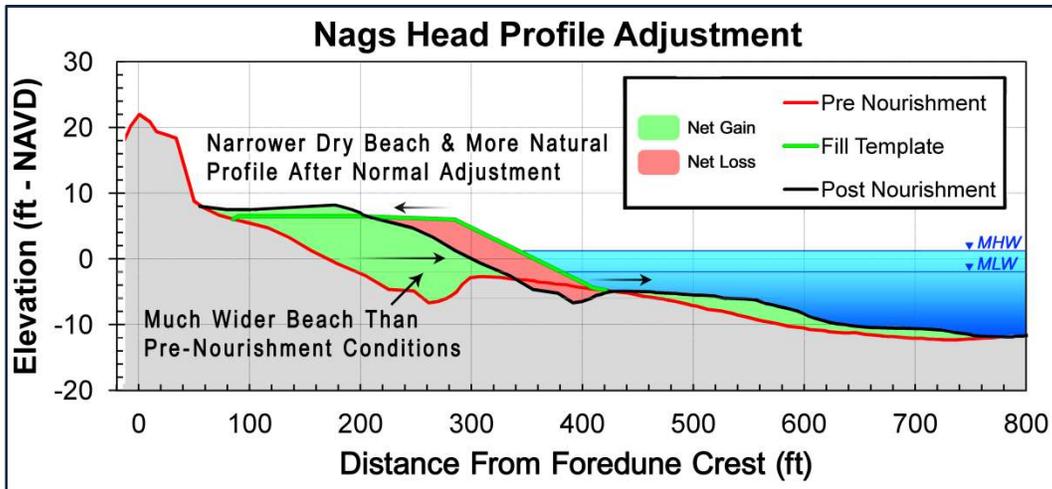
The lower diagram of Figure A compares the nourishment profile (referred to as “fill template”) and the adjusted profile. The red zone shows the portion of the nourishment profile that shifted onshore (to build the dry beach higher) and offshore (to form a new bar in shallow water). The green zone shows the net buildup of the beach and underwater area following nourishment and natural adjustments.

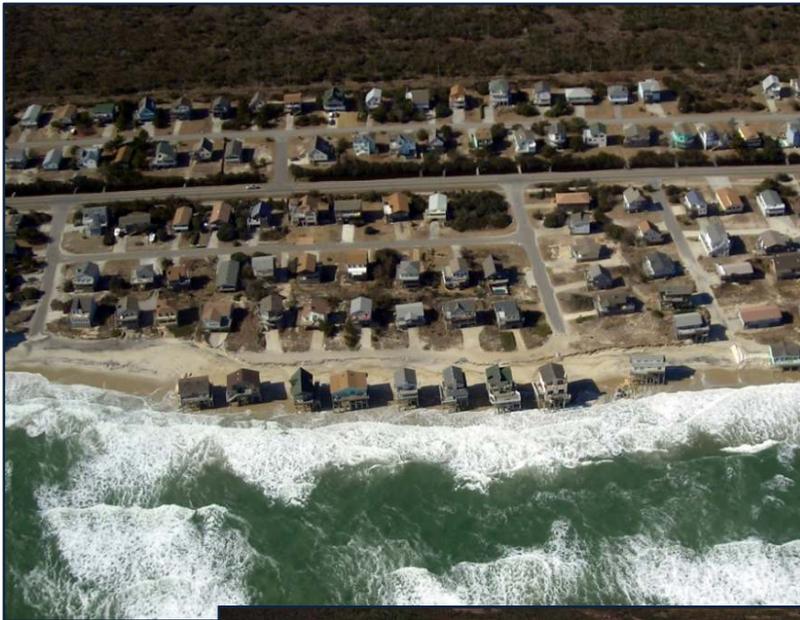
FIGURE B.
Aerial views of south Nags Head at
Seagull Drive.

[UPPER]
23 February 2011 – before nourishment.

Figure B illustrates conditions before and after nourishment. Prior to nourishment, condemned houses along Seagull Drive were sitting in the surf. Regulations precluded nourishment over exposed sandbags, so the project had to work around the Seagull houses, leaving a pond (see middle photo). Fall northeasters washed over the nourished beach and pushed sand into the pond (see bottom photo).

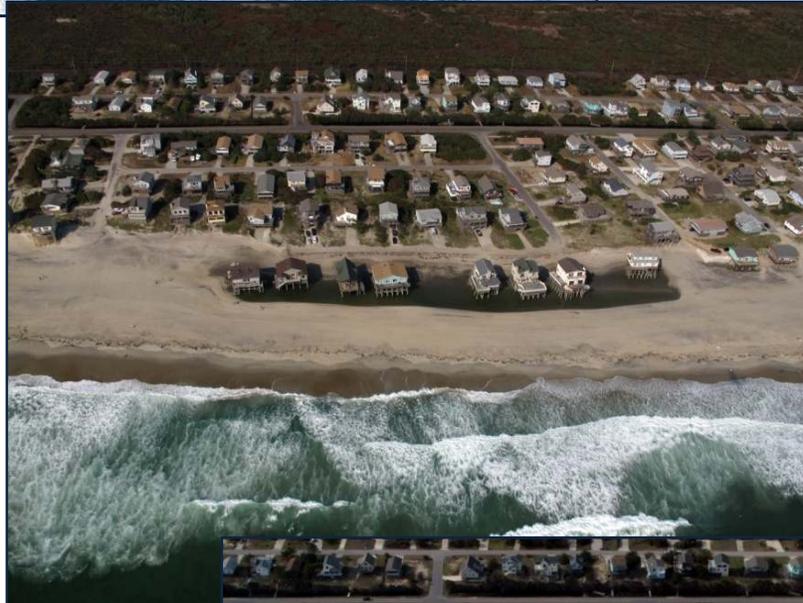
[MIDDLE]
2 September 2011 – after nourishment
and Hurricane *Irene* (note pond).

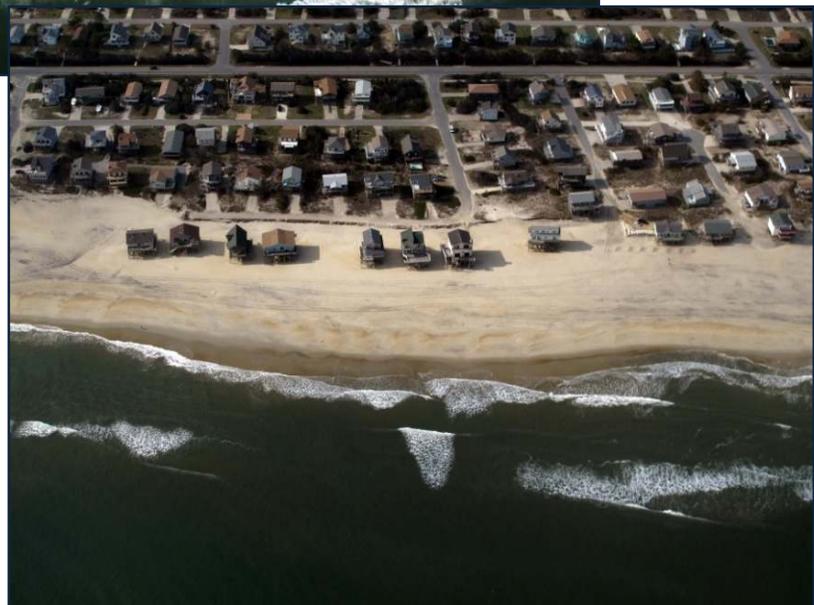
[LOWER]
21 November 2011 – after nourishment
and fall northeasters.

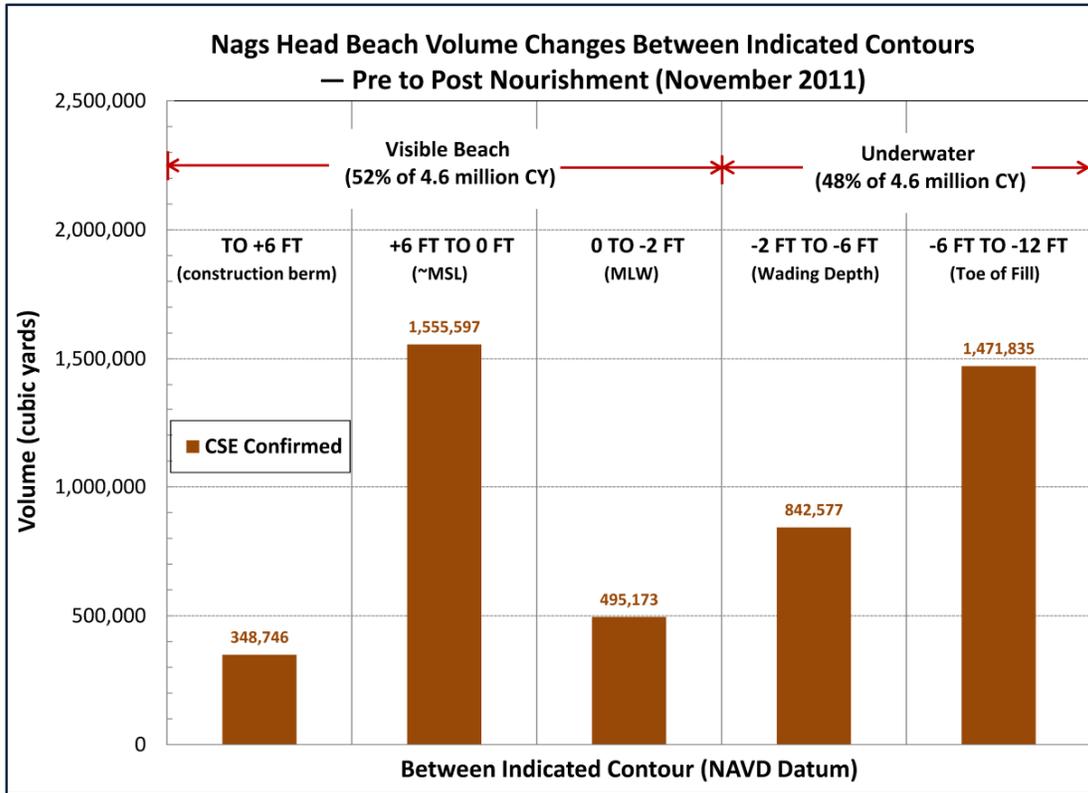
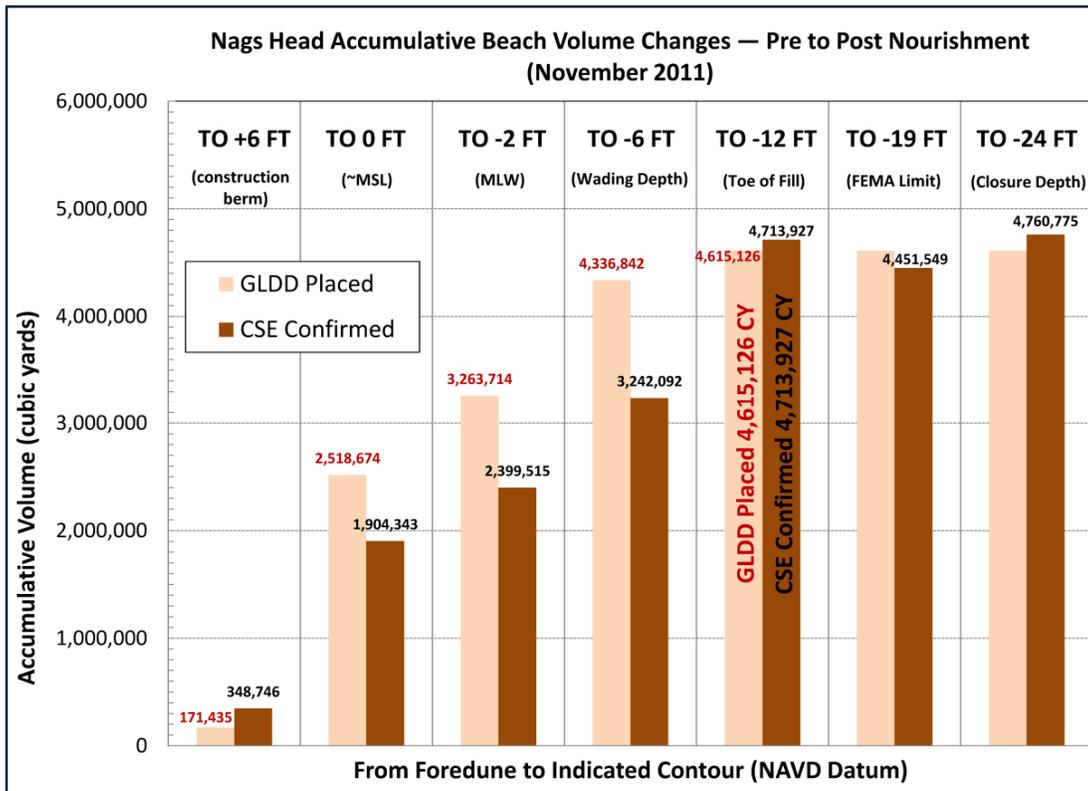
FIGURE C. Beach volume changes between November 2010 and November 2011. [UPPER] Sand volume changes between representative contours. [LOWER] Accumulated volume changes between the foredune crest and the indicated contour.

CSE’s measurements in November 2011 detected over 4.7 million cubic yards more sand along Nags Head beach (calculated to -12 ft contour) compared with conditions in November 2010. This result is better than expected and suggests there has been no loss of sand by natural processes over the past year and a gain of at least 4.6 million cubic yards via nourishment. Little or no sand has shifted out of the project area into deep water (>12 ft). Figure C (lower) shows the accumulated total volumes between the foredune and indicated depth contour. Project losses have been negligible to date within the boundaries set forth for the FEMA post-storm restoration criteria (-19 ft NAVD). Our measurements detected ~4.45 million cubic yards more sand between the foredune and the -19 ft contour. The difference between this volume and the nourishment volume (~150,000 cy) is about 3 percent which is considered within the limits of accuracy of underwater surveys for projects of this type.
