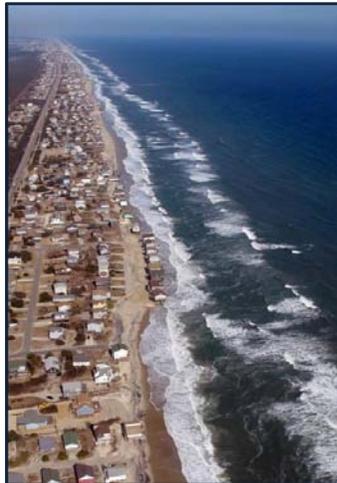
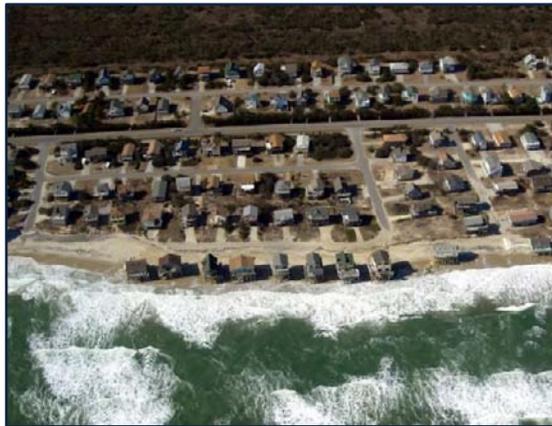
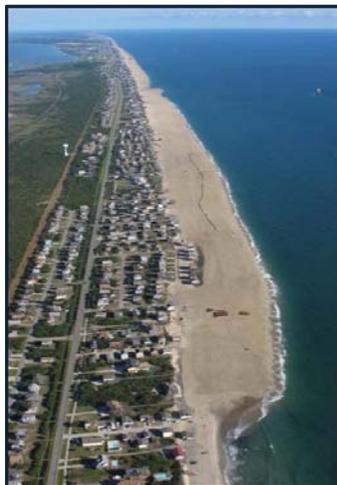
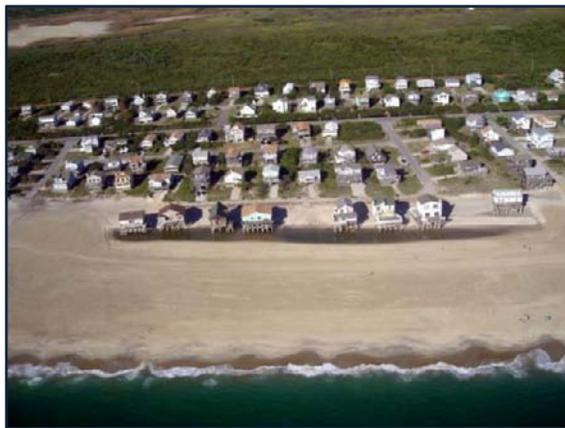
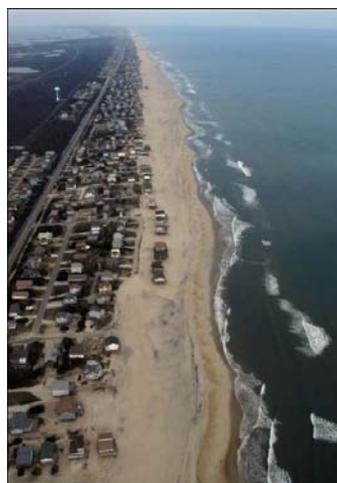
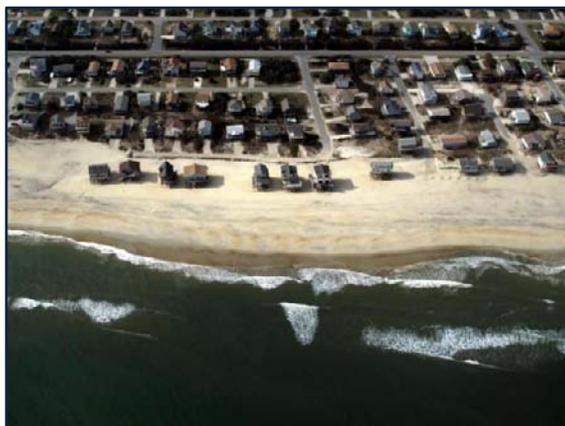
PHOTO 6 — South Nags Head (Reach 3): **[UPPER]** 23 February 2011 before nourishment showing condemned houses at Seagull Drive in the surf zone; **[MIDDLE]** 17 August 2011 after nourishment. Note a pond left in front of the condemned houses due to regulations precluding nourishment over exposed sandbags. **[LOWER]** 21 November 2011 after Hurricane *Irene* and project completion. Note the pond in front of the houses was filled naturally by overwash during fall northeasters. Also note rhythmic shoreline in November following passage of fall hurricanes and extratropical storms, reflecting irregular offshore bar morphology.

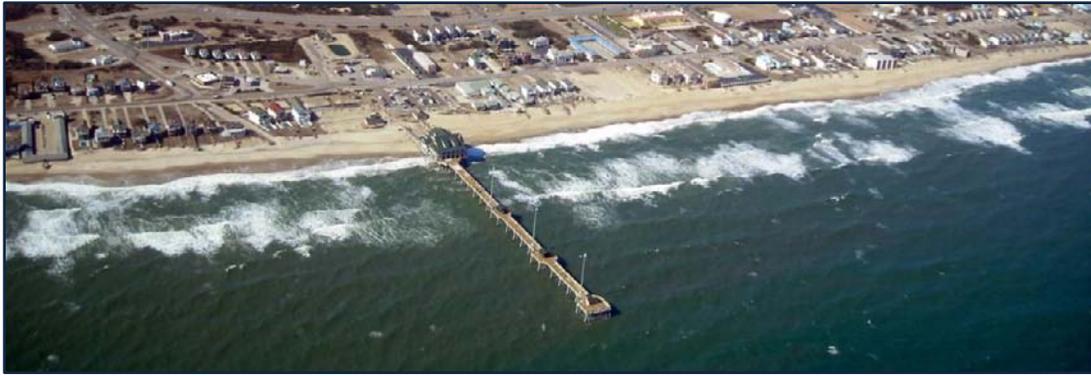
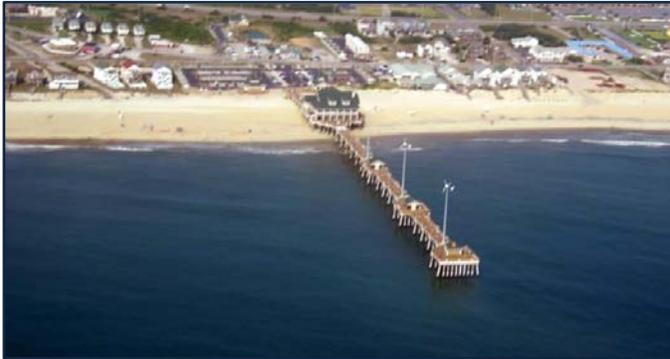
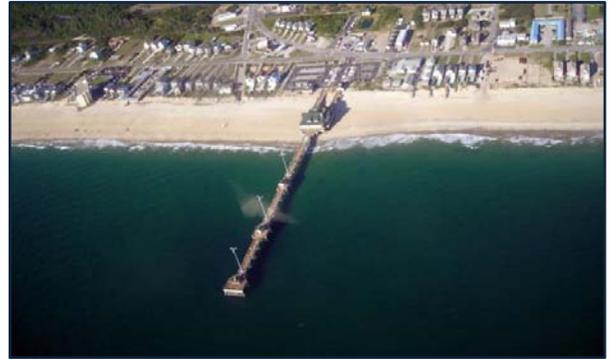
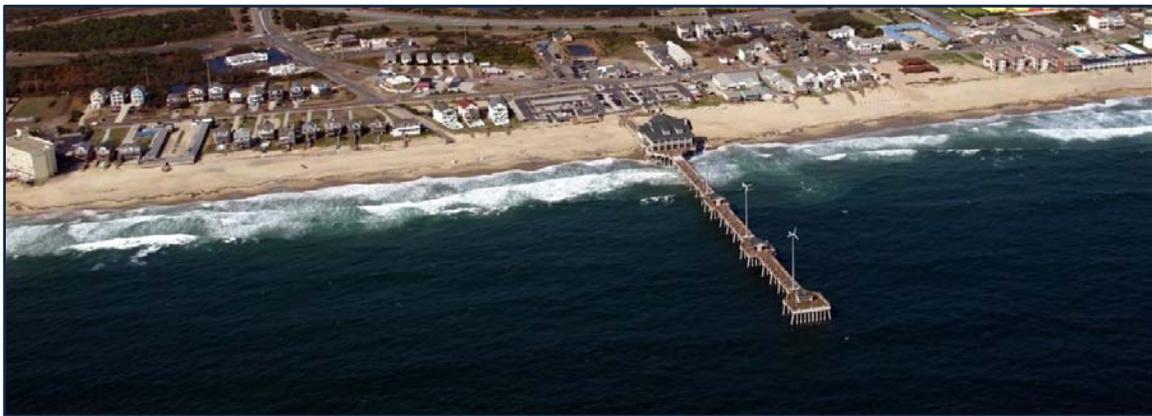
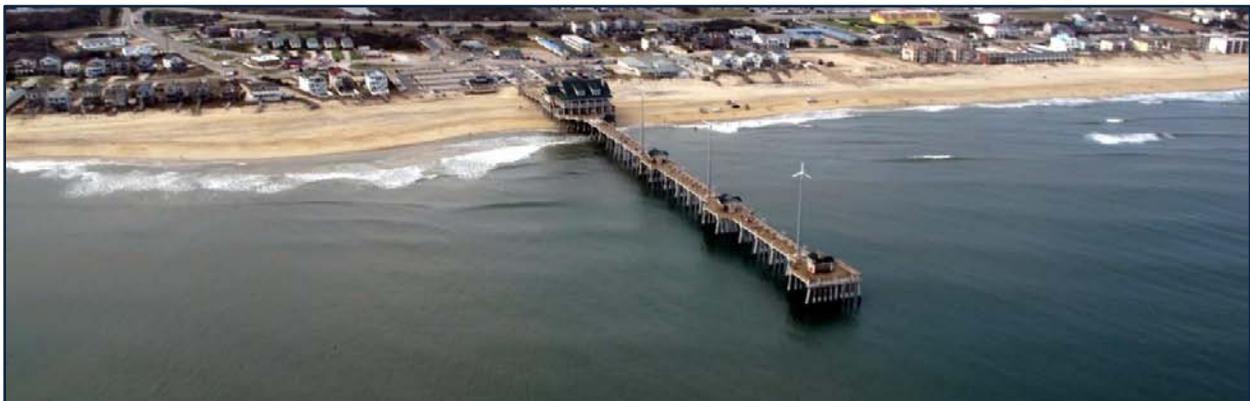
PHOTO 7 — Jennette's Pier (Reach 1): (upper) 23 February 2011, before the beach nourishment project; (middle left) 22 July, nourishment under the pier is completed; (middle right) 17 August, ten days before Hurricane *Irene*; (middle) 2 September six days after *Irene*; and (lower) 21 November, four weeks after project completion.

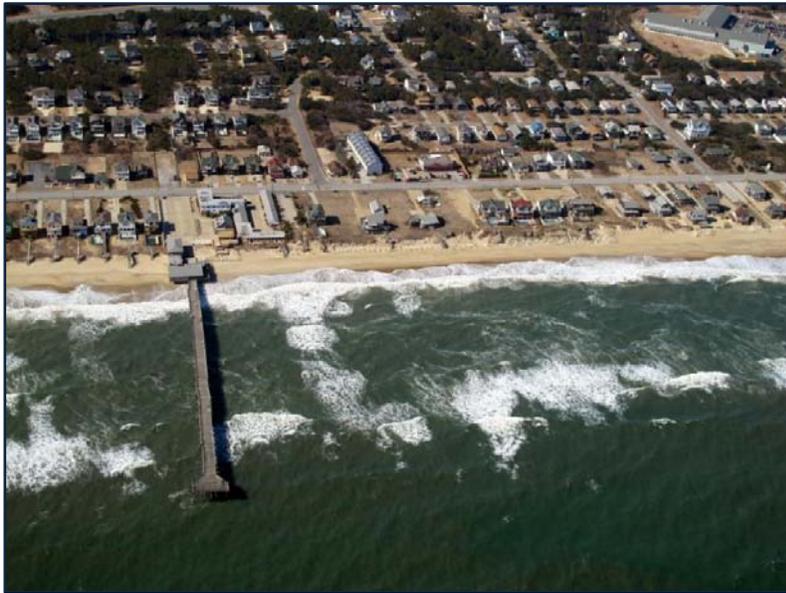
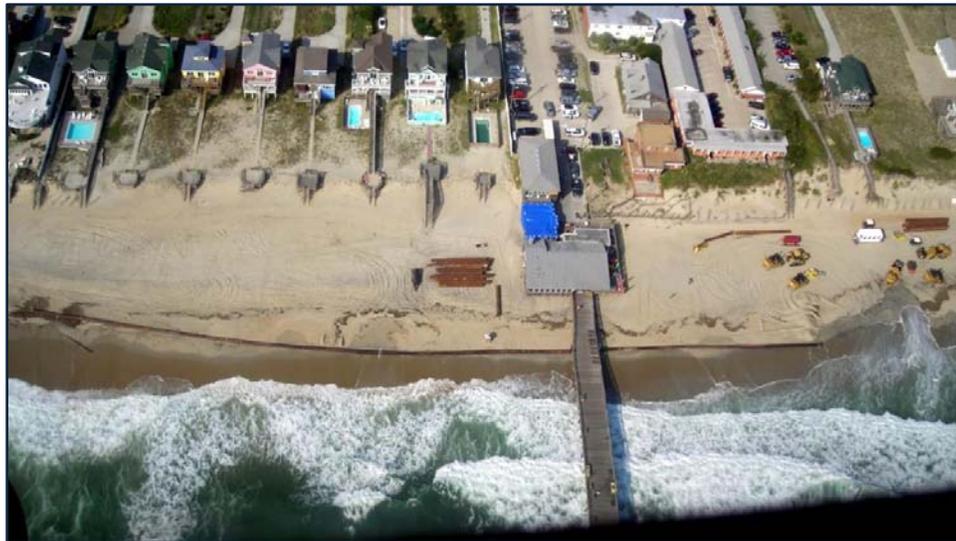
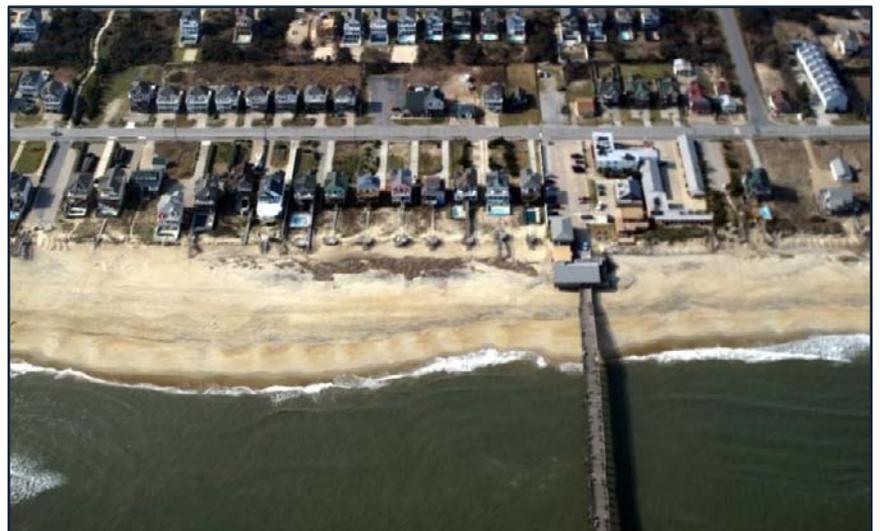
PHOTO 8 — Nags Head Pier (Reach 1)

[UPPER] 23 February 2011 before the beach nourishment project.

[MIDDLE] 2 September 2011, six days after Hurricane *Irene*; discharge point was just north of the pier.

[LOWER] 21 November 2011, four weeks after construction was completed.

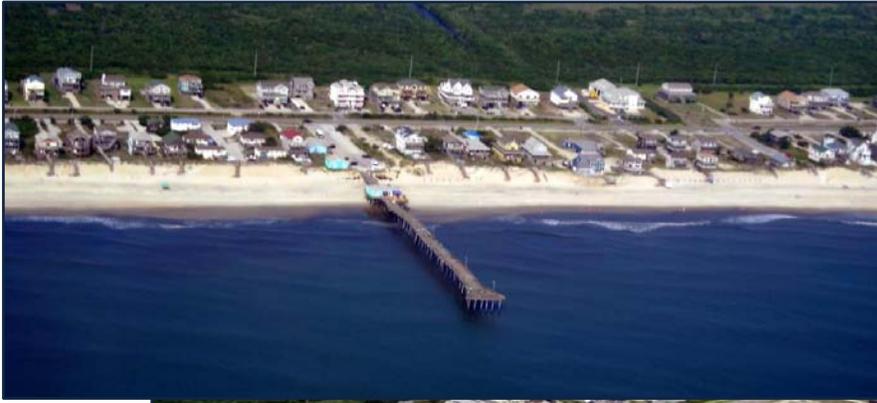
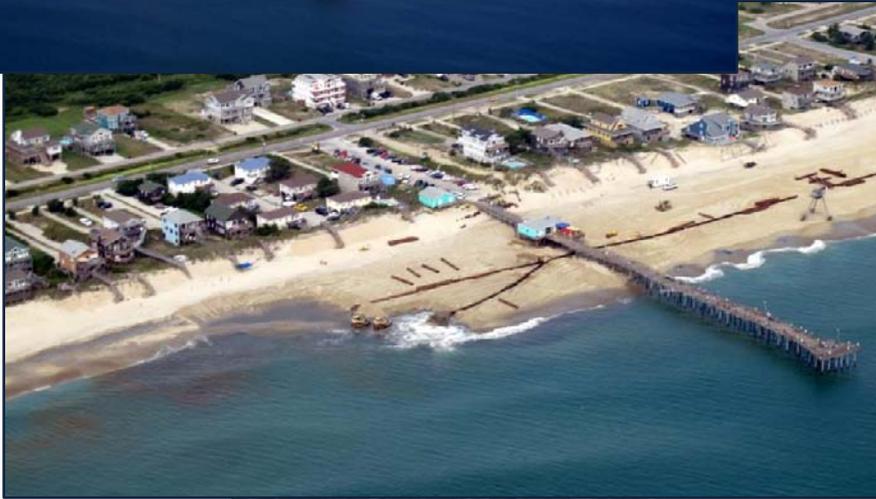
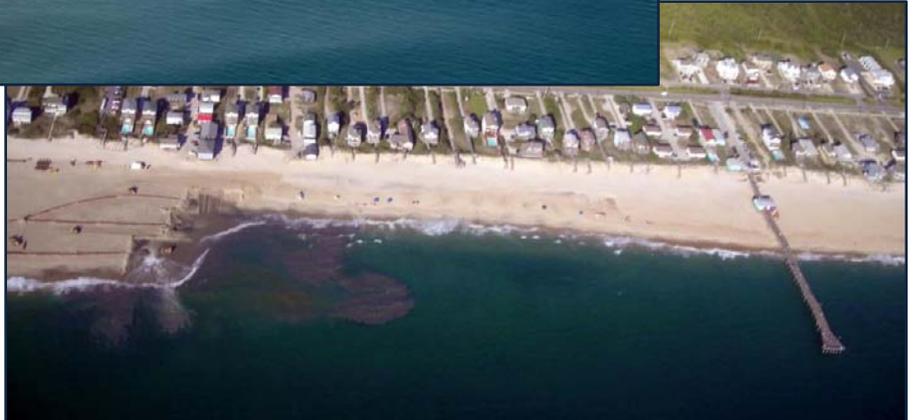
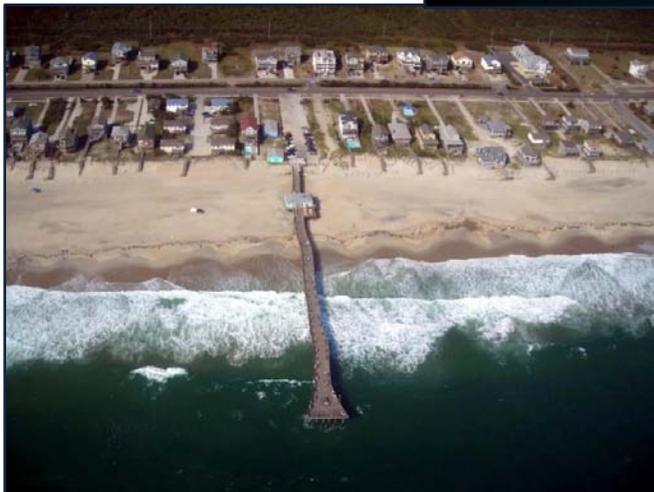
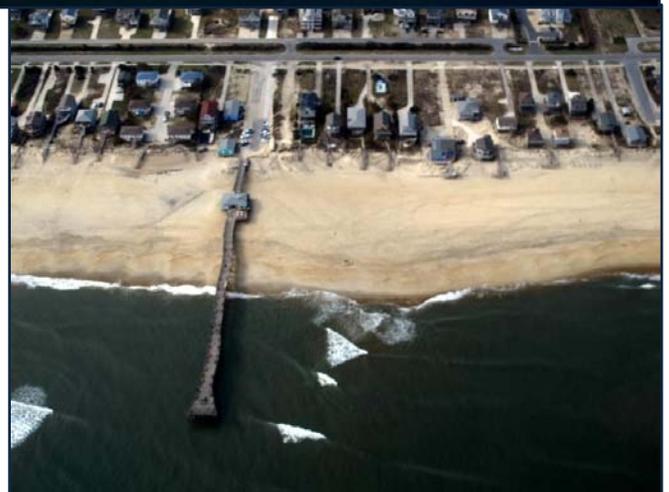
PHOTO 9 — Outer Banks Pier (Reach 2): (upper) 22 July 2011, before the beach nourishment project; (middle) 3 August, just pumping through the pier and the discharge point was south of the pier; (lower) 17 August, pumping from south of the pier; (lower left) 2 September, six days after Hurricane *Irene*; (lower right) 21 November, four weeks after construction was completed.

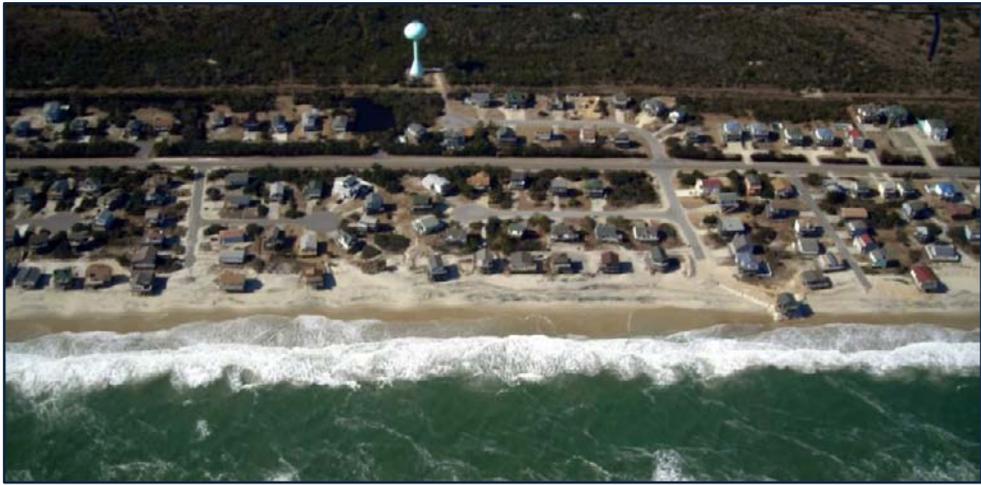
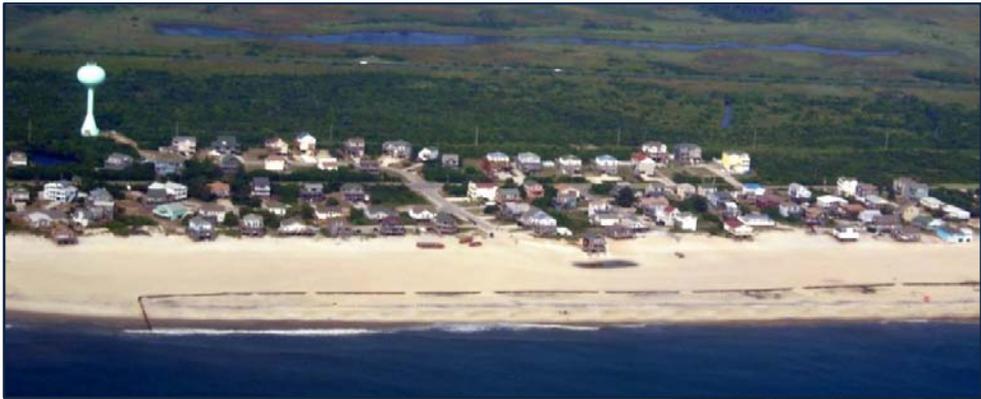
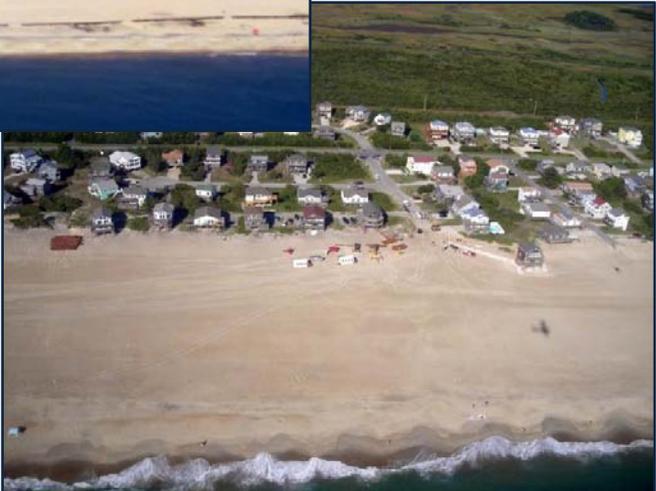
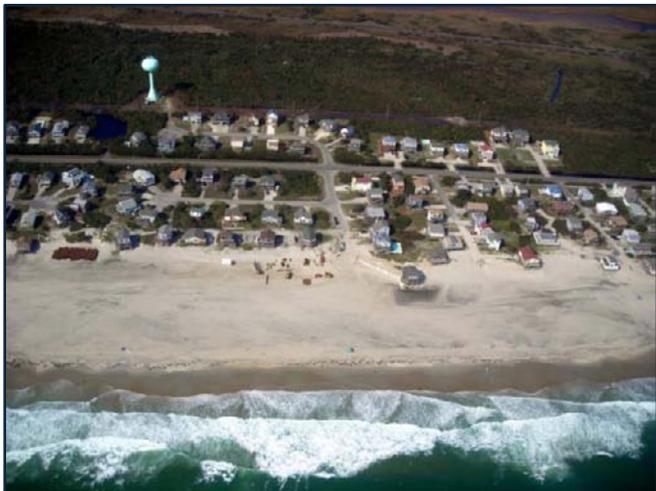
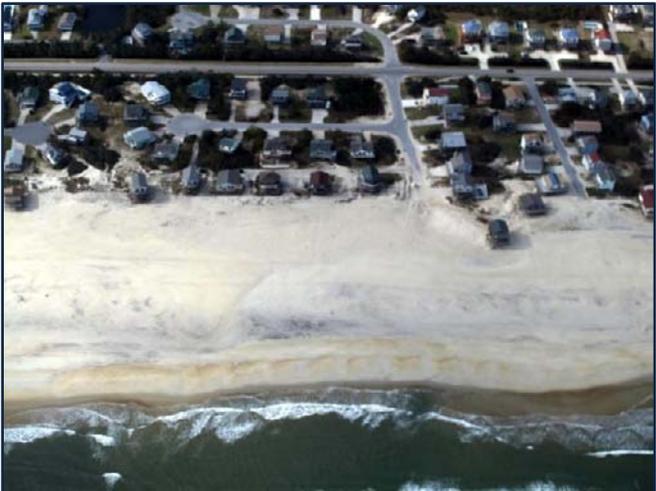
PHOTO 10 — Surfside Drive (Reach 3): (upper) 23 February 2011, before the nourishment project; (center left) 22 July, after nourishment project; (center right) 17 August, ten days before Hurricane *Irene*; (lower left) 2 September, six days after *Irene*; and (lower right) 24 November, four weeks after the project was completed.

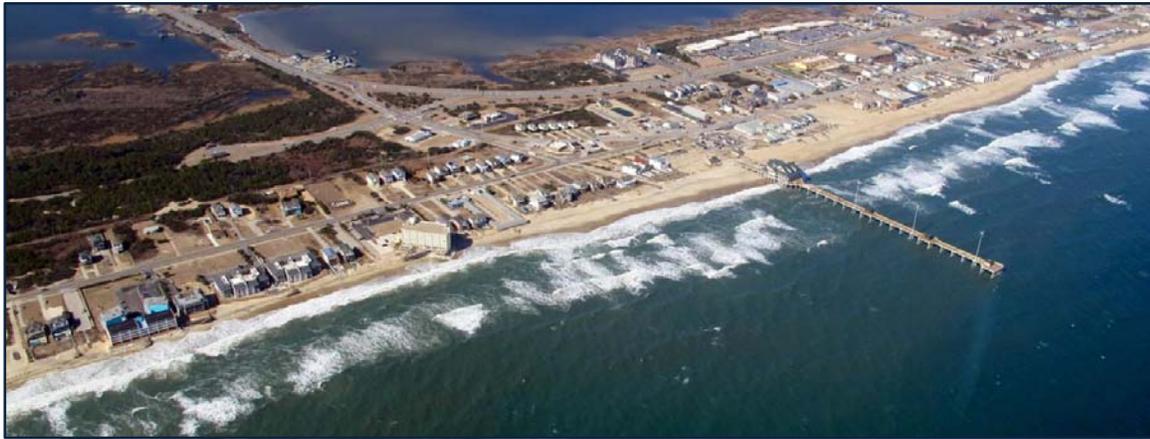
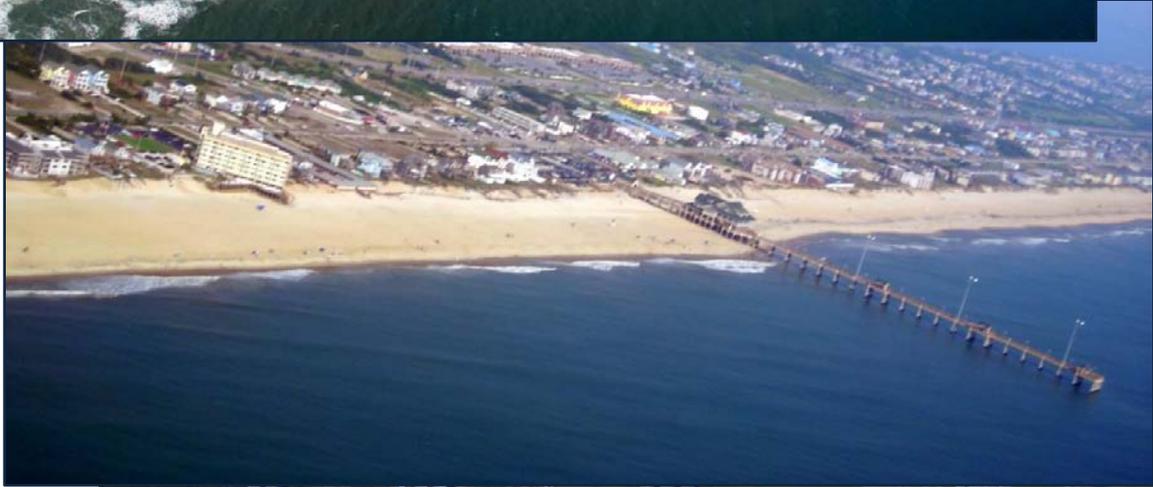
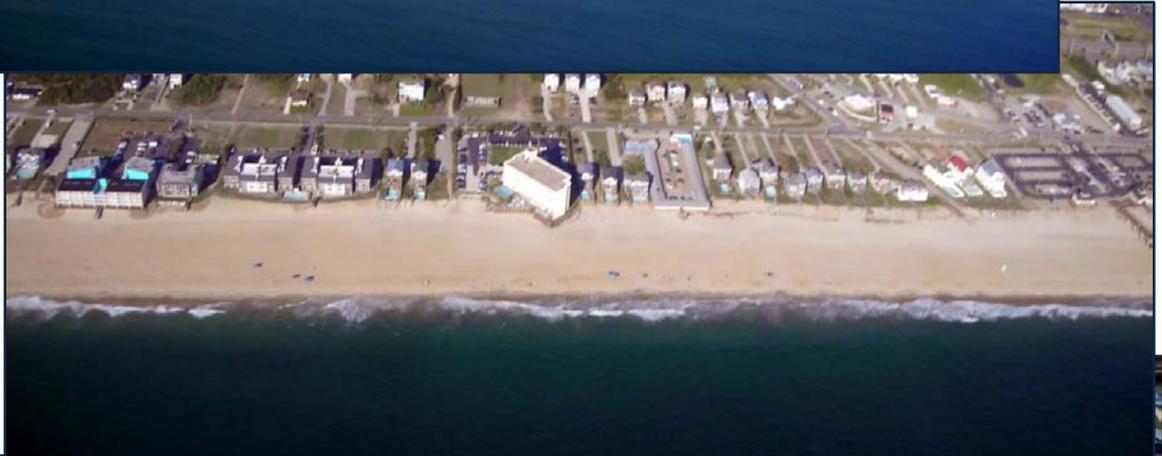
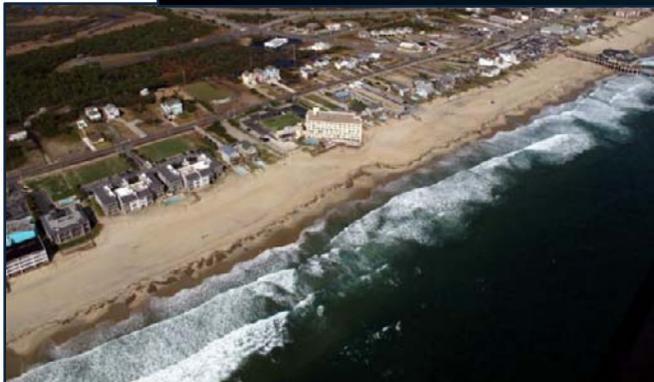
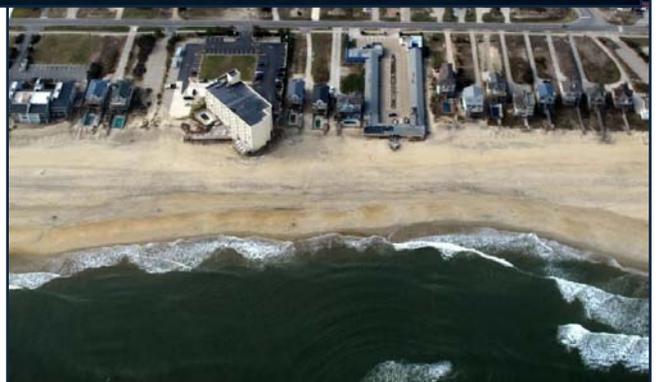
PHOTO 11 — Comfort Inn: (upper) 23 February 2011, before the beach nourishment project; (center) 22 July, shortly after pumping in front of the hotel; (lower) 17 August, ten days before Hurricane *Irene*; (bottom left) 2 September, six days after *Irene*; (bottom right) 21 November, four weeks after project completion.

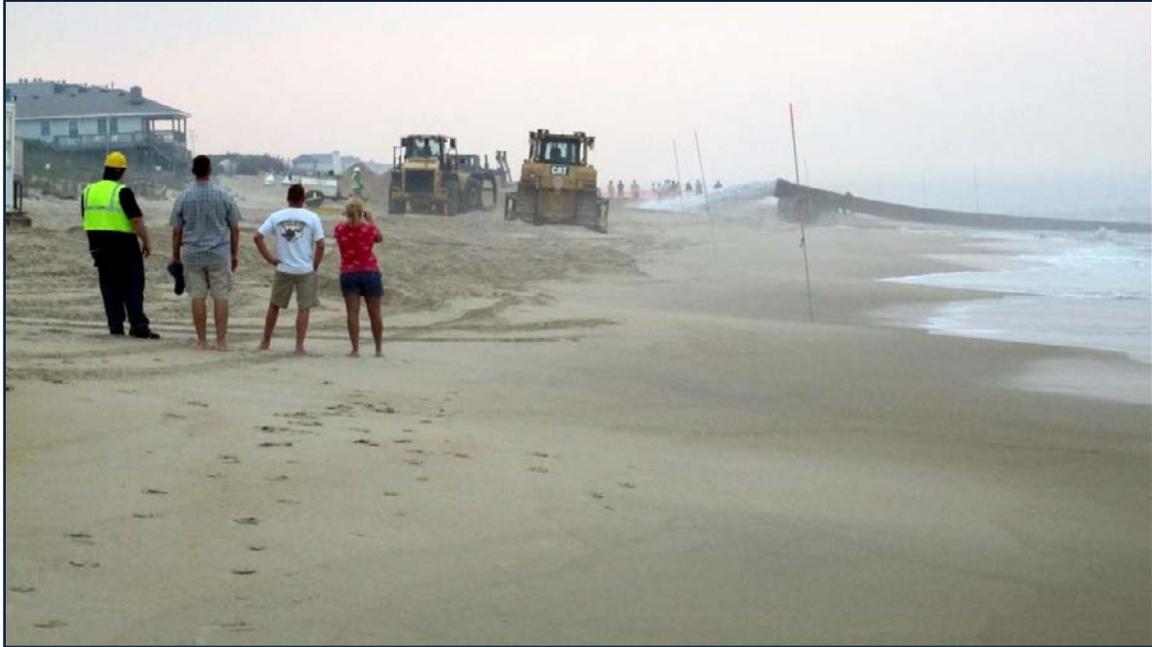
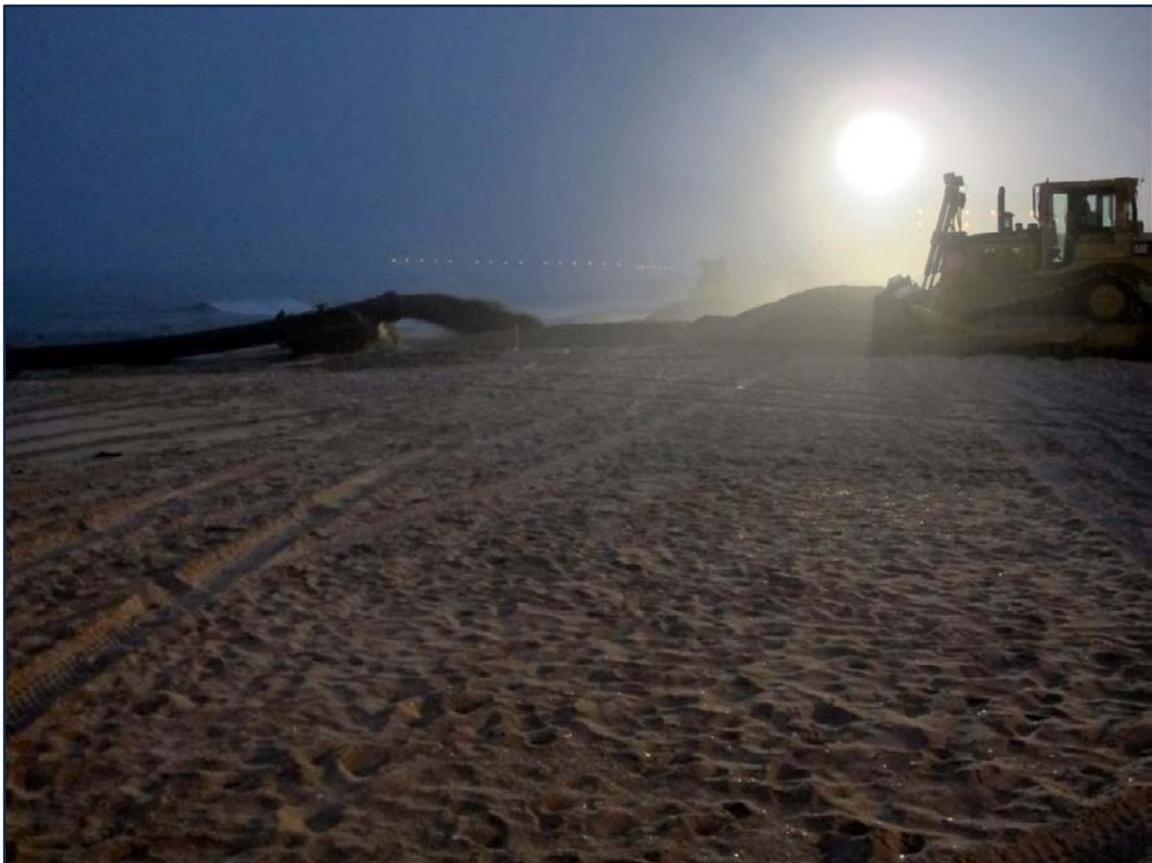
PHOTO 12 — First load of sand was pumped at 8:20 pm on 24 May 2011 by dredge *Liberty Island*. The discharge point was at station 728+00 near Forbes Street.

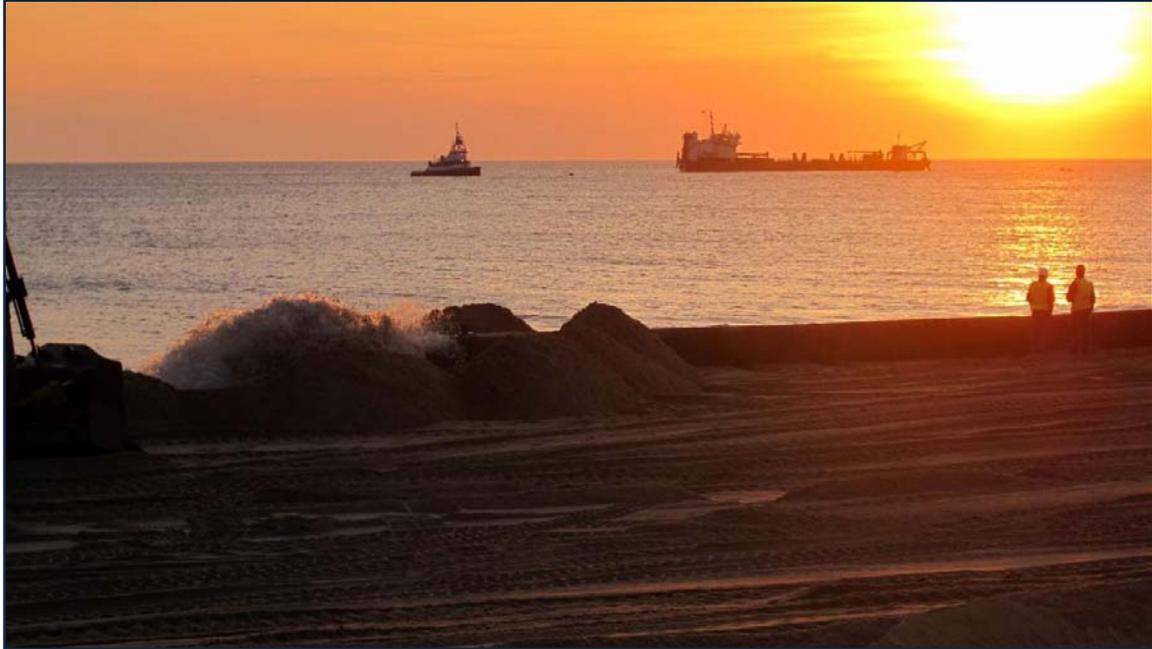
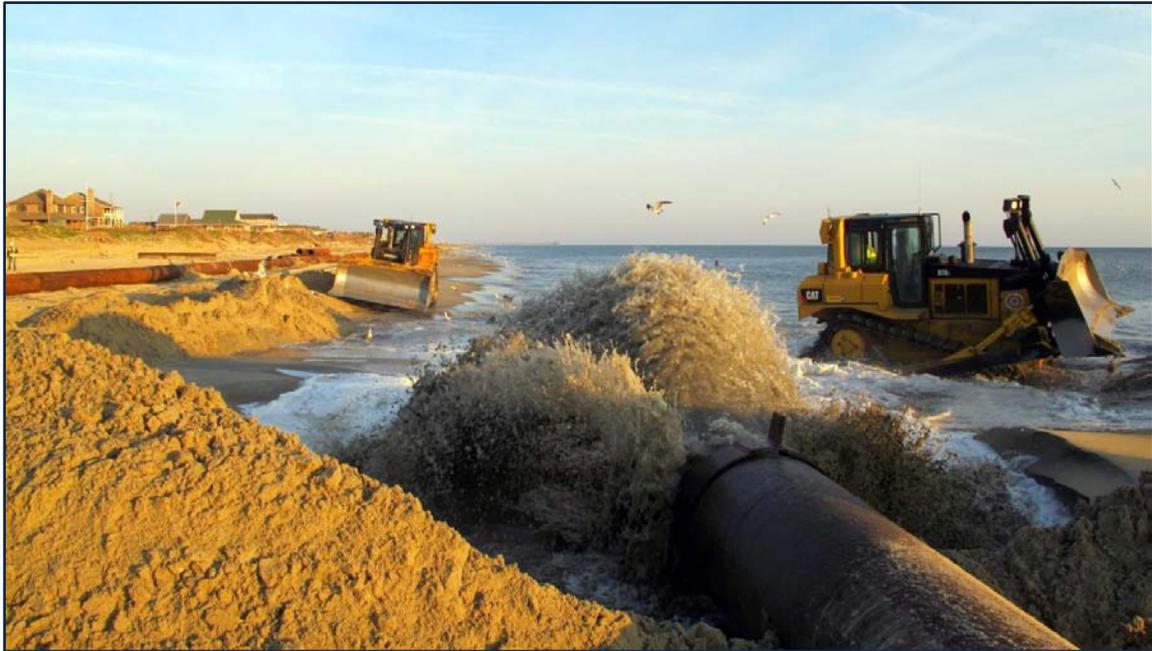
PHOTO 13 — Last load of sand was pumped at 8:20 am on 27 October 2011 by dredge *Padre Island*. The discharge point was at station 585+00 in Nags Head historic district.

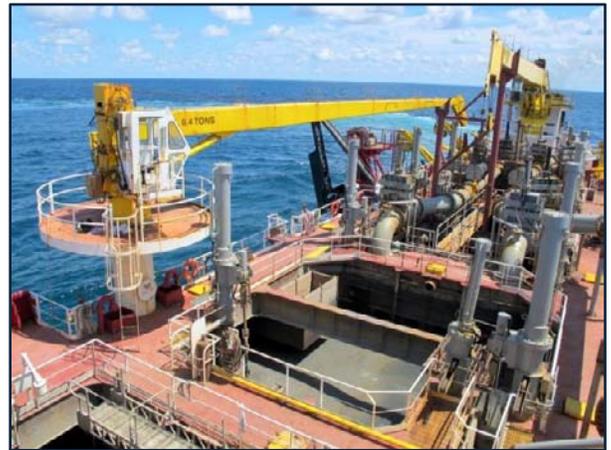
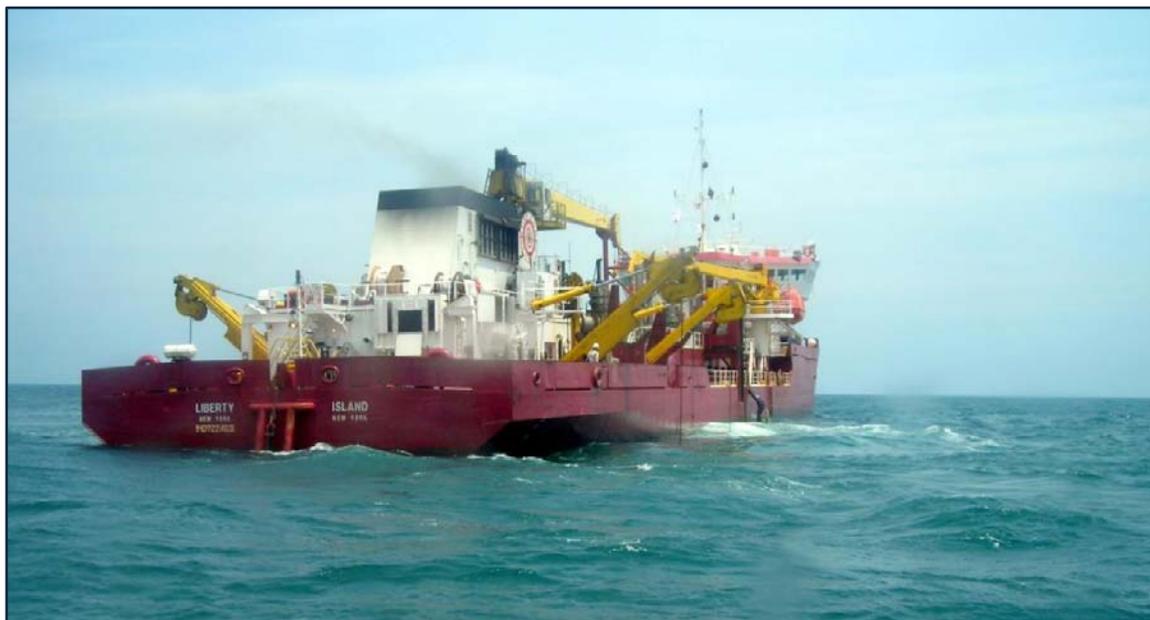
[UPPER RIGHT] GLDD's survey equipment Coastal Research Amphibious Buggy (CRAB) was collecting data on 27 October 2011.

[MIDDLE and LOWER] Dredge *Liberty Island* completed 499 loads with a reported volume of ~2.2 million cy (almost half of the total contract volume).

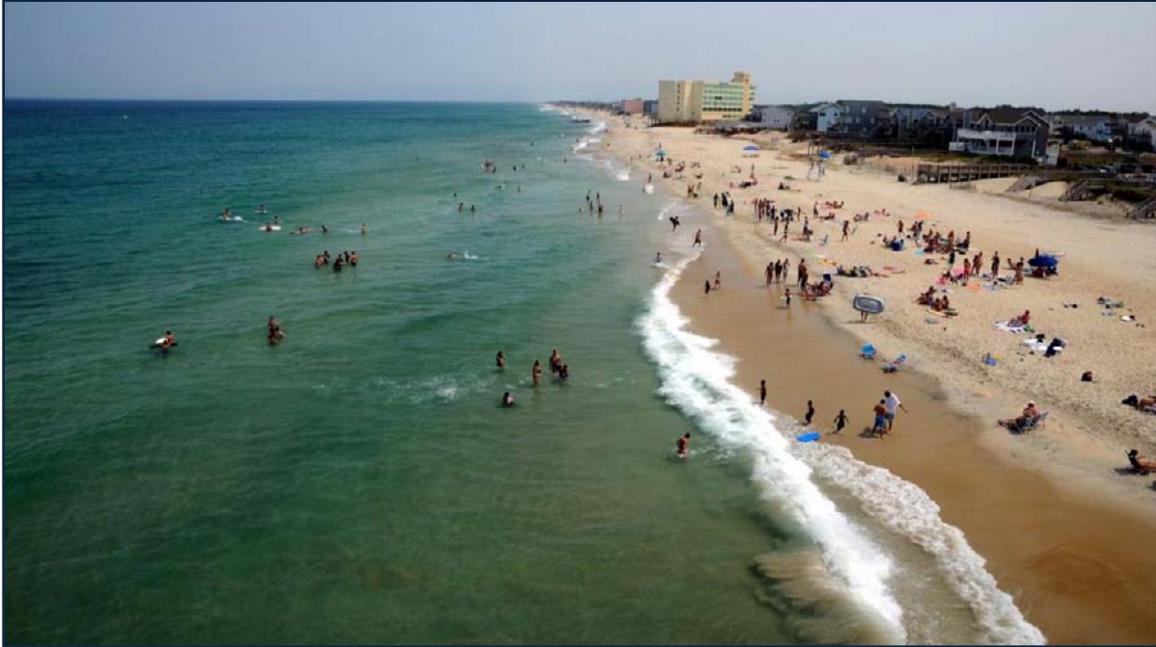
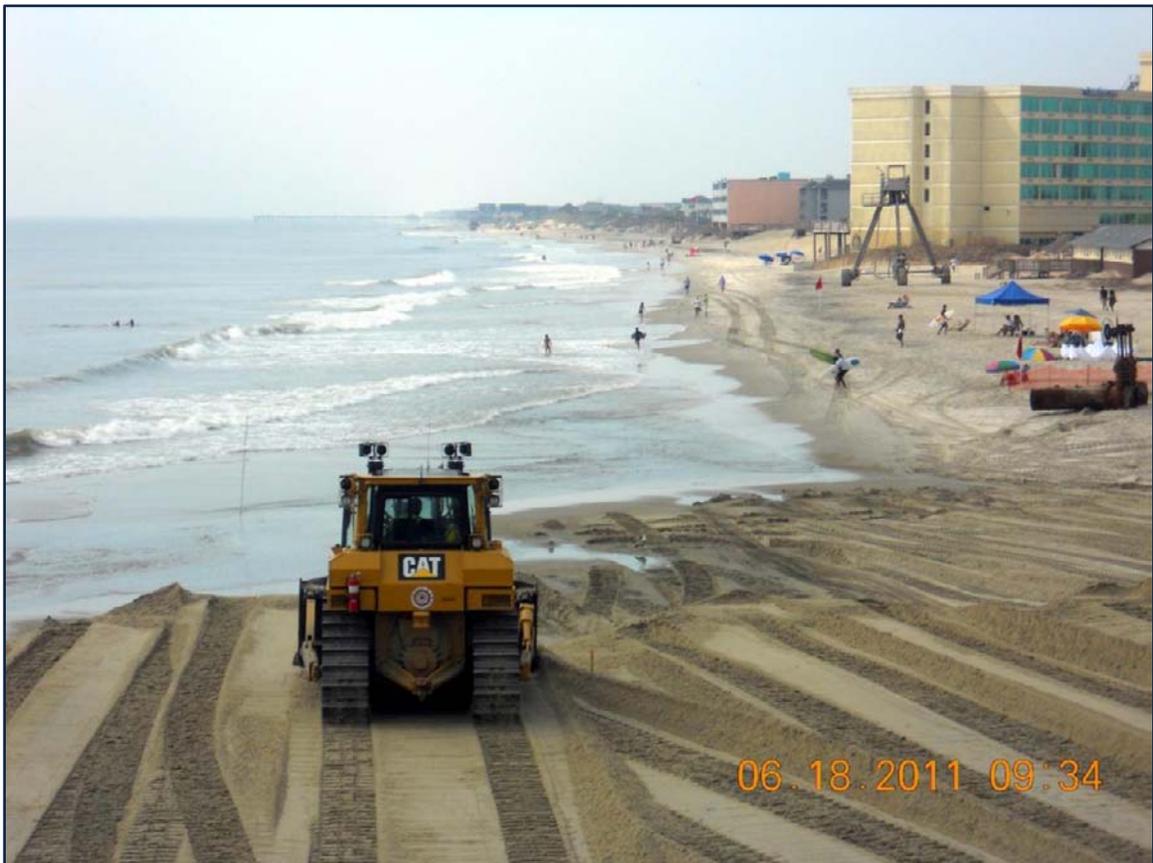
PHOTO 15 — Looking south from Jennette's Pier: (upper) 9 June 2011, before the nourishment project; (lower) 18 June, during construction.

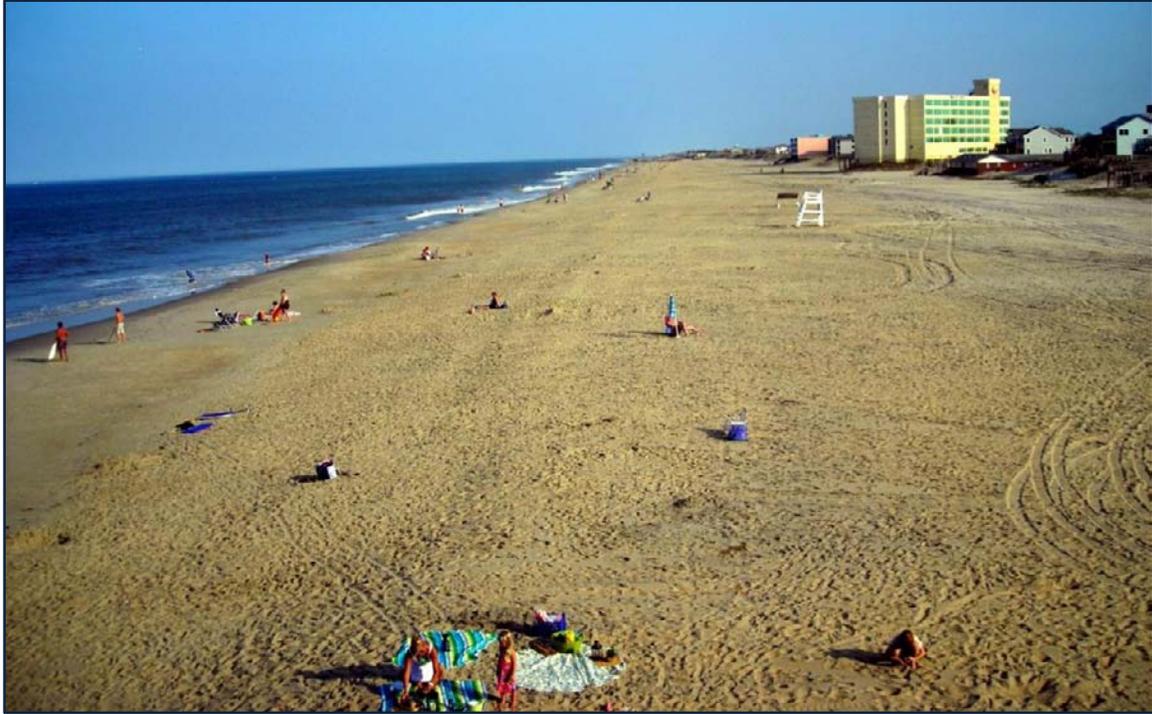
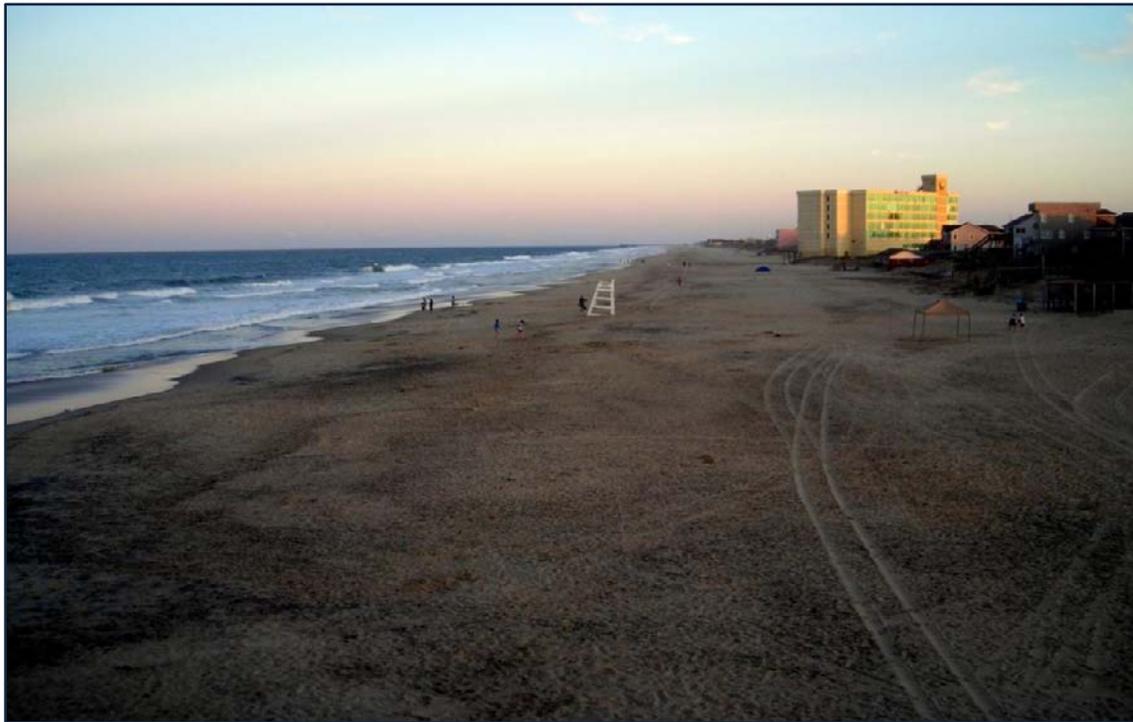
PHOTO 16 — Looking south from Jennette's Pier: (upper) 20 July 2011, a month after the nourishment project; (lower) 31 August, four days after Hurricane *Irene*.

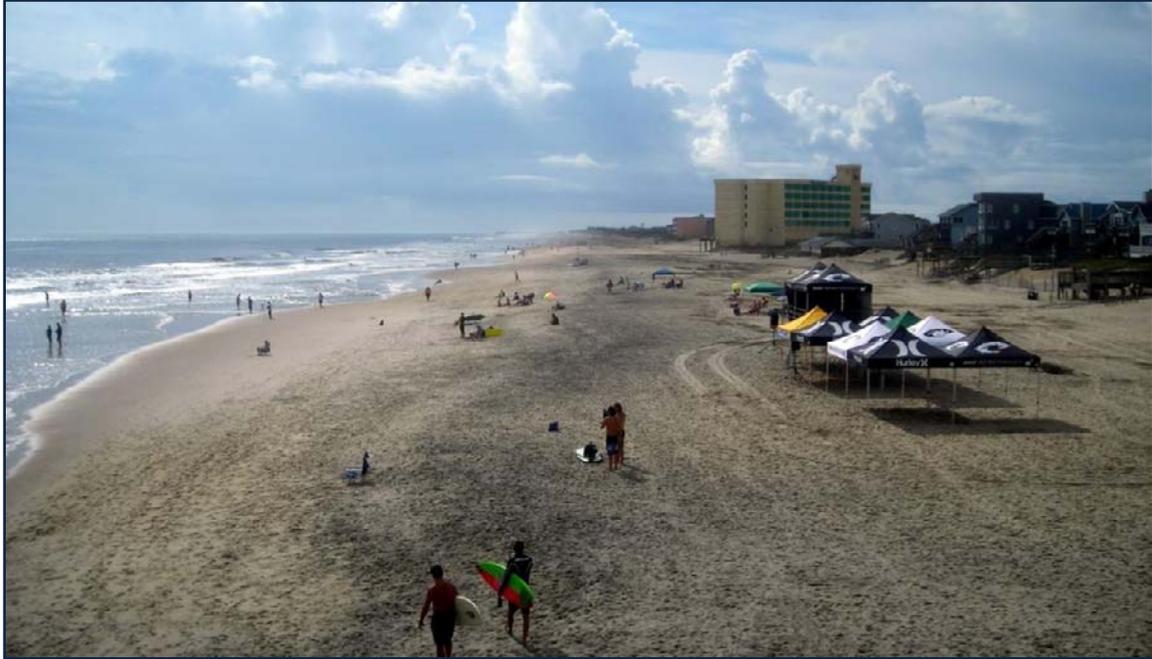
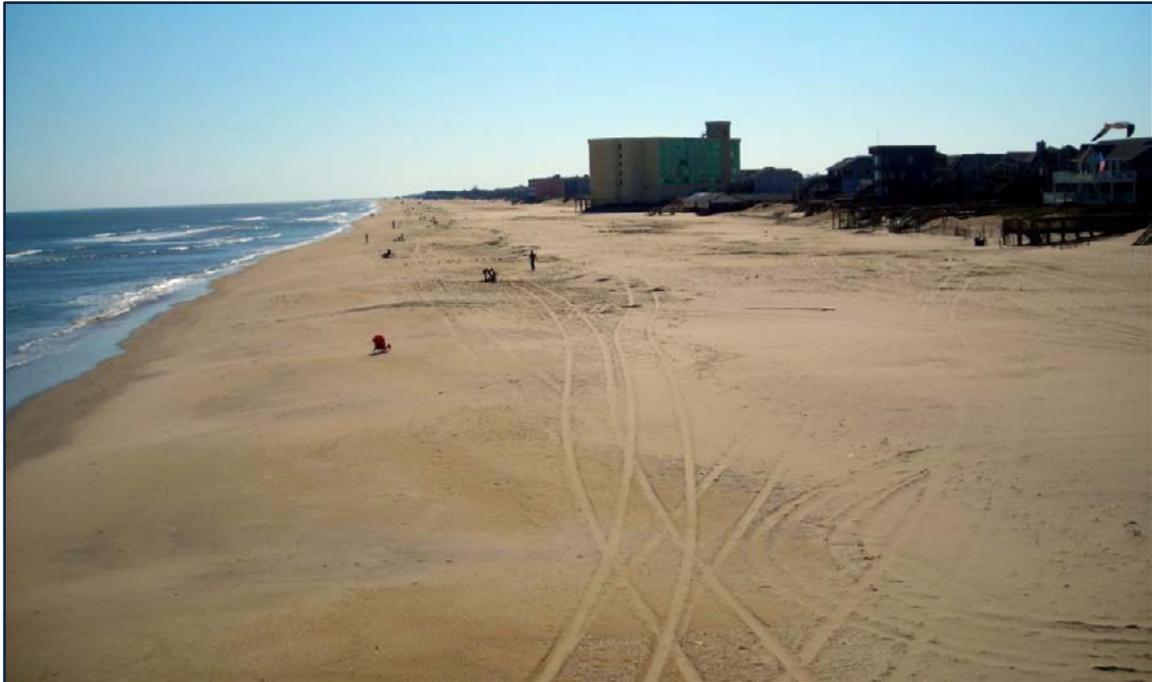
PHOTO 17 — Looking south from Jennette's Pier: (upper) 22 September 2011, three months after the nourishment project; (lower) 27 October, the day of the project completion.

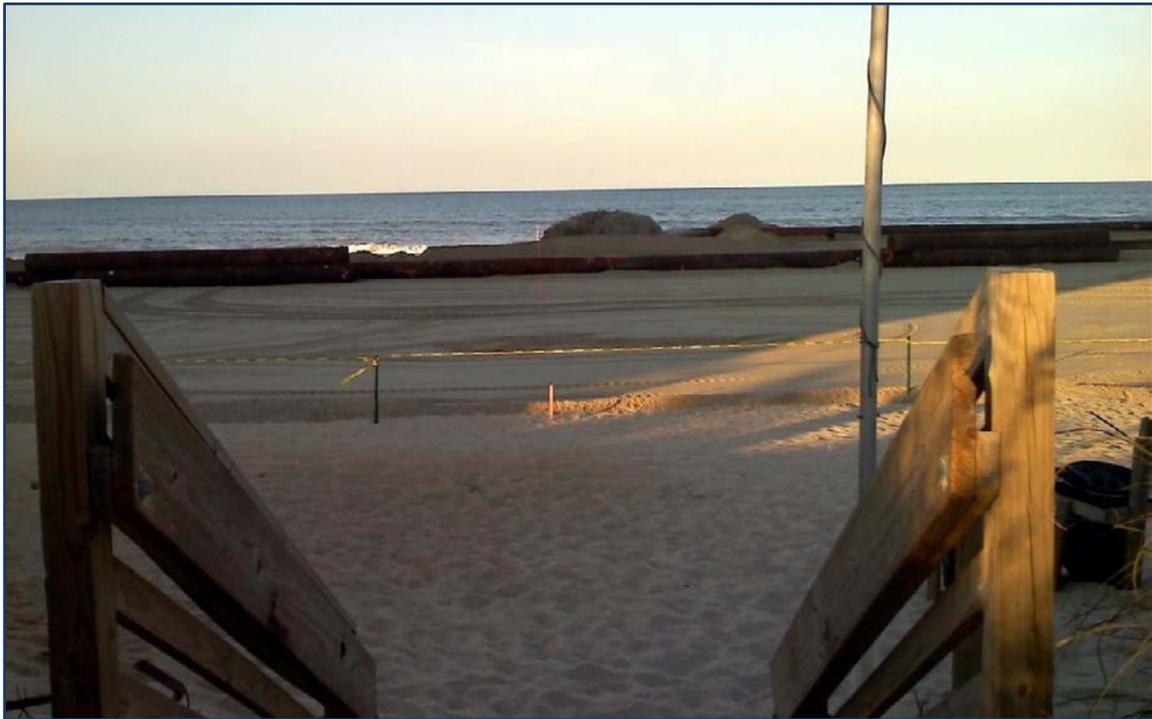
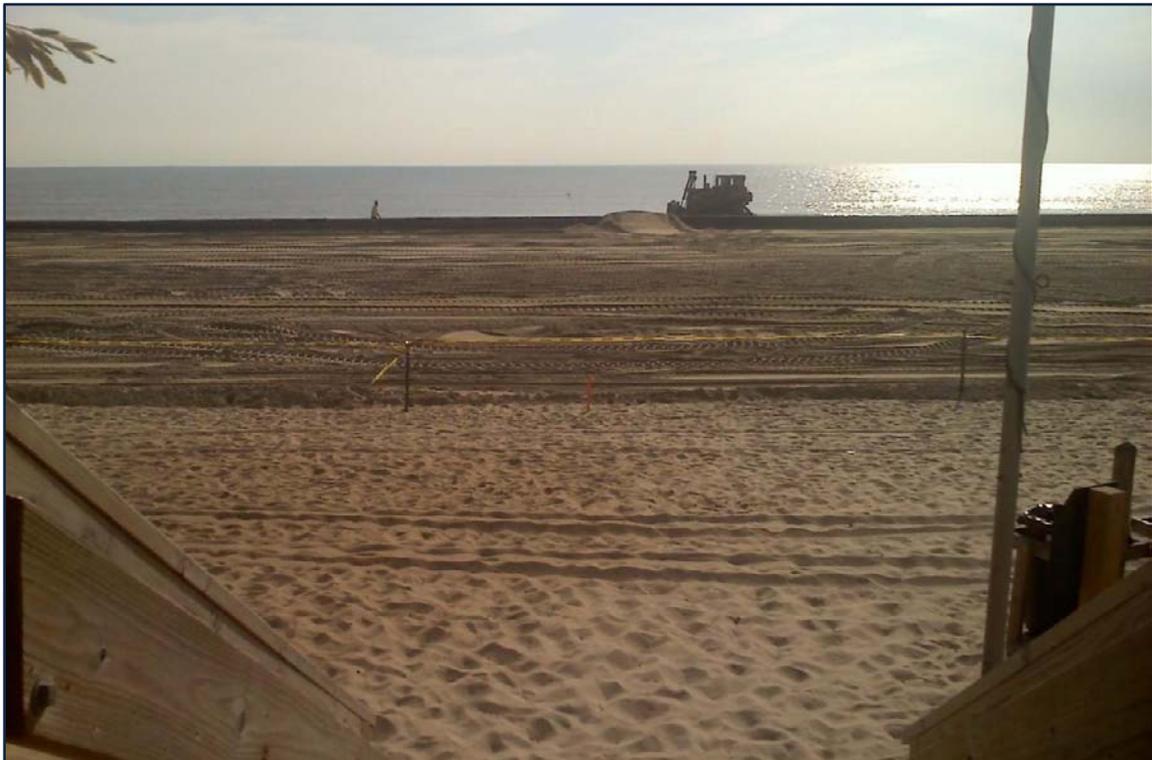
PHOTO 18 — Governor Street: (upper) 21 July 2011, pumping operations were in front of the public beach access; (lower) 22 July, 24 hours after the pumping operations. A dozer was pushing up sand to make a ramp over the discharging pipes.
