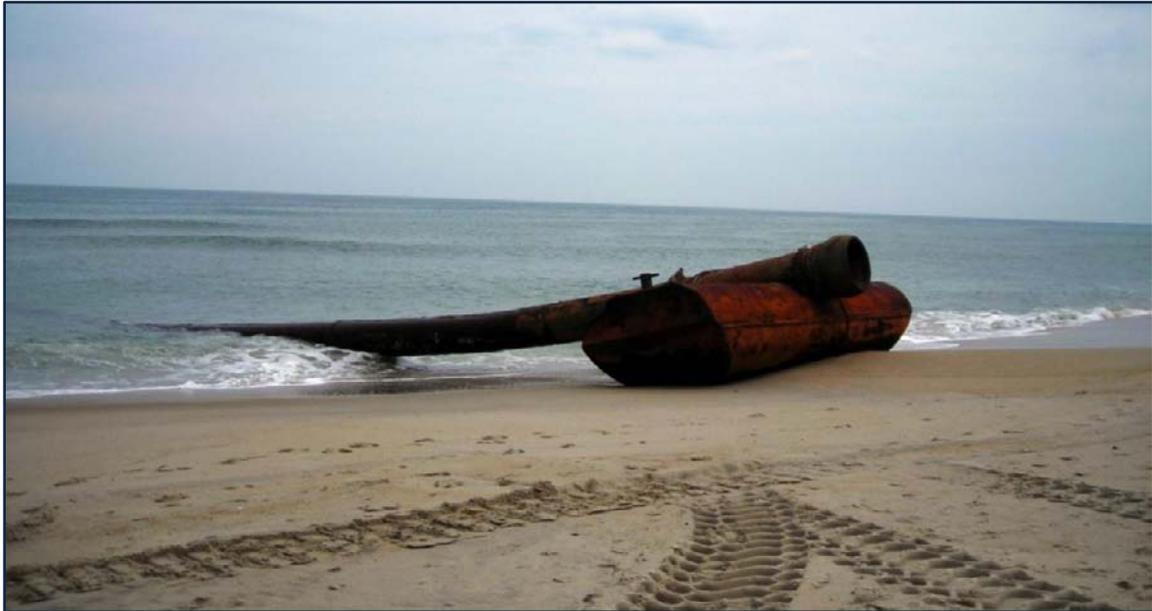
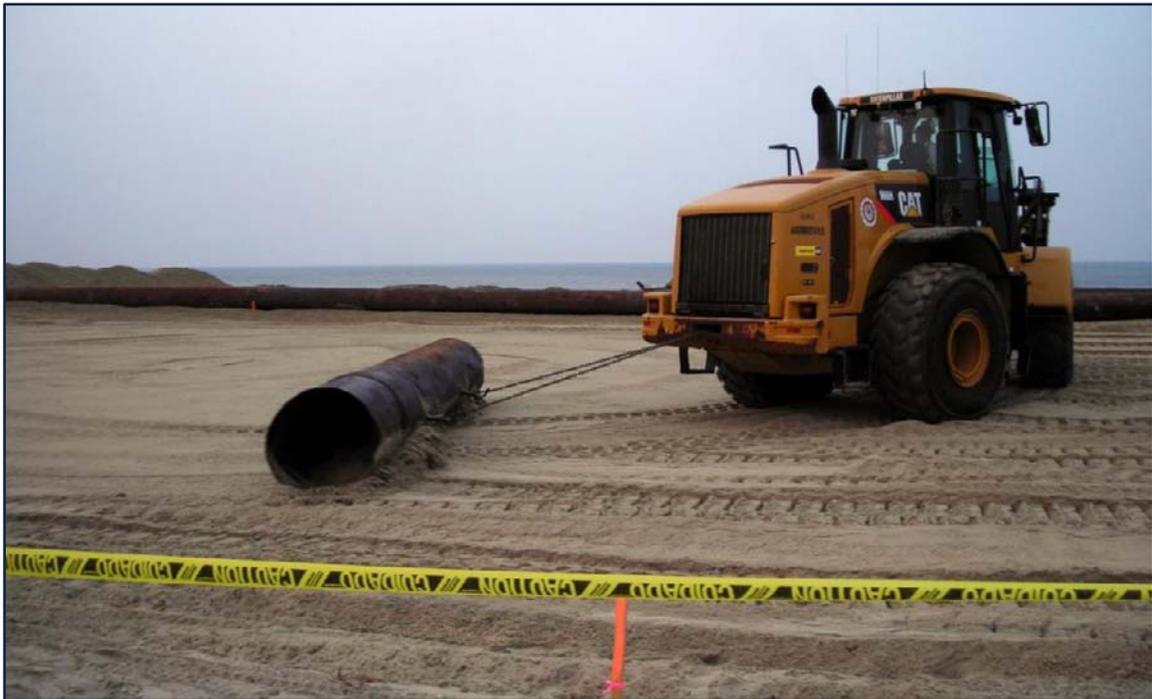
PHOTO 19 — [UPPER] First submerged pipe landing point at station 728+50 near Forbes Street (20 May 2011). [LOWER] GLDD's D7 dozer dragging a pipe to smooth the newly nourished beach before it is re-opened to the public on (22 June 2011).

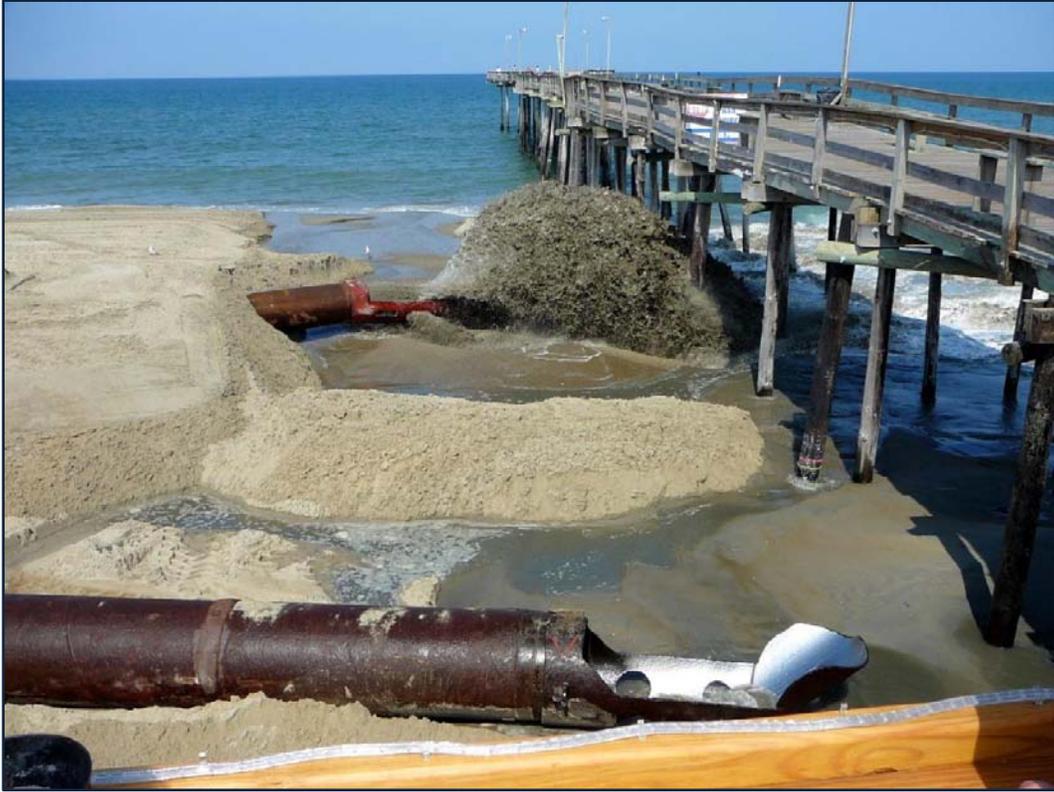
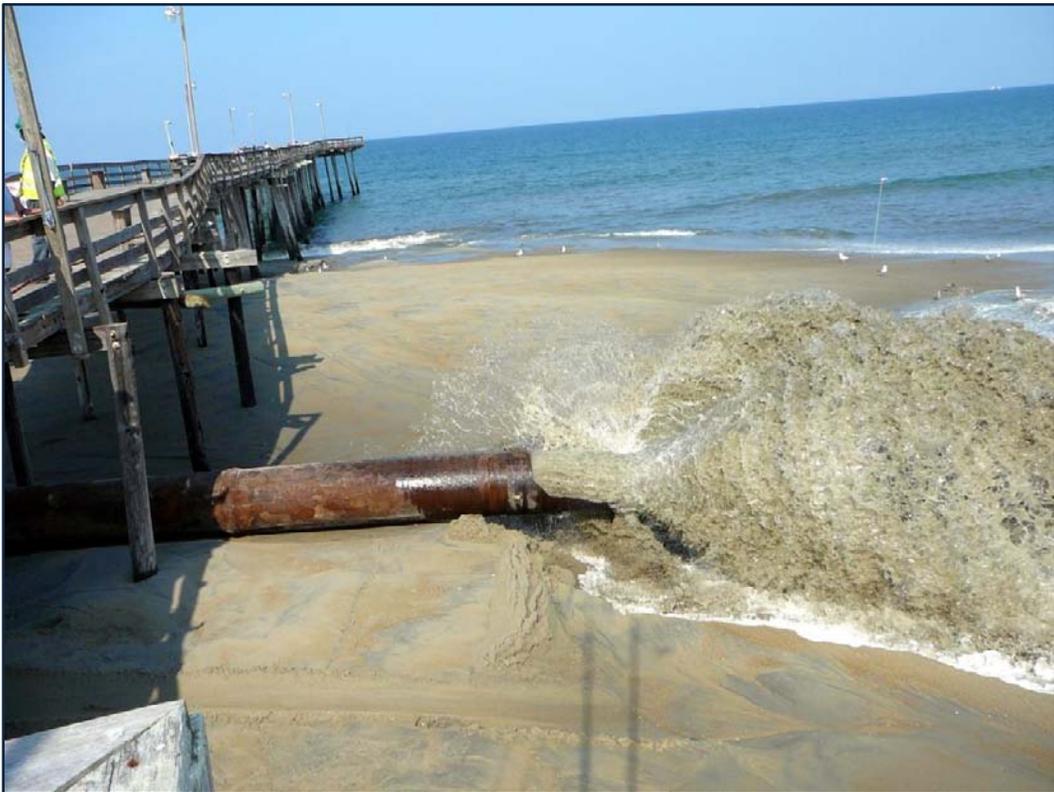
PHOTO 20 — Pumping through Outer Banks Pier (photo by Marvin Demers, Nags Head citizen, 2 August 2011).

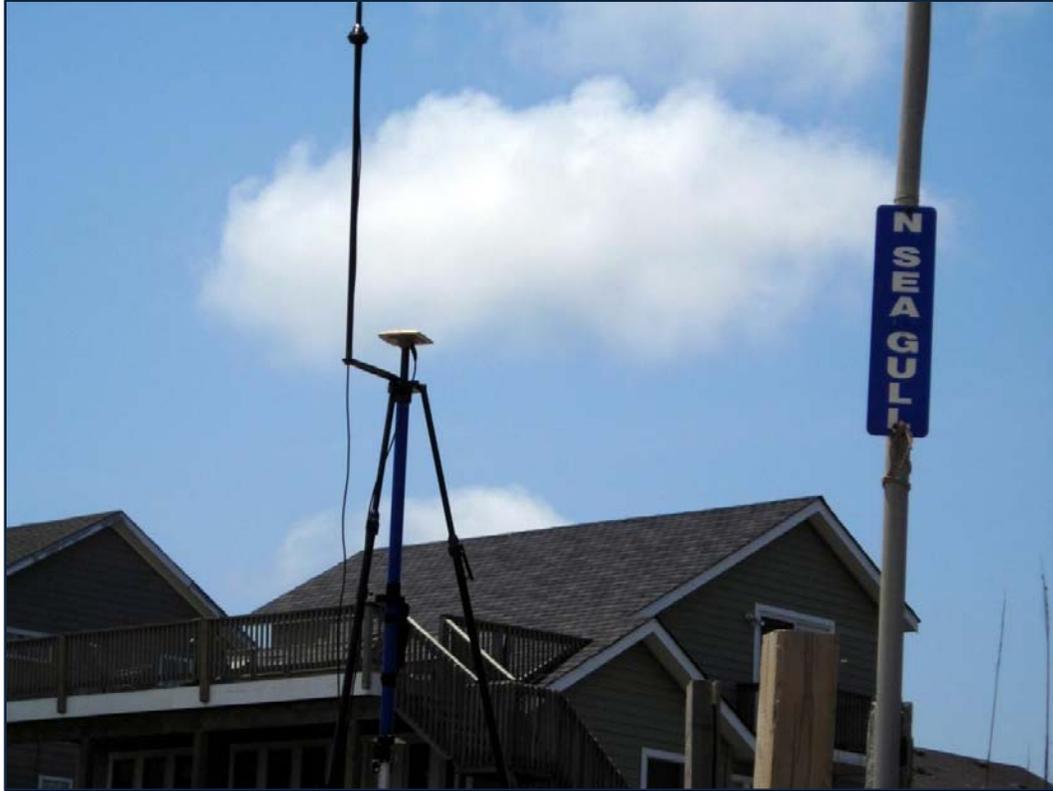
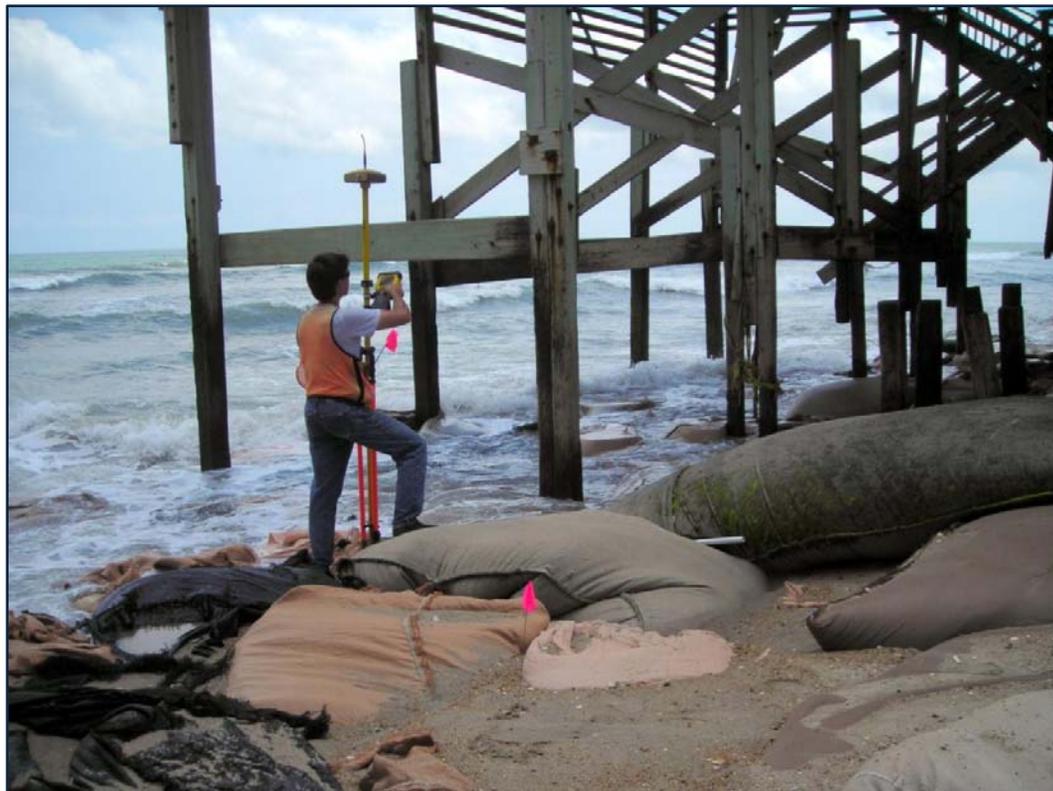
PHOTO 21 — Mean high water (MHW) survey at Sea Gull Drive on 27 May 2011: (upper) base station set up by a professional surveyor Katy C Marchello of Quible & Associates; (lower) MHW point (the pink flag in the lower part of the image) marked by KC Marchello.

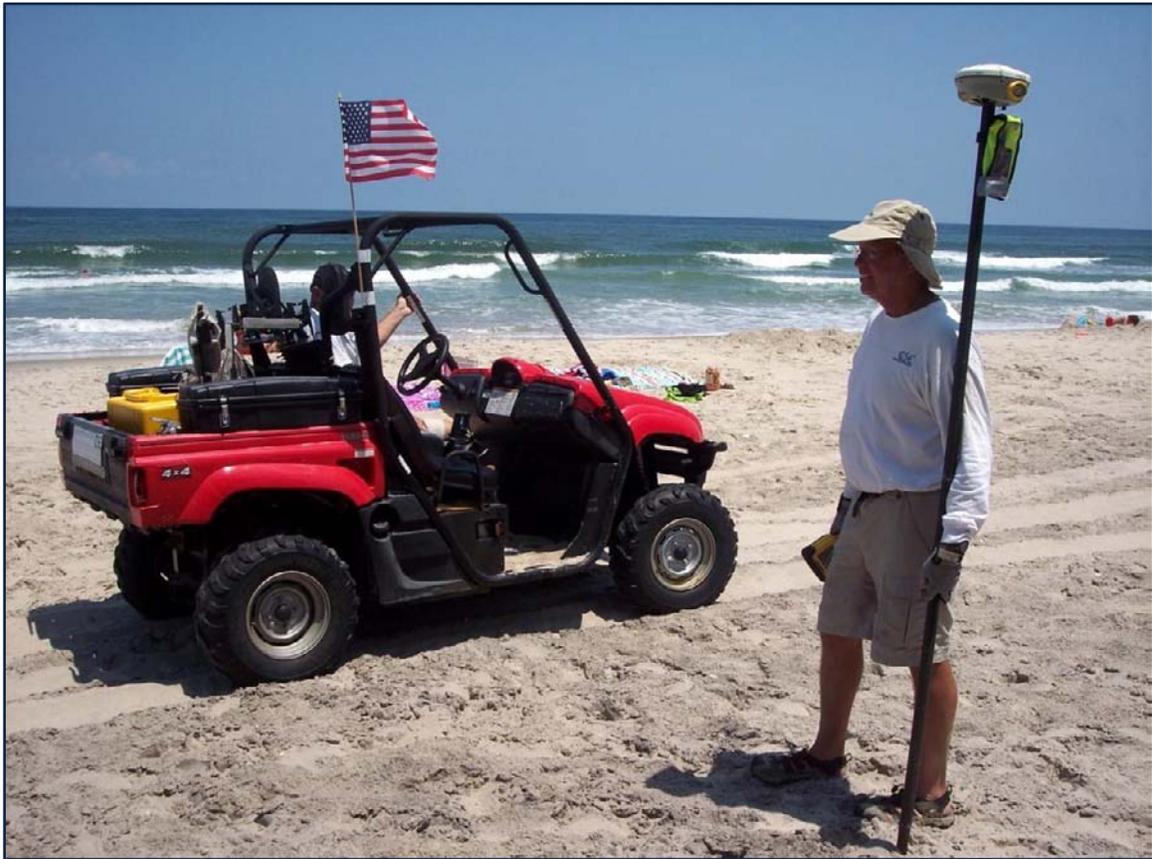
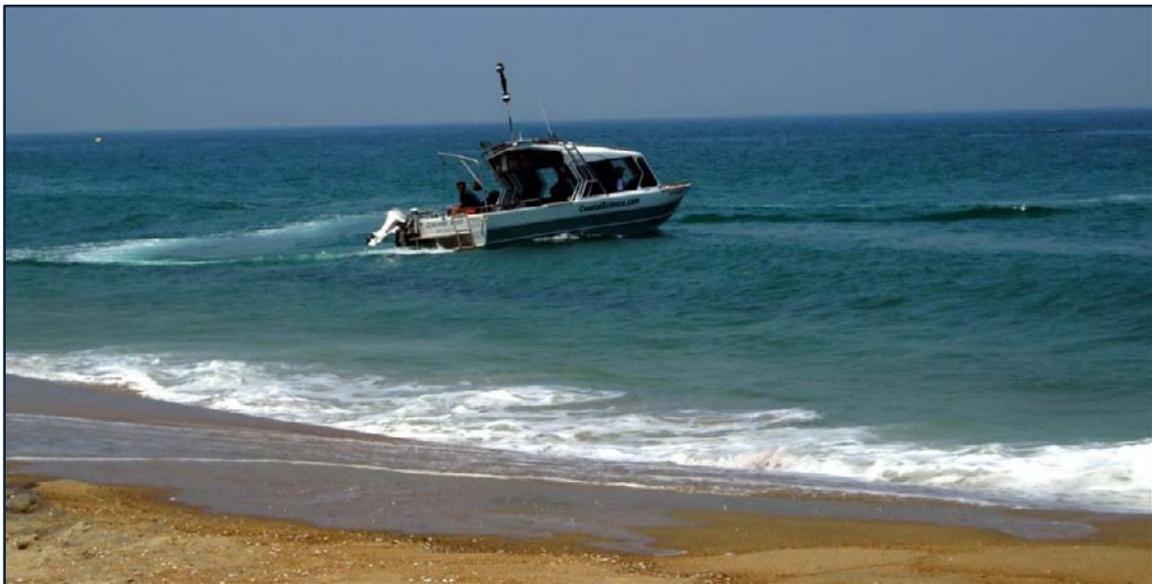
PHOTO 22 — CSE's land and boat survey to determine before-dredging condition and pump volumes. (upper) CSE chief of field data collection Philip McKee standing with an RTK-GPS (Trimble™ Model R8 GNSS) in hand (photo by ST Traynum, 6 June 2011). (lower) CSE survey boat (*Congaree River*) collecting data near Glidden Street during favorite conditions (10 June 2011).

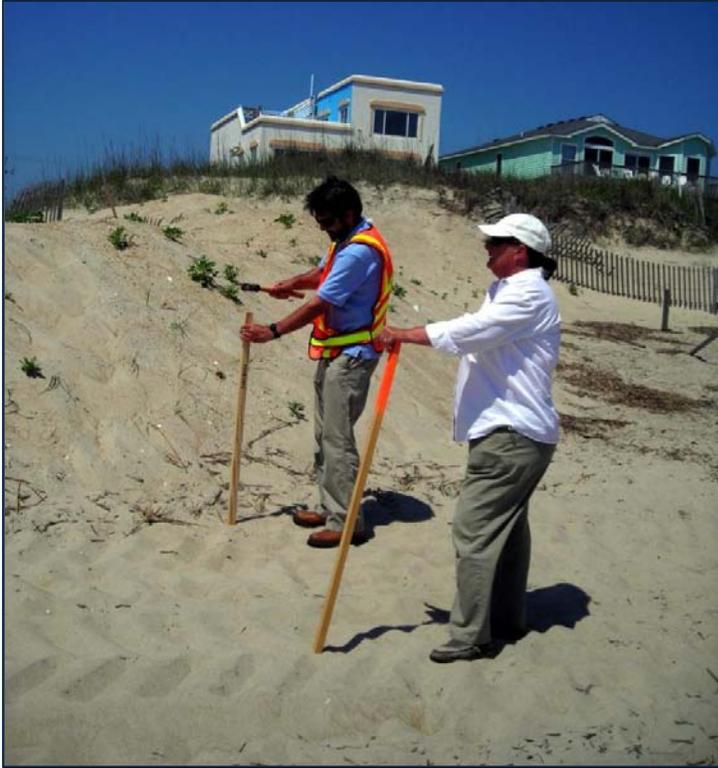
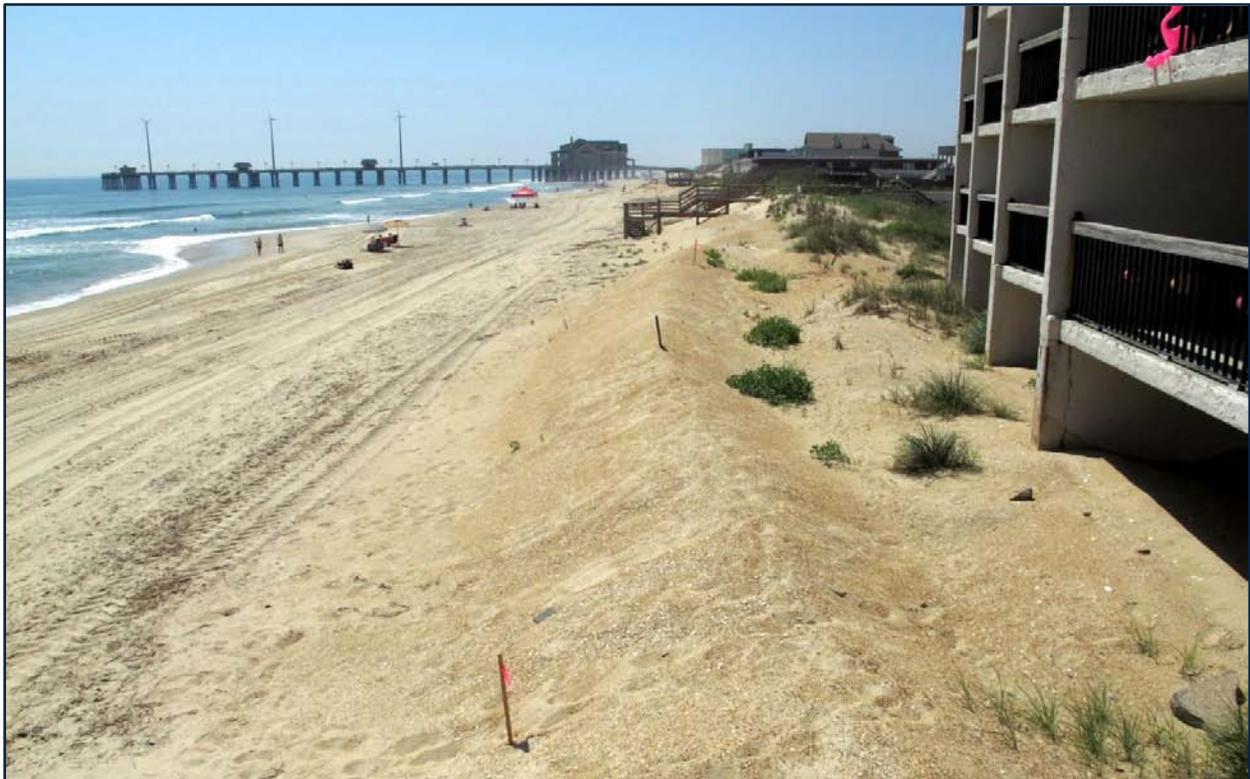
PHOTO 24

[UPPER] NCDCM representatives, Lynn Mathis (right) and John Cece (left) placing CAMA stakes along the toe lines of sandbags that were subject to removal. (3 June 2011)

[LOWER] CAMA stakes along the toe lines of sandbags that were subject to removal. (3 June 2011).

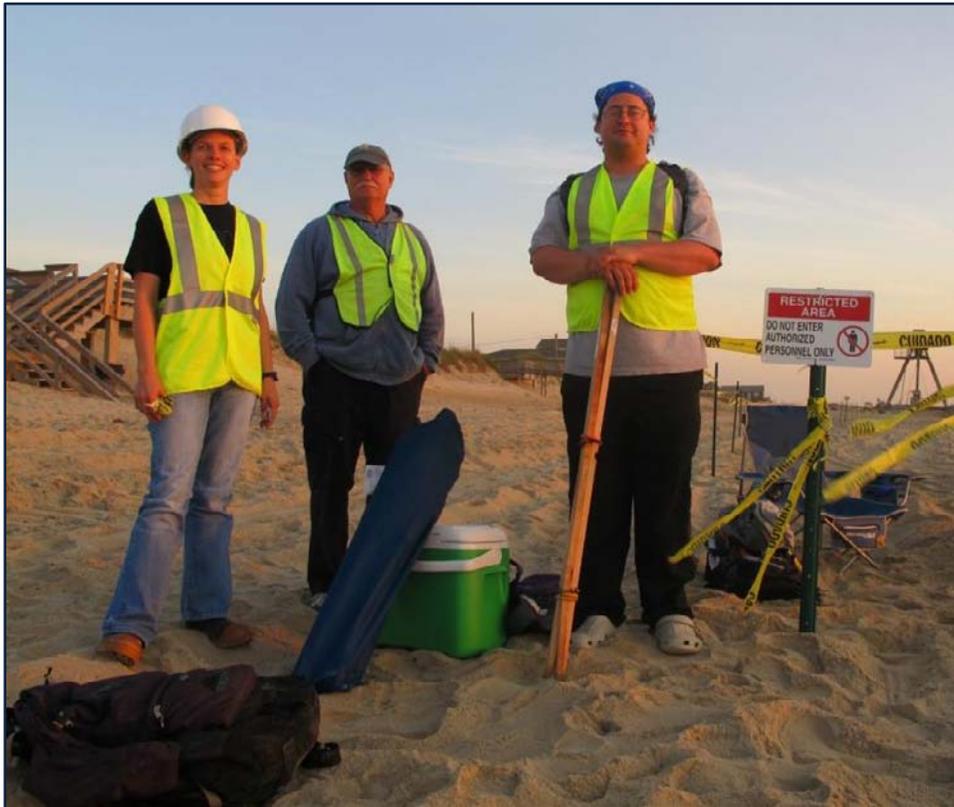
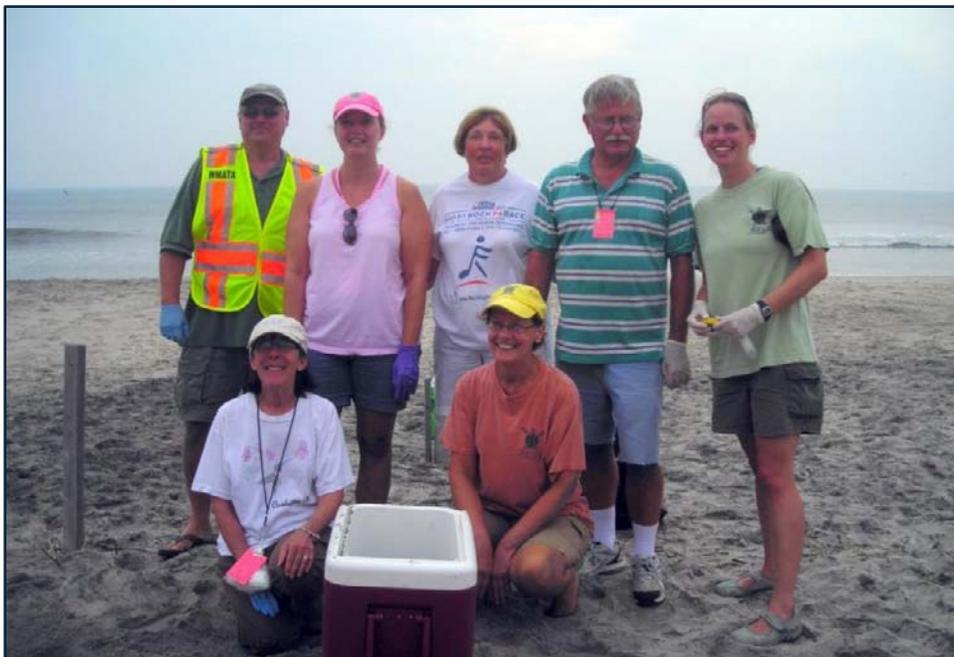
PHOTO 25 — Sea turtle monitoring on the beach: [UPPER] One of the sea-turtle monitoring crews under the direction of Ms. Christian Legner (left, 3 June 2011). [LOWER] NEST volunteers relocated a loggerhead turtle nest found near McCall Street on 29 June 2011.

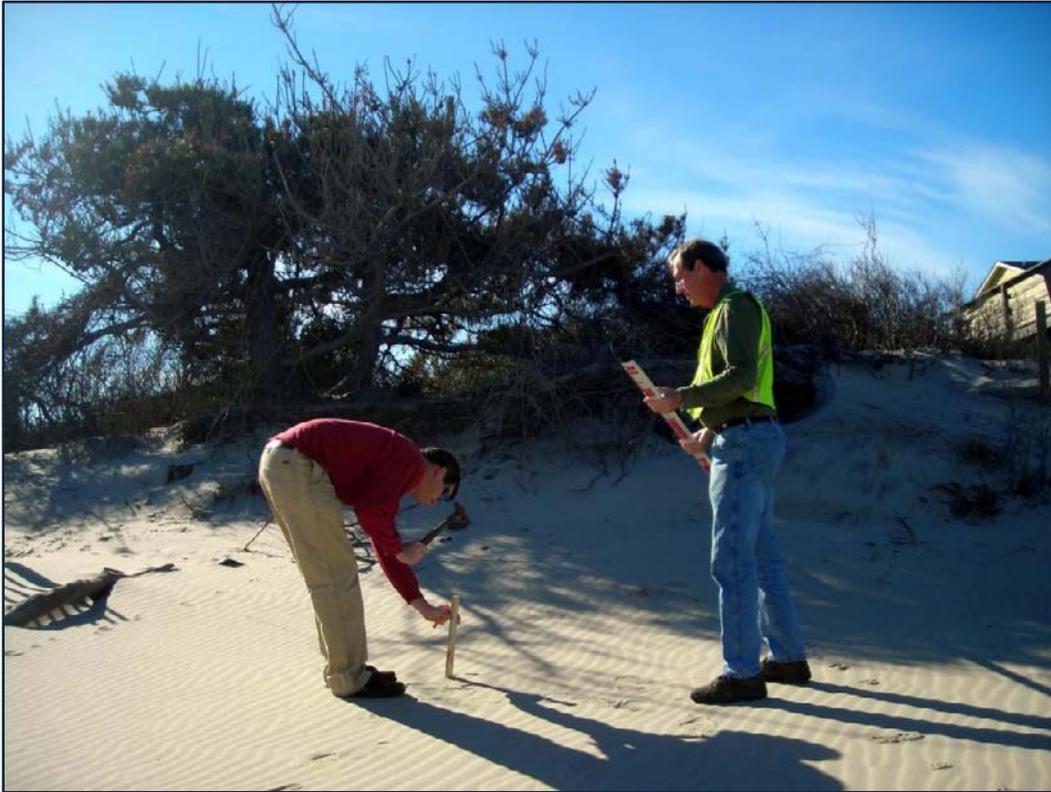
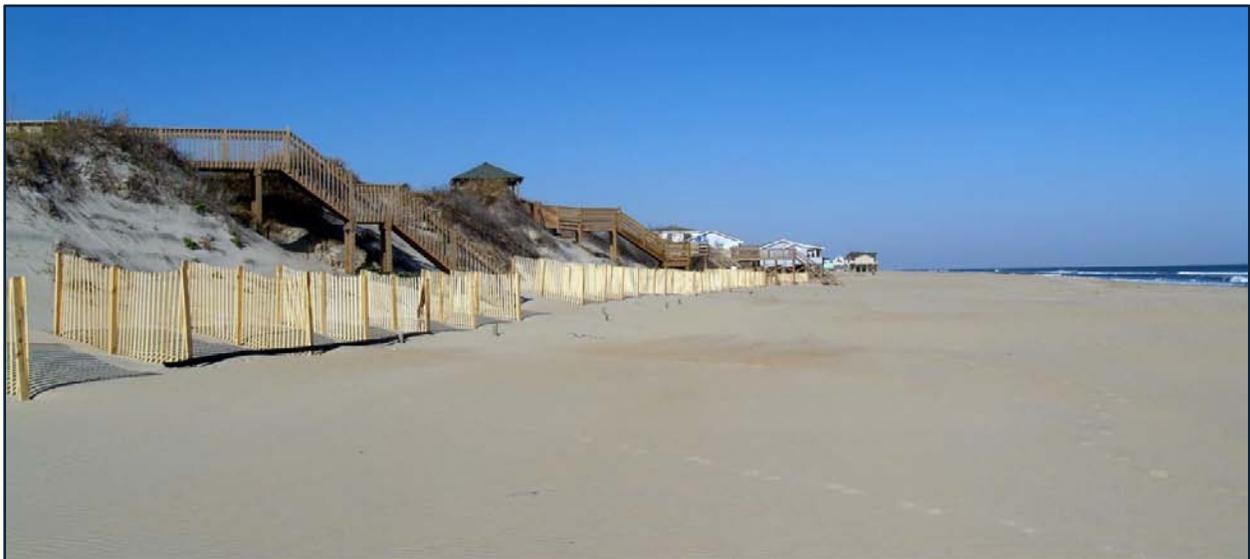
PHOTO 26 — [UPPER] After the project's completion, CSE staff placed stakes as guidance for sand-fencing installation at Reach 3. Tim Kana (right, CSE project director) measuring the distance from the toe of dune, and Steven Traynum (left, CSE senior physical scientist) hammering in a stake.

[LOWER] New sand fencing was installed in December 2011 along Reach 3 following CSE's recommendation in compliance with CAMA's regulations for 10-ft sections at 45 degree angles. (Photo by the Town of Nags Head)
