# Monitoring and Analyses of the 2011 Nags Head Beach Nourishment Project

## 2015 BEACH MONITORING REPORT

[CSE2387-YR4]  
OCTOBER 2015

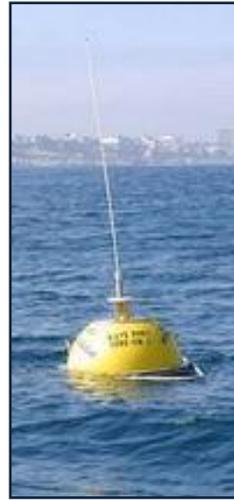
**FIGURE 4.1.**

Datowell Directional Waverider 630 (WMO ID 44056) is located at 36°11.993N, 75°42.843W, 3 km (~1.9 miles) offshore where water depths are ~17.4 m (57 ft). It has collected wave height, period, and directional data since 1997.

Waverider Buoy 630 is located ~1.9 miles offshore of the FRF site in ~57 ft of water (Fig 4.1), and it computes mean wave direction, significant wave height, and wave period from recorded wave data. A 21-year record (1986-2006) of wave data at Buoy 630 was used to determine seasonal variations in the wave climate at Nags Head (CSE 2011a). Wave height, period, and direction were summarized by month and listed in Table 3.1. Average significant wave heights are greatest from September to April (3.4–3.9 ft) and decrease from May to August (2.1–3.0 ft). Average wave periods remain consistent (~8-9 seconds), with highest wave period being in September, coinciding with the peak of the Atlantic hurricane season. Wave direction during the fall and winter is from the east-northeast, averaging between 70° and 80° from north, coinciding with larger waves produced from northeaster storms. During the spring and summer months, waves approach more from the east and average between 84° and 96°.

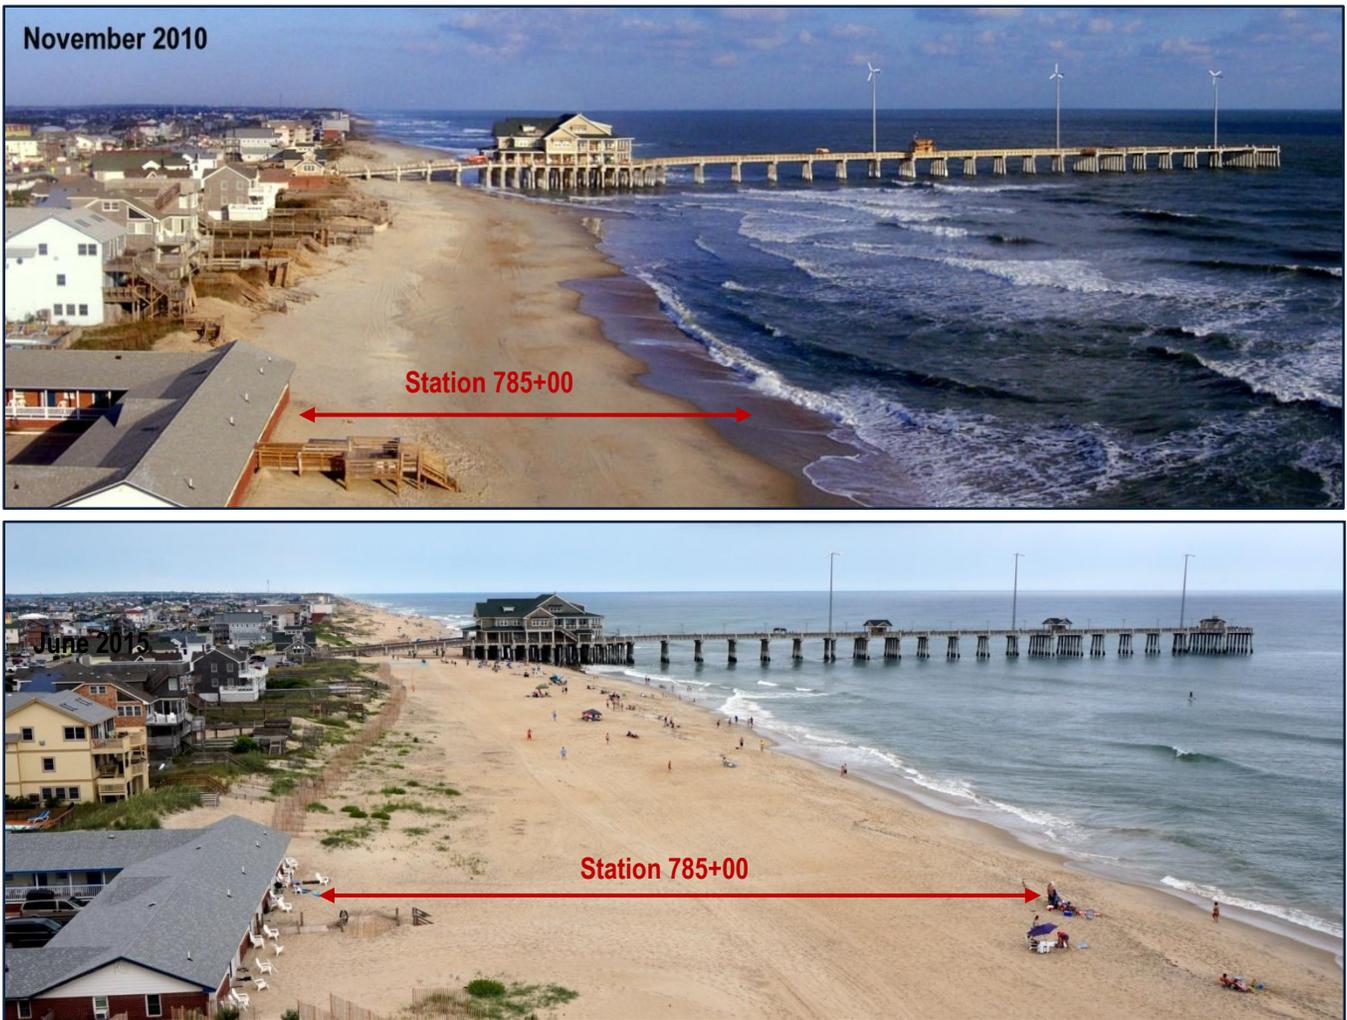
**FIGURE 4.12.** Photos taken from the roof of Comfort Inn looking northeast. Station 785+00 showing pre-project conditions (upper) versus recent conditions in 2015 (lower). Note the buried walkover right below this station.

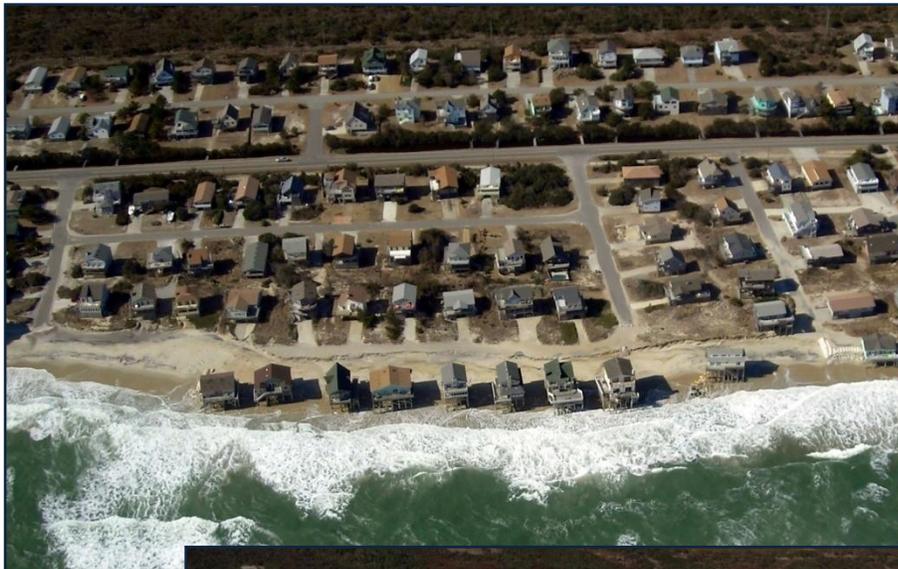
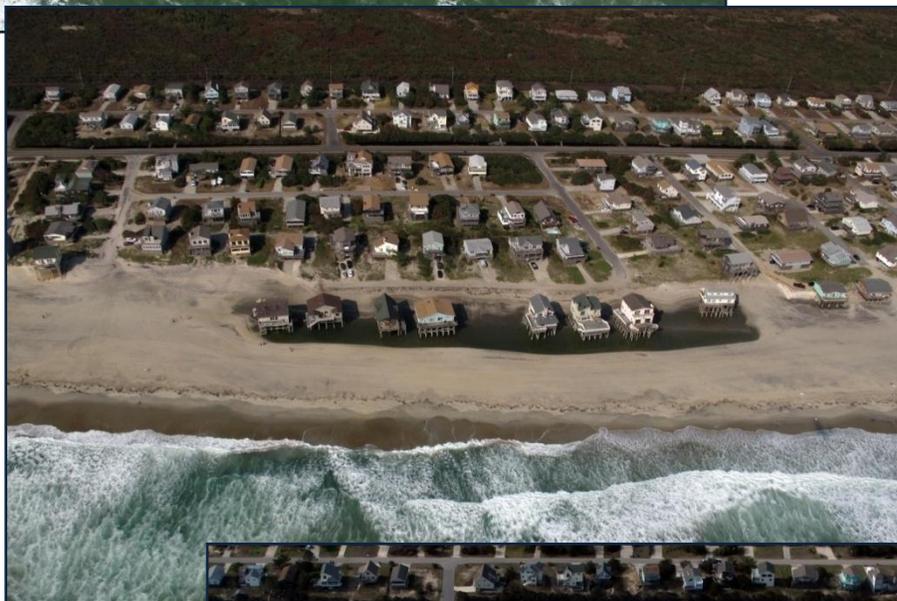
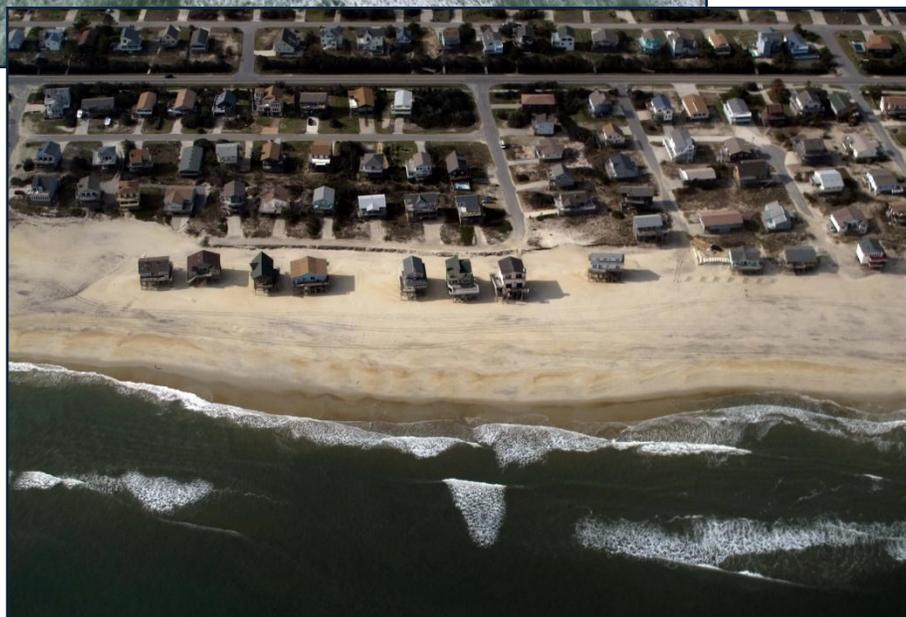
**FIGURE 5.6.**

Aerial views of south Nags Head at Seagull Drive.

Figure 5.6 and Figure 5.7 illustrate conditions before and after nourishment at Seagull Drive near station 995+00. Prior to nourishment, condemned houses along Seagull Drive were sitting in the surf, and the official MHW contour was positioned under the buildings. The remnant of dry beach terminated 60 ft **landward** of the houses before the project. State regulations precluded nourishment over exposed sandbags, so the project had to work around the Seagull houses. This resulted in no sand placement in the low areas around the houses, which resulted in a pond (see middle photo of Fig 5.6).

Fall northeasters in 2011 washed over the nourished beach and eventually pushed sand into the pond (see bottom photo of Fig 5.6). The width of dry beach increased as much as 190 ft **seaward** of the houses after project completion. Although the dry-beach width is clearly

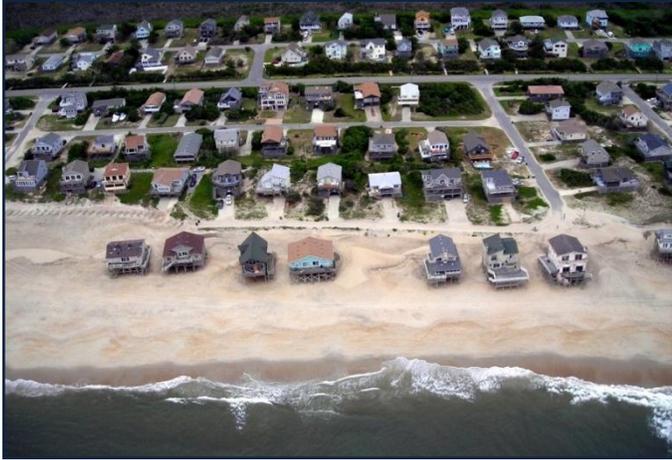
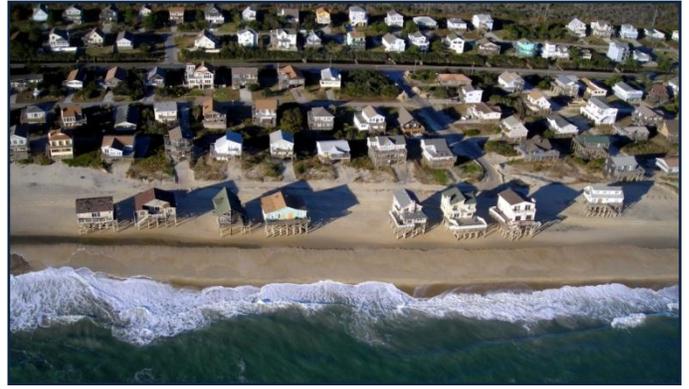
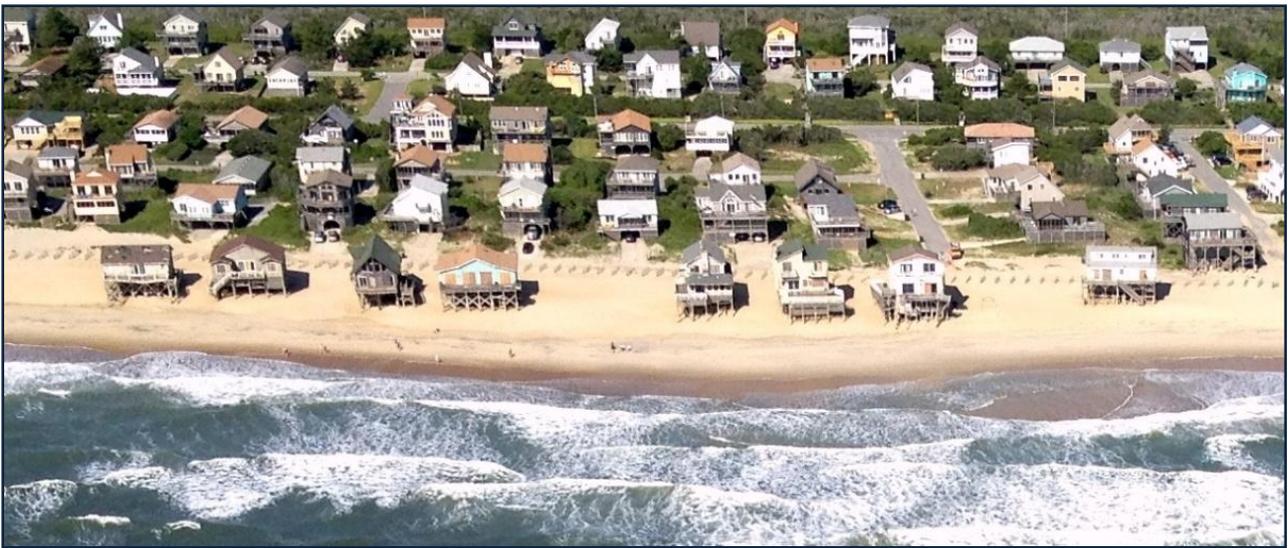
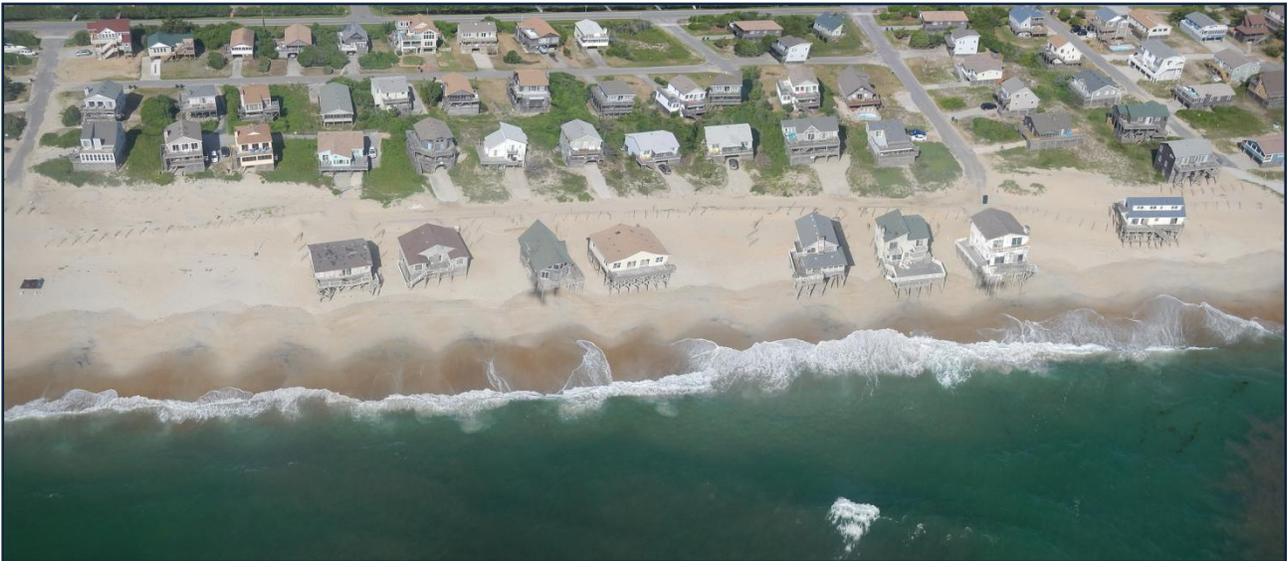
**FIGURE 5.7.** Aerial views of south Nags Head at Seagull Drive.  
[UPPER LEFT] 12 June 2012 – before 2012 hurricane season. [UPPER RIGHT] 3 November 2012 – after Hurricane *Sandy*. [MIDDLE] 20 JUNE 2013 – before 2013 hurricane season. [LOWER] 7 June 2014 – before 2014 hurricane season.

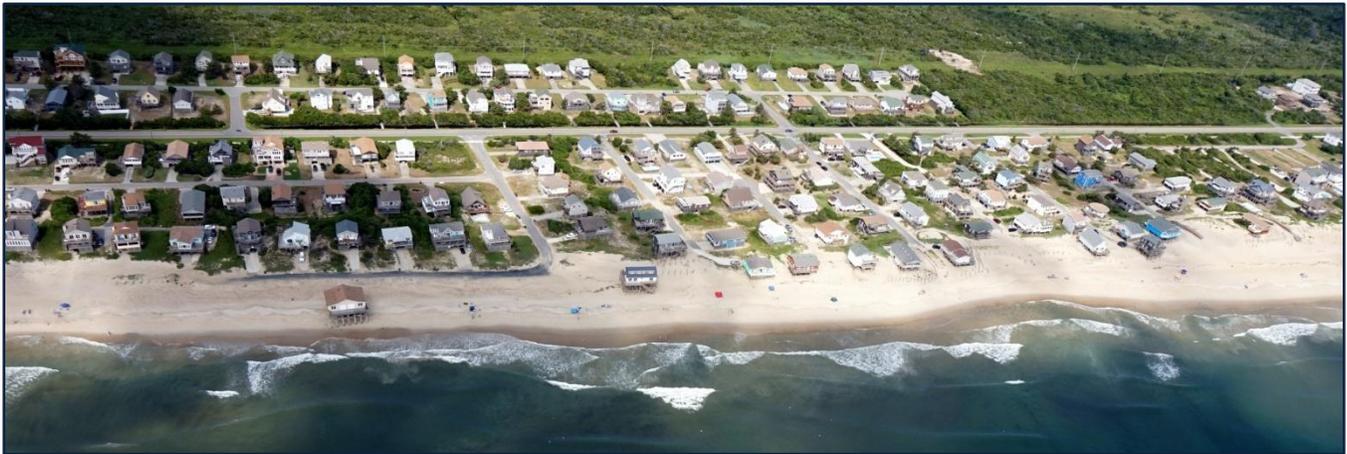
**FIGURE 5.8. [UPPER]** Aerial photo taken on 28 June 2015 – before 2015 hurricane season. Six abandoned houses were removed in May 2015, and only one remained at the time when the photo was taken. **[LOWER]** Complete profile from the back of the house to deep water. Unit volumes of each survey are listed in the figure.

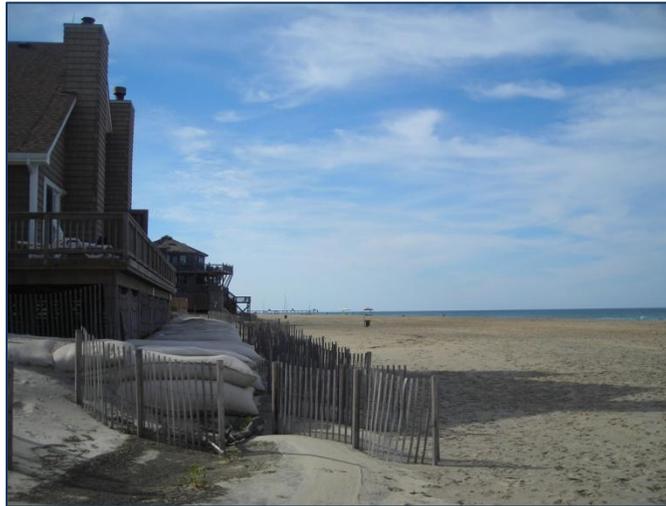
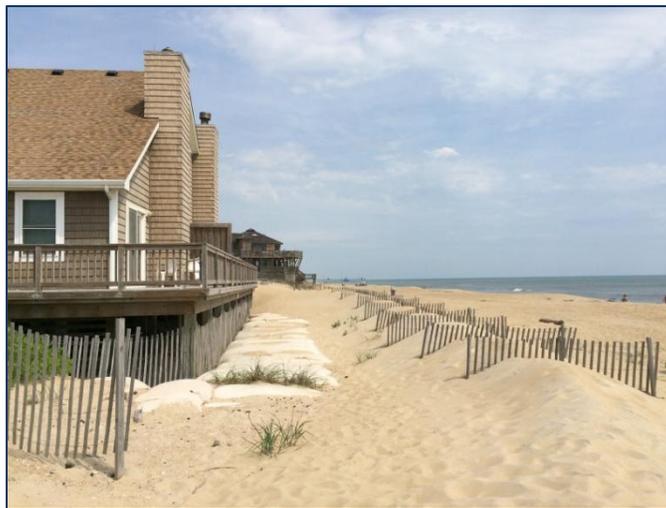
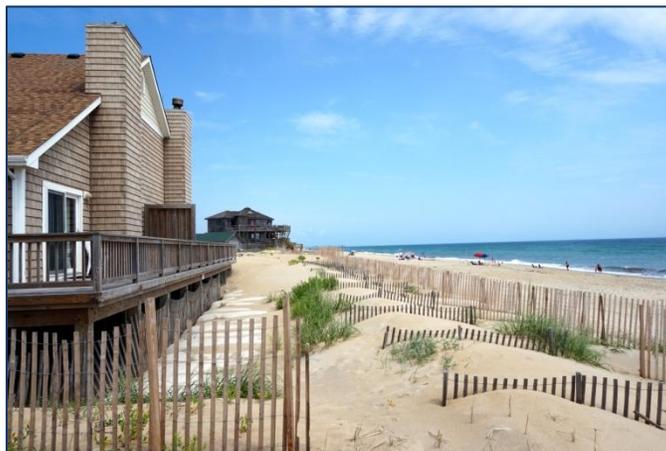
**FIGURE 6.3.** Incipient dunes formed and stabilized after nourishment near station 855+00, and sand bags gradually buried. **[UPPER]** Photo taken on 11 June 2012, seven months after project completion, shows a row of sand fencing seaward of the sand bags. **[MIDDLE]** Photo taken on 5 June 2014, two years and seven months after project completion, shows a second row of sand fencing seaward of the first row. **[LOWER]** Photo taken on 27 June 2015, three years and seven months after project completion, shows a third row of sand fencing and sprouted vegetation on the dunes.

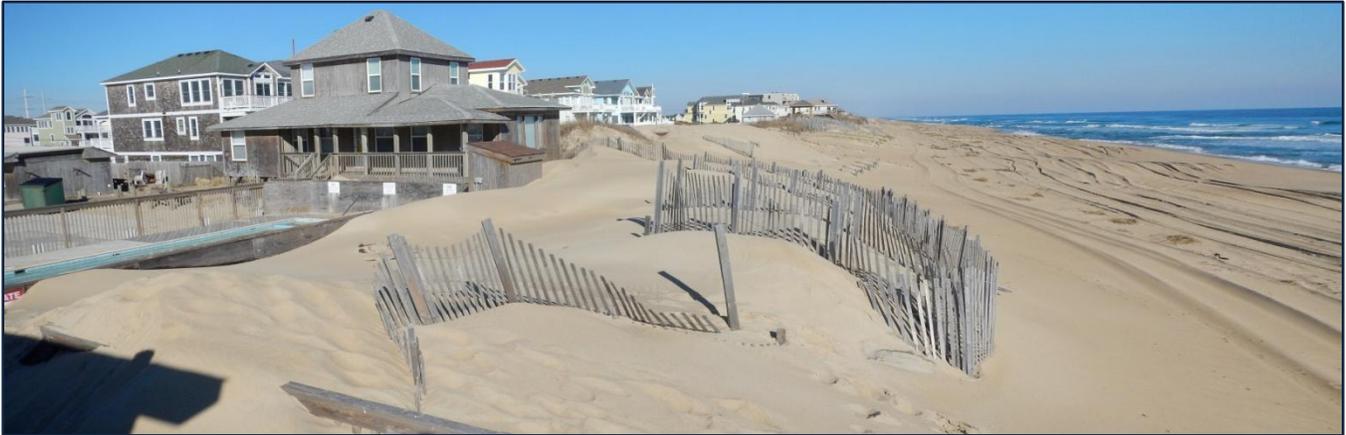
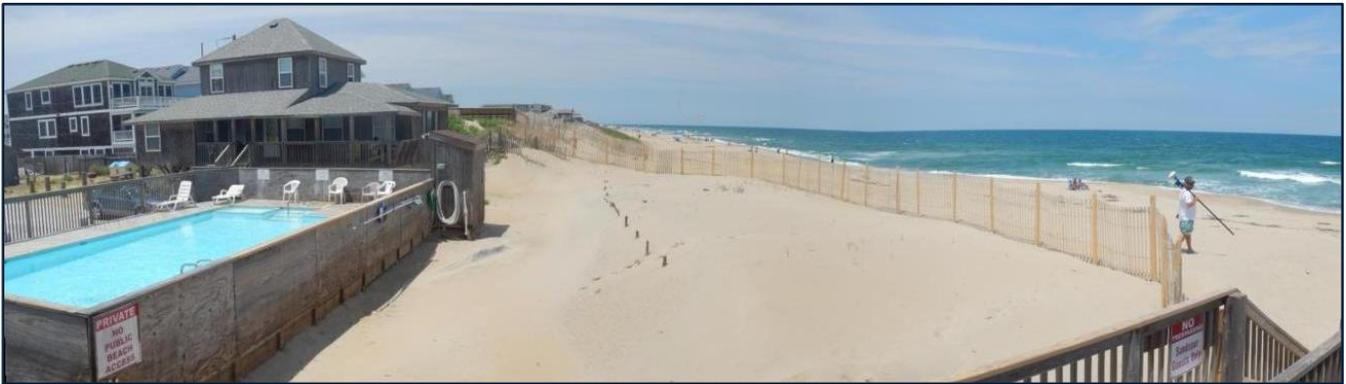
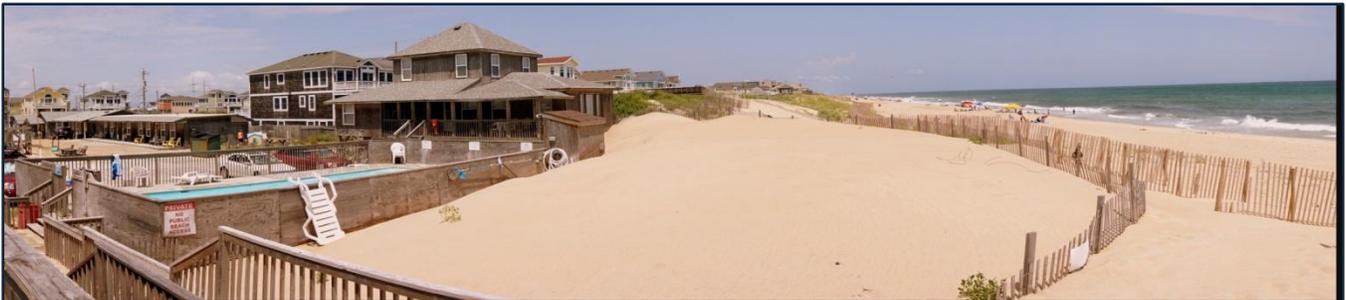
**FIGURE 6.4.** Photos at Sandspur Hotel near project station 735+00 and Jennette's Pier.

**[UPPER]** Photo taken by T Hair on 28 February 2014 showing the accreted sand encroaching on the swimming pool.

Figure 6.4 shows evidence of dune encroachment on a swimming pool at the Sandspur Hotel in February 2014 and its condition after the emergency sand removal in June 2014 and June 2015.

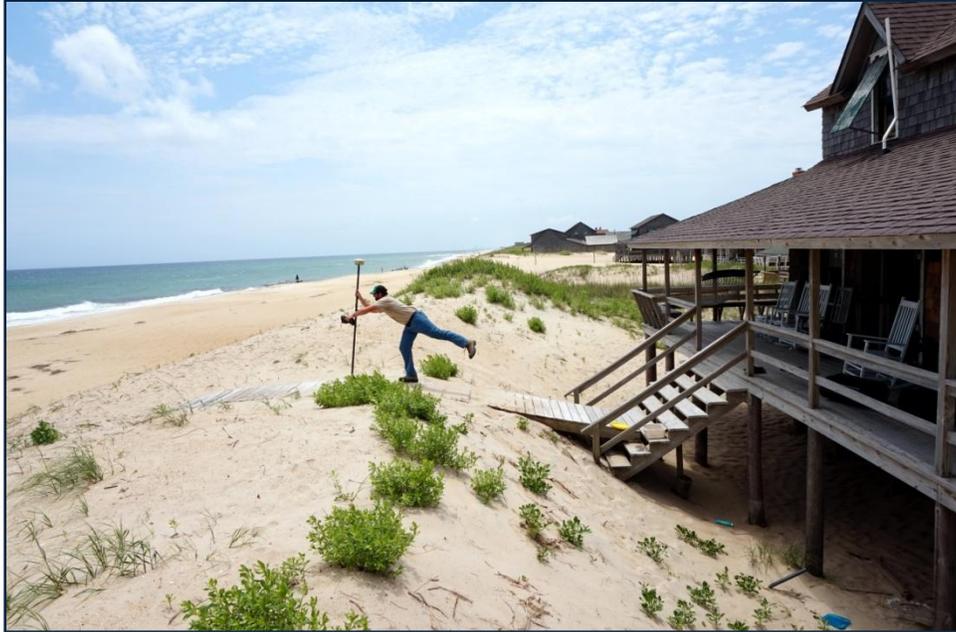
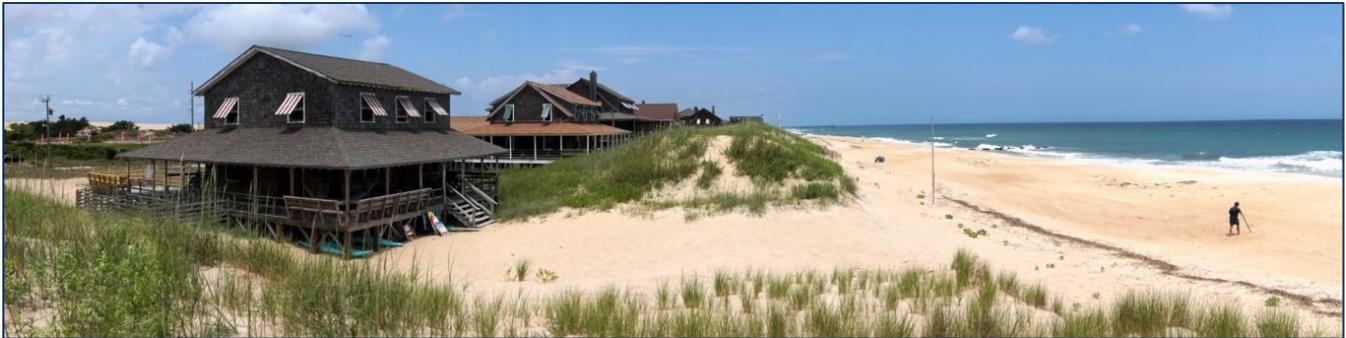
**FIGURE 6.5(b).** Ground photos taken on 27 June 2015 near line 585+00(1) showing the mature vegetation on both sides of the property, but lack of dune and vegetation in front of the property. [UPPER] Looking southwest. [LOWER] Looking northeast.

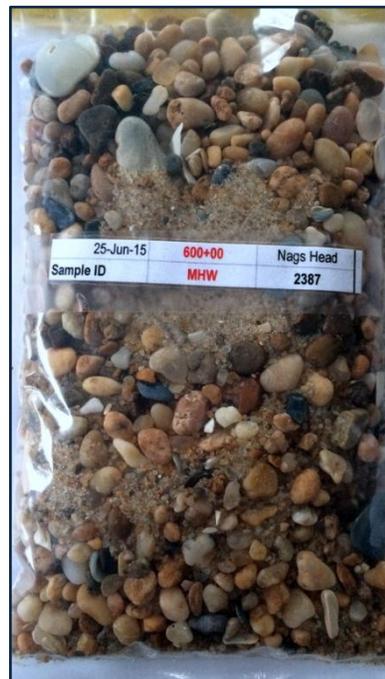
Sediment sample collected on the beach around mean high water mark at station 600+00. Note rounded pebbles.

Gravel content was 52.5 percent at this locality at the time of sample collection on 25 June 2015.

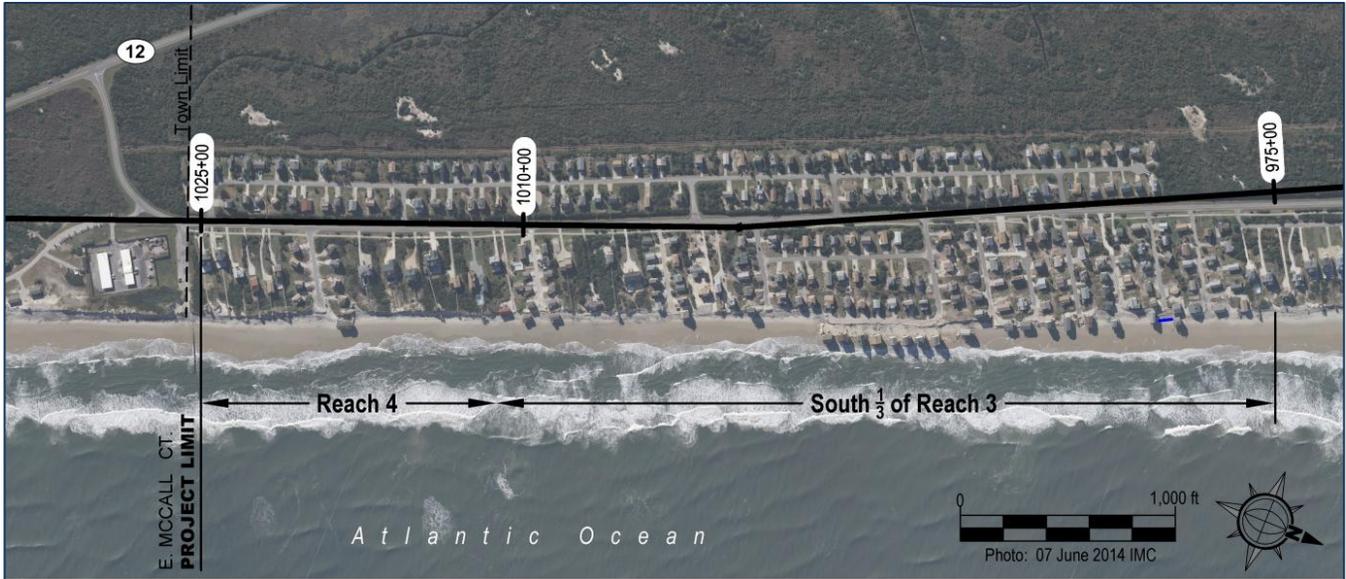
**FIGURE 9.1.** Higher erosion area along south Nags Head between station 975+00 in Reach 3 and station 1025+00 in Reach 4. The background aerial photo was taken on 7 June 2014 by IMC. The portion of Reach 3 to the north (out of the image) retained a large reservoir of nourishment sand which will continue to mitigate erosion at the south end of the project.

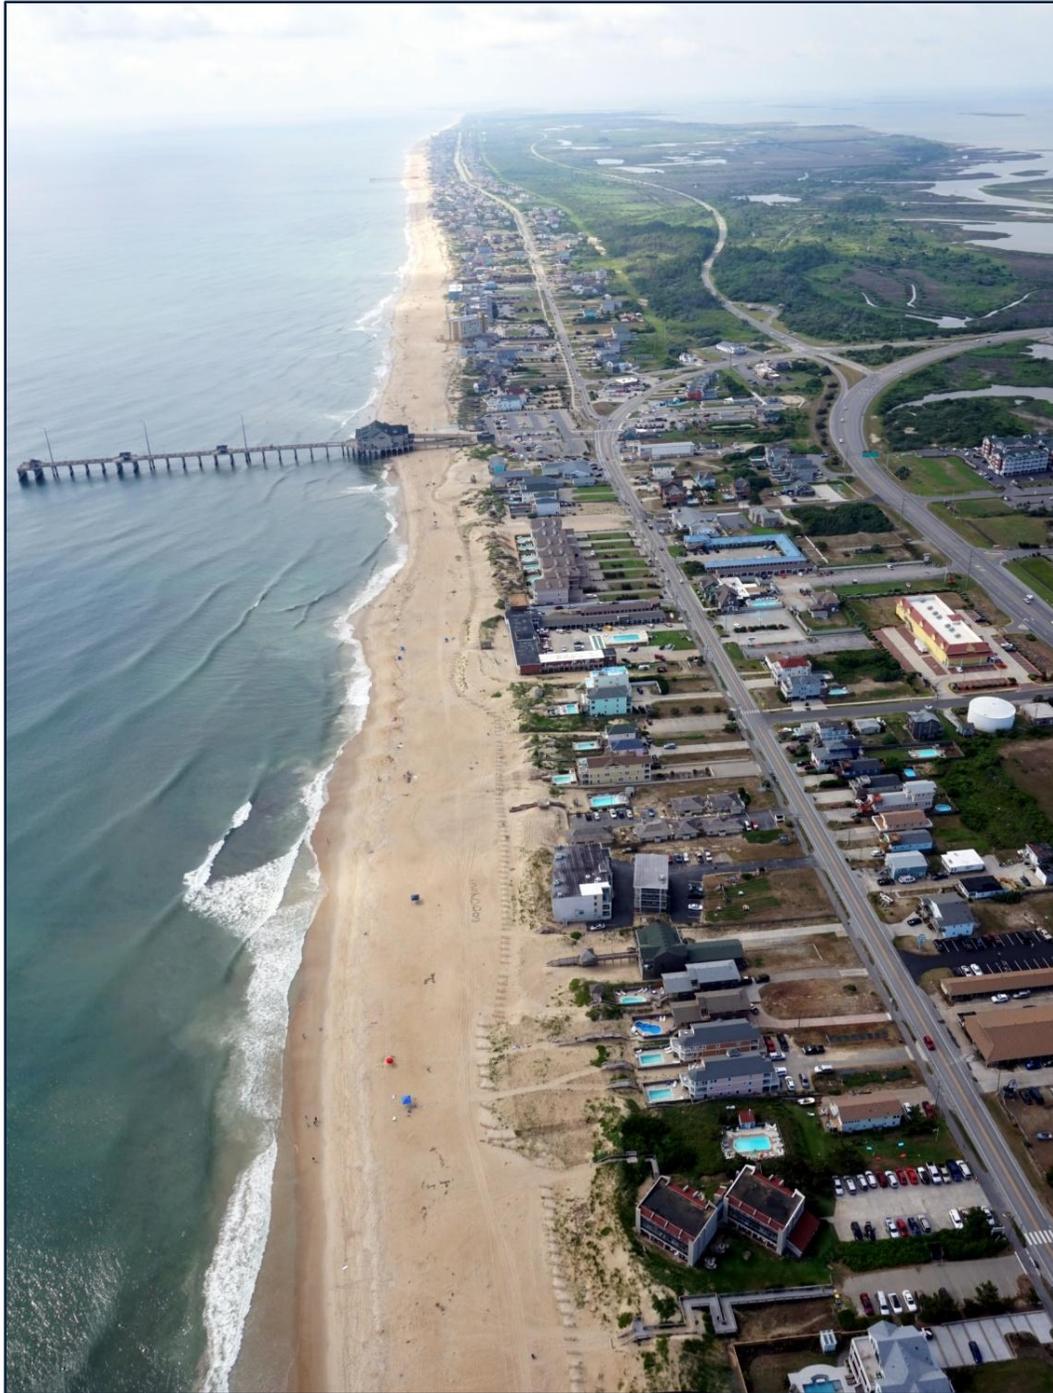
**PHOTO 1** — Nags Head Reaches 1 and 2 condition on 28 June 2015. Jennette's Pier is situated near one-third of the photo, and Outer Banks Pier is above (south of) Jennette's Pier.

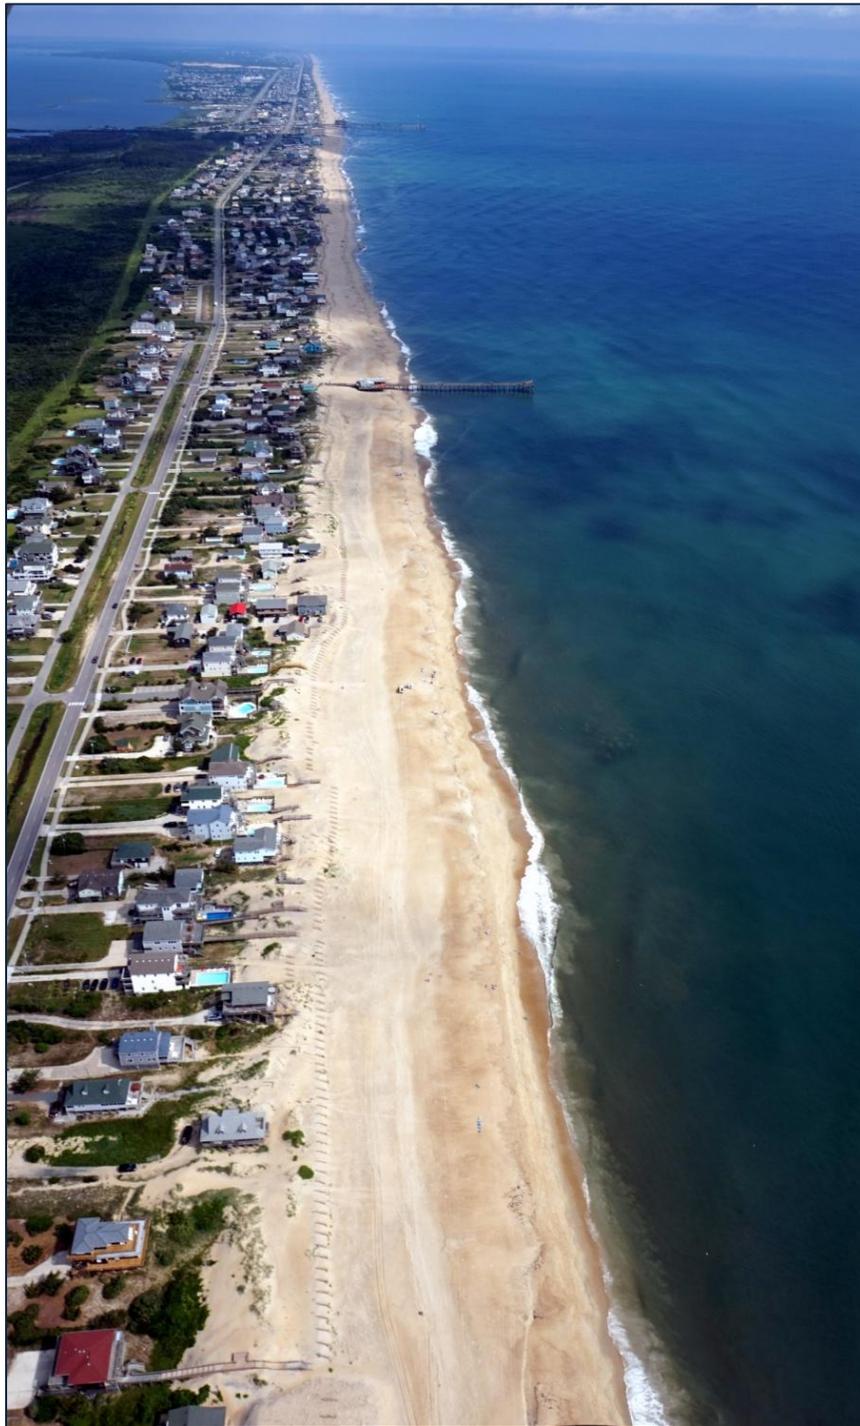
**PHOTO 2** — Nags Head Reaches 1, 2 and 3 condition on 28 June 2015. Jennette's Pier is situated at the very top of the photo, and Outer Bank's Pier is below (south of) Jennette's Pier.

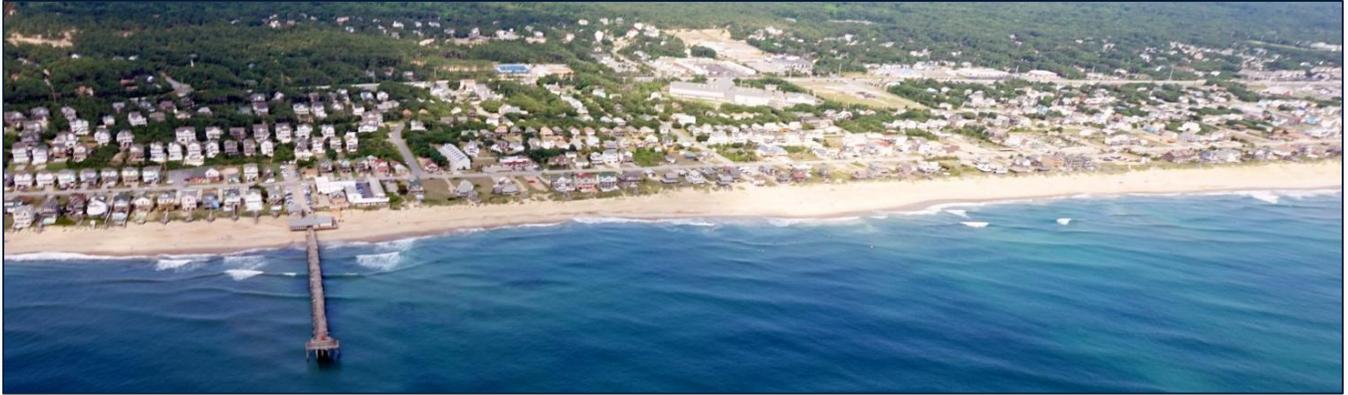
**PHOTO 3** — Nags Head Reach 1 condition on 28 June 2015. Nags Head Pier is shown in the photo.

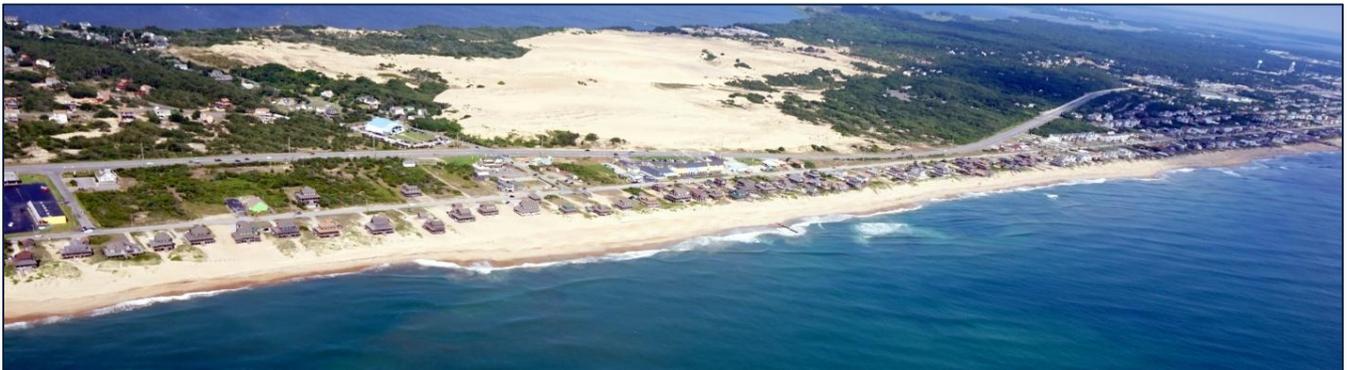
**PHOTO 4** — Nags Head Reach 1 condition on 28 June 2015. Nags Head Pier is situated at the very right (north of) the photo, and Jockey's Ridge is on the upper middle of the photo:

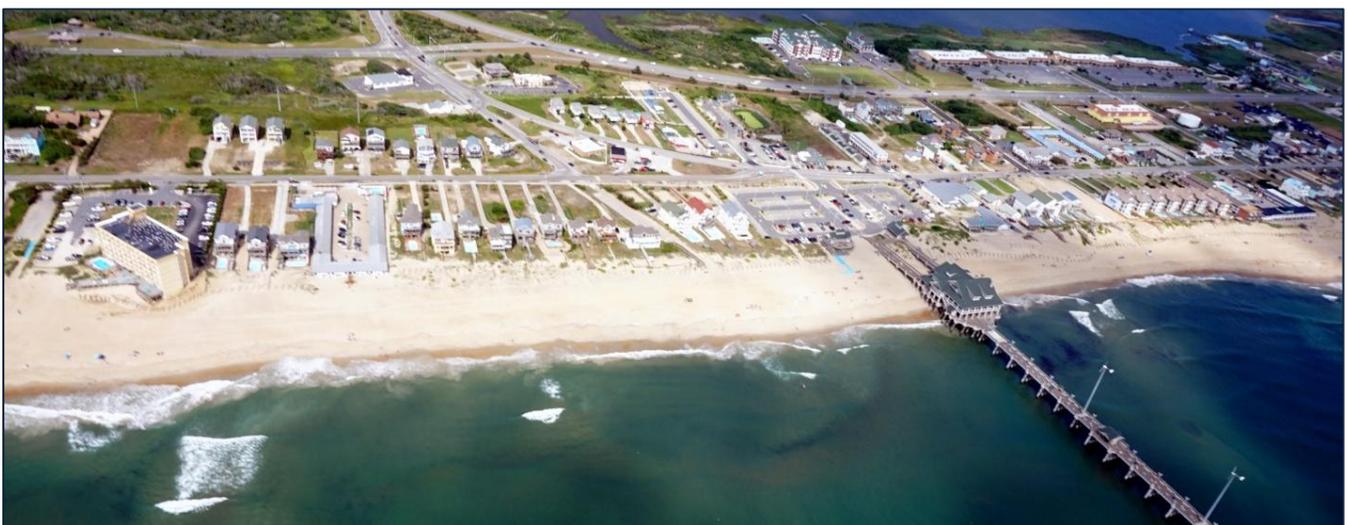
**PHOTO 5** — Nags Head Reach 1 condition on 28 June 2015. Jennette's Pier is shown in the photo, and Comfort Inn is on the left (south of) the pier. North of Comfort Inn is Reach 1, and south of Comfort Inn is Reach 2.

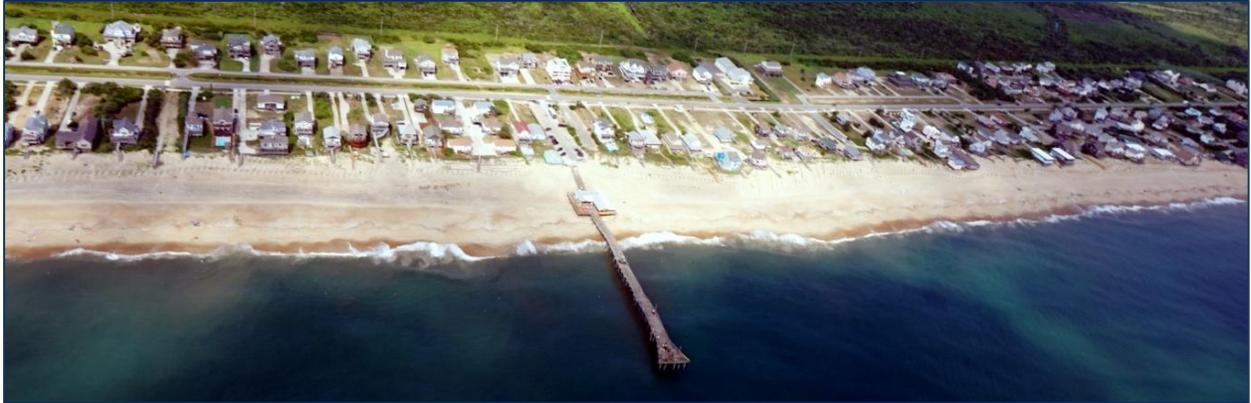
**PHOTO 6** — Beach condition near Outer Bank's Pier in Reach 3 on 28 June 2015.

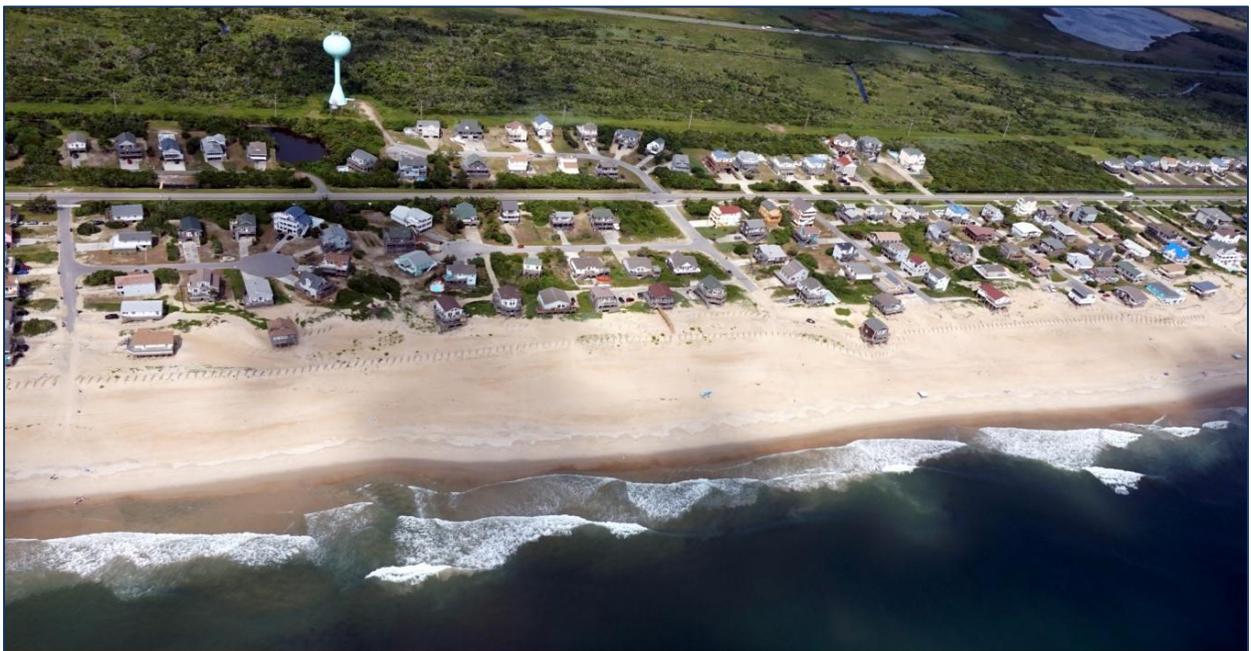
**PHOTO 7** — Beach condition near Surfside Drive in Reach 3 on 28 June 2015.

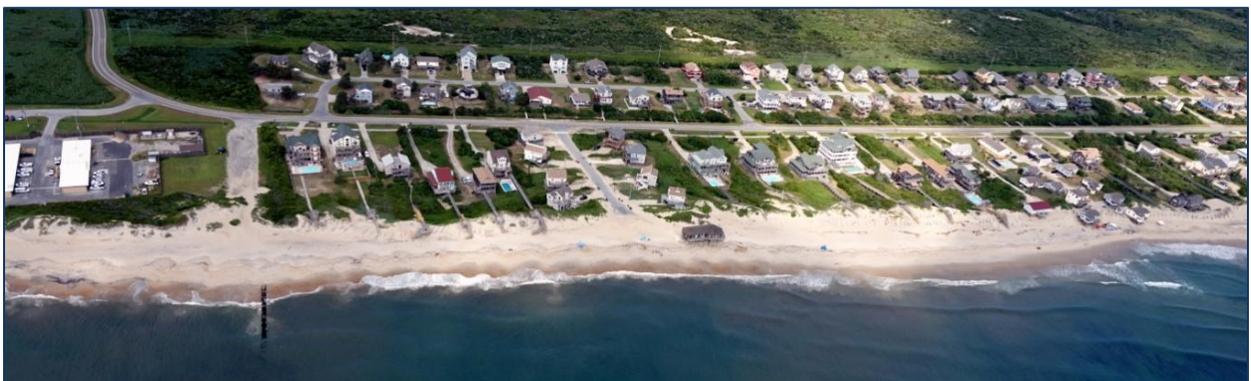
**PHOTO 8** — Reach 4 and south end of Reach 3 on 28 June 2015.

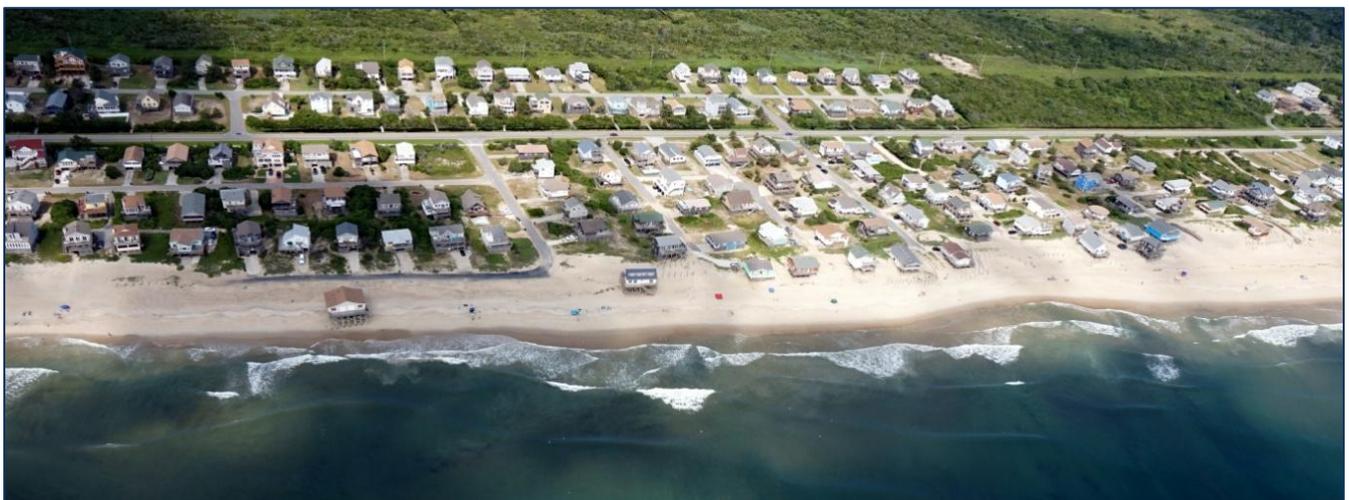
**PHOTO 9** — South Nags Head near Seagull Drive on 28 June 2015. Five condemned houses have been removed by June 2015.
