## MEMORANDUM

RE: Nags Head Post-*Matthew* Beach Condition Survey [CSE 2458–Task 2]  
**Preliminary Results**

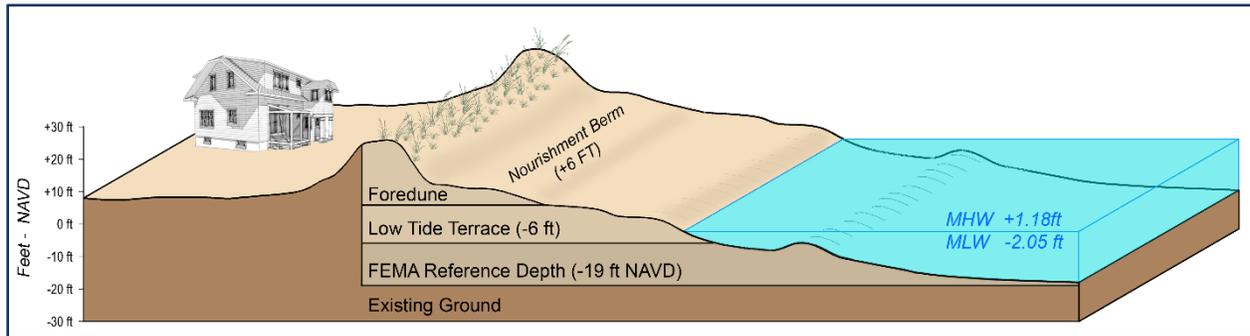
**Figure A.** Illustration of the three lenses used in the profile volume analysis for Nags Head.

Illustration of these three lenses used in the volume analysis is shown in Figure A.

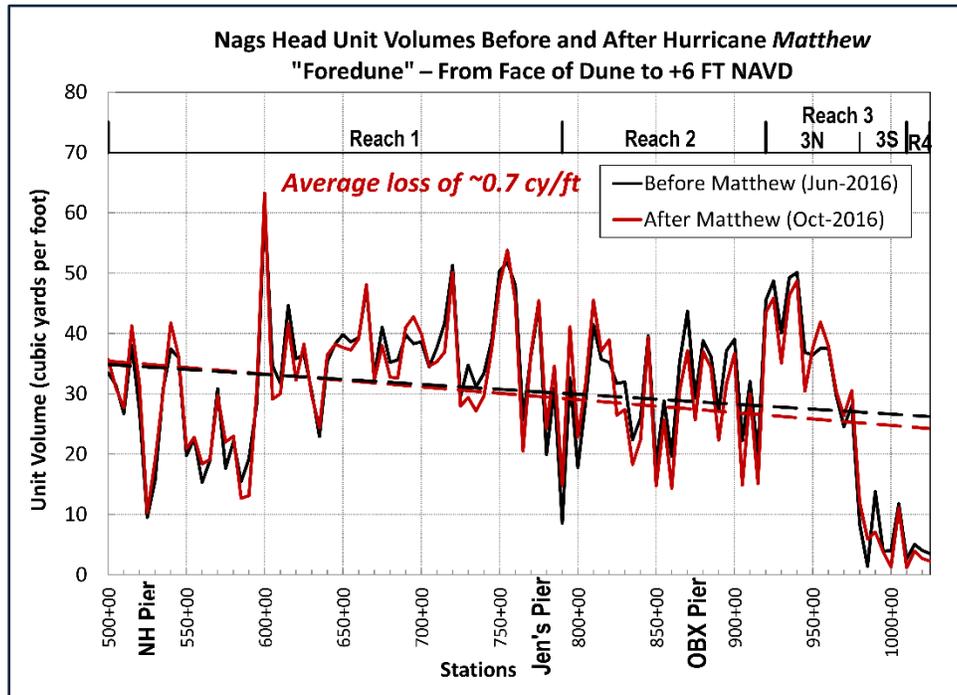
Figures B, C, and D show unit volumes station by station in different lenses comparing June 2016 (pre-hurricane season) and October 2016 (post-*Matthew*). The dashed lines show the trend of data of each survey set. Nearly all stations lost sand in October 2016 in all lenses, and the largest unit volume loss occurred when measured to the FEMA depth limit at -19 ft NAVD (Fig D). There are several sections of the beach where the October lines are above the June lines, meaning those particular localities had more sand after the storm. Such differences are caused mainly by sand migration alongshore during the storm. On average, Nags Head lost ~27 cubic yards per linear foot of shoreline (cy/ft) between the foredune and -19 ft NAVD after *Matthew*, which is equivalent to a total volume loss of ~1.43 million cubic yards along the 10-mile project area.

**FIGURE B.** Comparison of unit volumes by station in the foredune areas (Lens 1) before and after Hurricane *Matthew*.

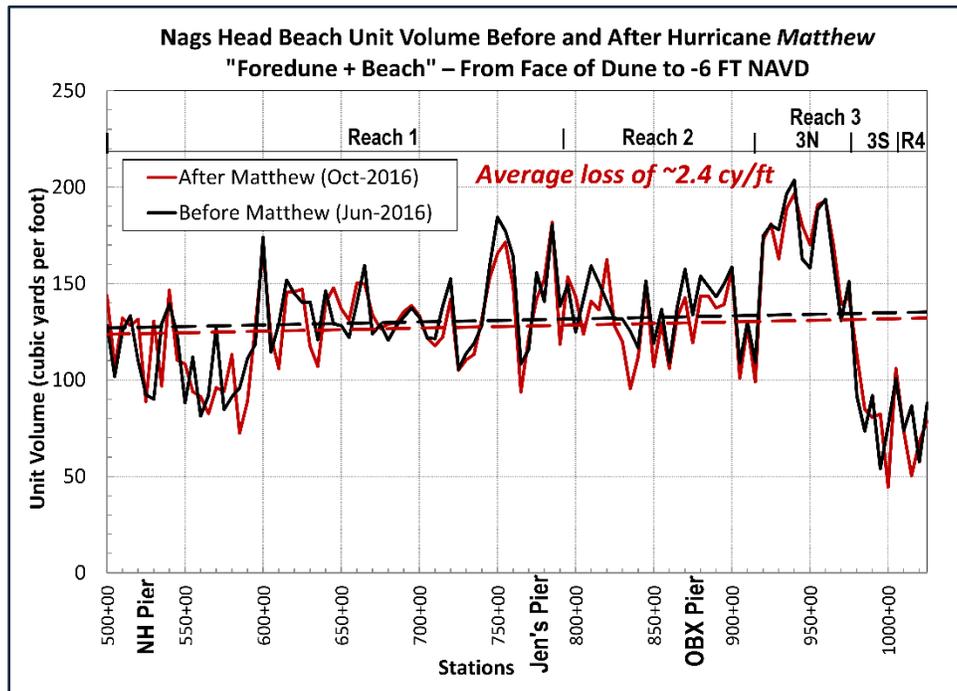
**FIGURE C.** Comparison of cumulative unit volumes by station in the foredune and beach areas (Lenses 1 and 2) before and after Hurricane *Matthew*.

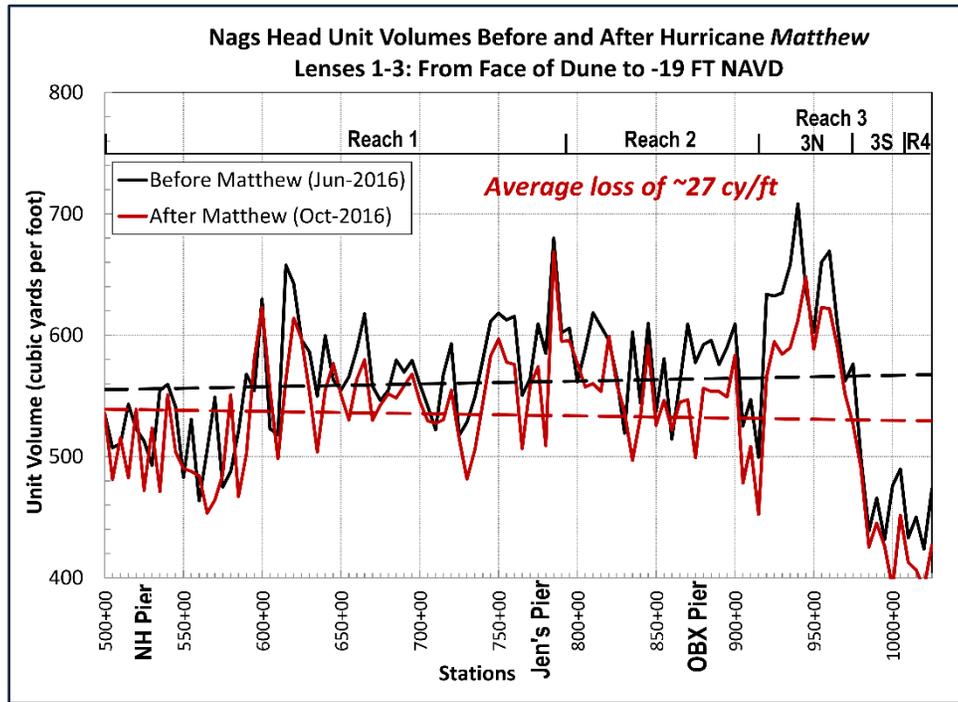
**FIGURE D.** Comparison of cumulative unit volumes by station between the foredune and –19 ft NAVD (Lenses 1, 2, and 3) before and after Hurricane *Matthew*.

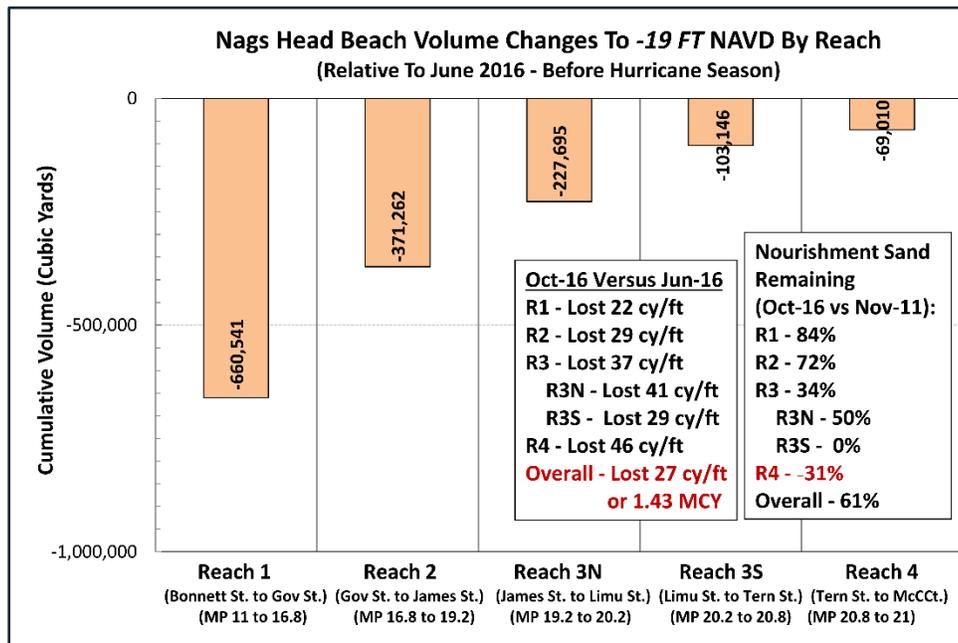
Figure E provides overall results by reach relative to the pre-hurricane season condition. All reaches and subreaches lost a significant amount of sand after *Matthew*.

To summarize sand losses in all reaches and subreaches, the results show that **the 10-mile Nags Head engineered beach has lost 1,431,653 cy of sand after Hurricane *Matthew* measured from the foredune to -19 ft NAVD**. This loss represents ~30 percent of the total nourishment volume placed in 2011.

**FIGURE E.** Beach volume changes by reach and subreach relative to June 2016 survey results from the foredune to –19 ft NAVD.

According to the Federal Emergency Management Agency (FEMA) Disaster Assistance Fact Sheet DAP9580.8 – Eligible Sand Replacement on Public Beaches (dated 1 Oct 2009), Nags Head is eligible for assistance in Permanent Work under Category G guidelines because of the following reasons:

The amount of sand eligible for replacement with Permanent Work funding is limited to the amount lost as a result of the disaster event. For Nags Head, the nearshore measurement limit was set at –19 ft NAVD in the Maintenance Plan. Therefore, the net sand losses to –19 ft NAVD between June 2016 and October 2016 constitute the volume of sand that CSE believes the Town of Nags Head is eligible to claim as a storm loss. We have calculated this volume loss to be 1,431,653 cy. CSE recommends the Town of Nags Head apply for FEMA post-storm beach restoration funding, and CSE will assist the Town with document preparation and other necessary tasks as requested related to this application.

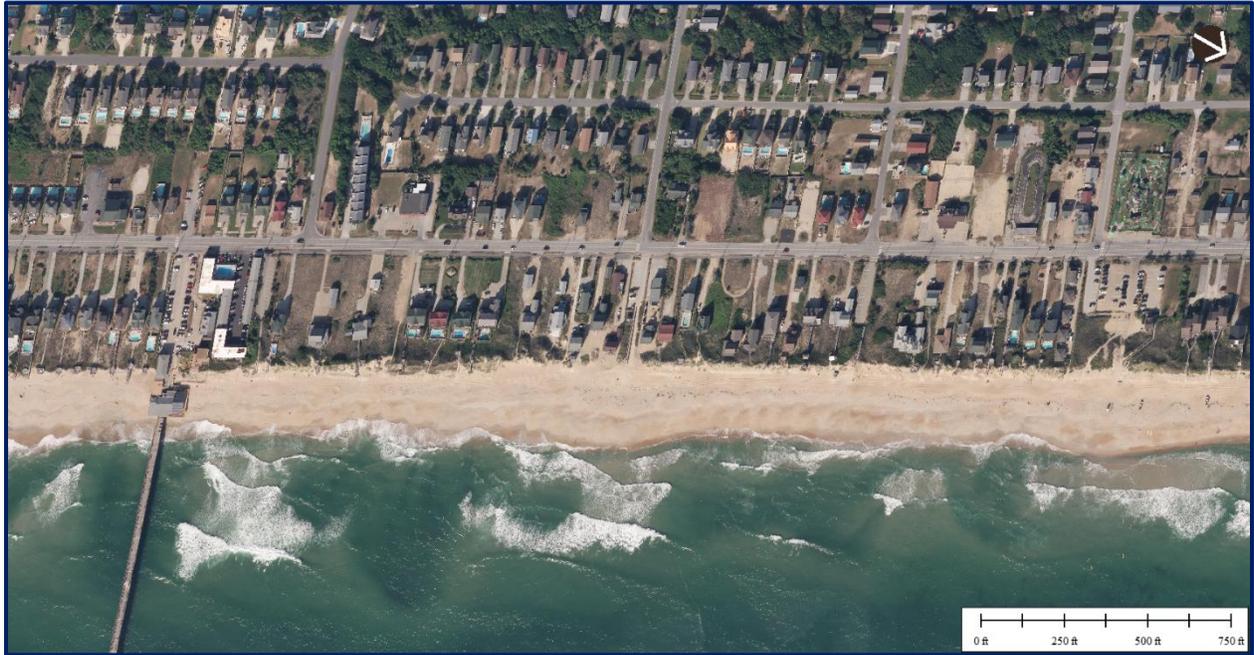
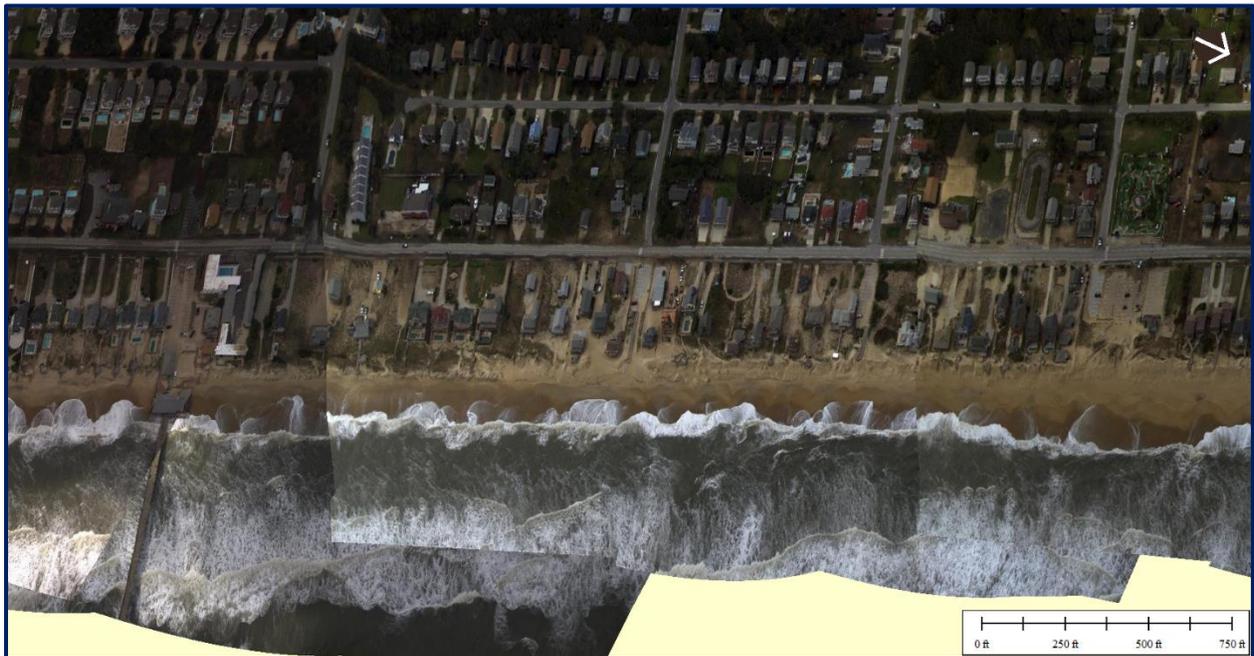
Figures F, G, and H are three sets of orthophotos showing the impact of *Matthew* along the northern and southern ends of Nags Head. The top photos were taken in June 2014 (the most recent orthophotos that the Town has), and the bottom photos were taken by NOAA on 10 October 2016 right after *Matthew*'s passage.

**FIGURE F.** Orthophotos of project’s north limit near Nags Head Pier and Bonnett Street) before (7 June 2014) and after (10 October 2016) Hurricane *Matthew*.

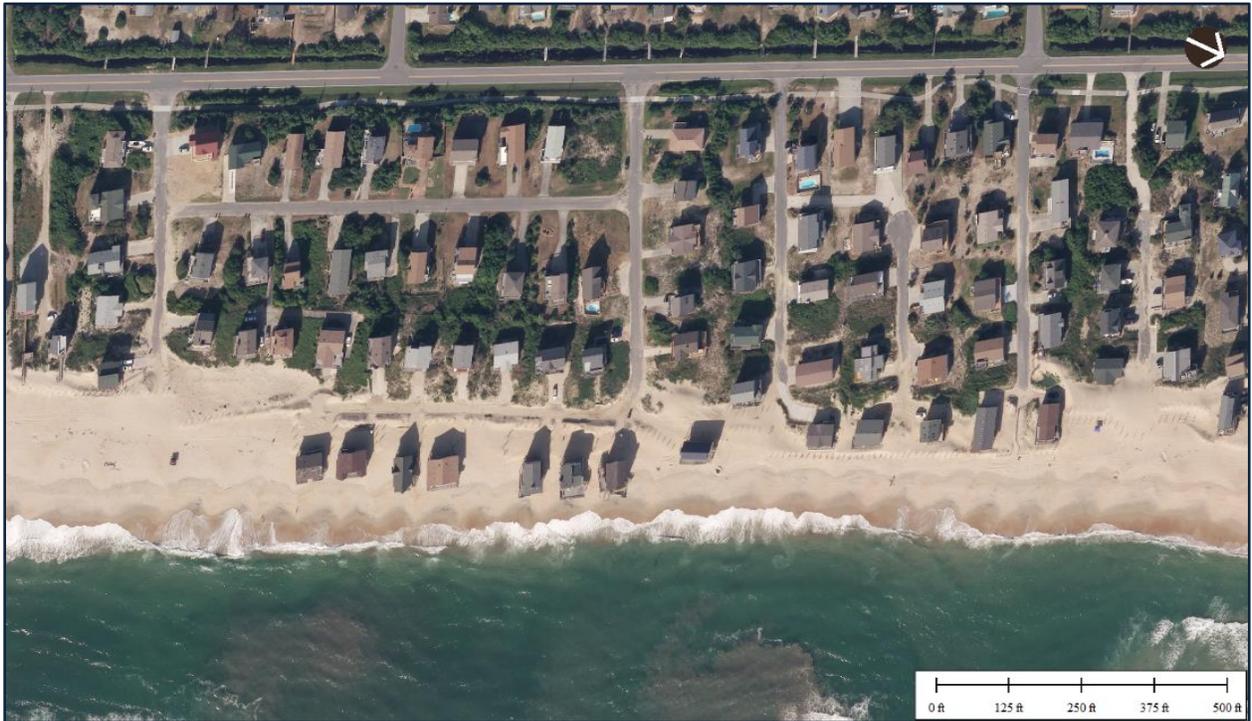
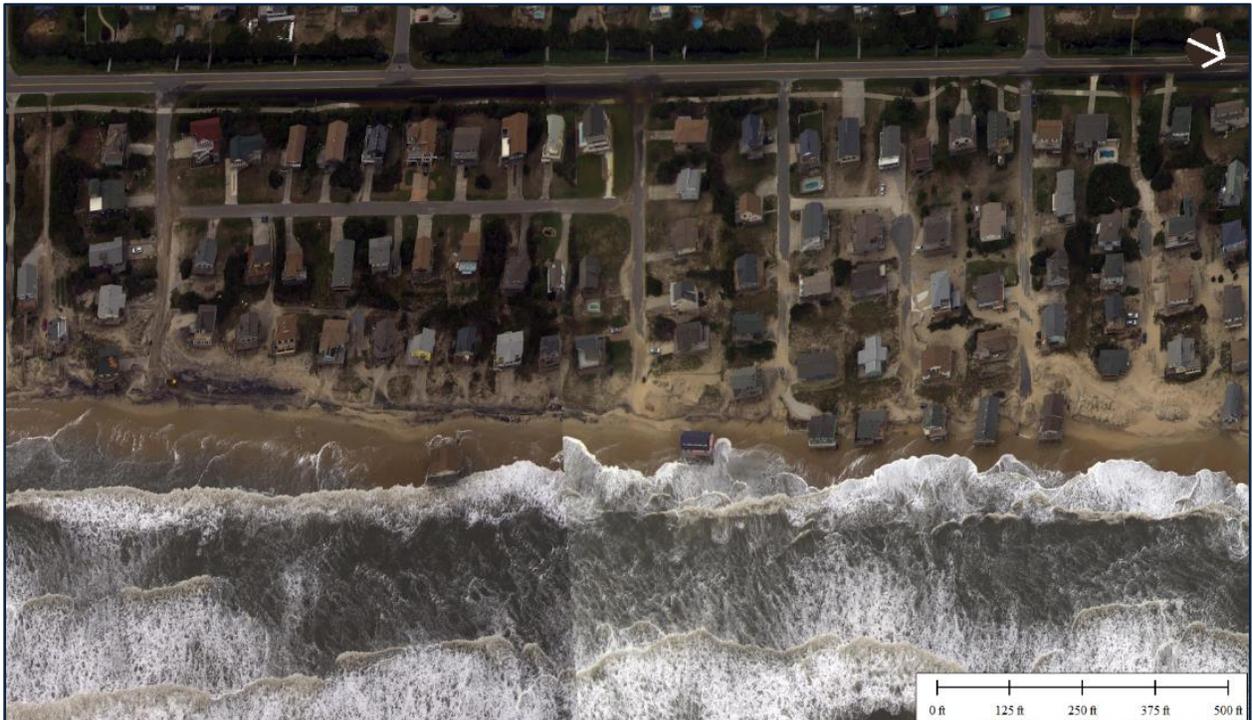
**FIGURE G.** Orthophotos of Seagull Drive before (7 June 2014) and after (10 October 2016) Hurricane *Matthew*.

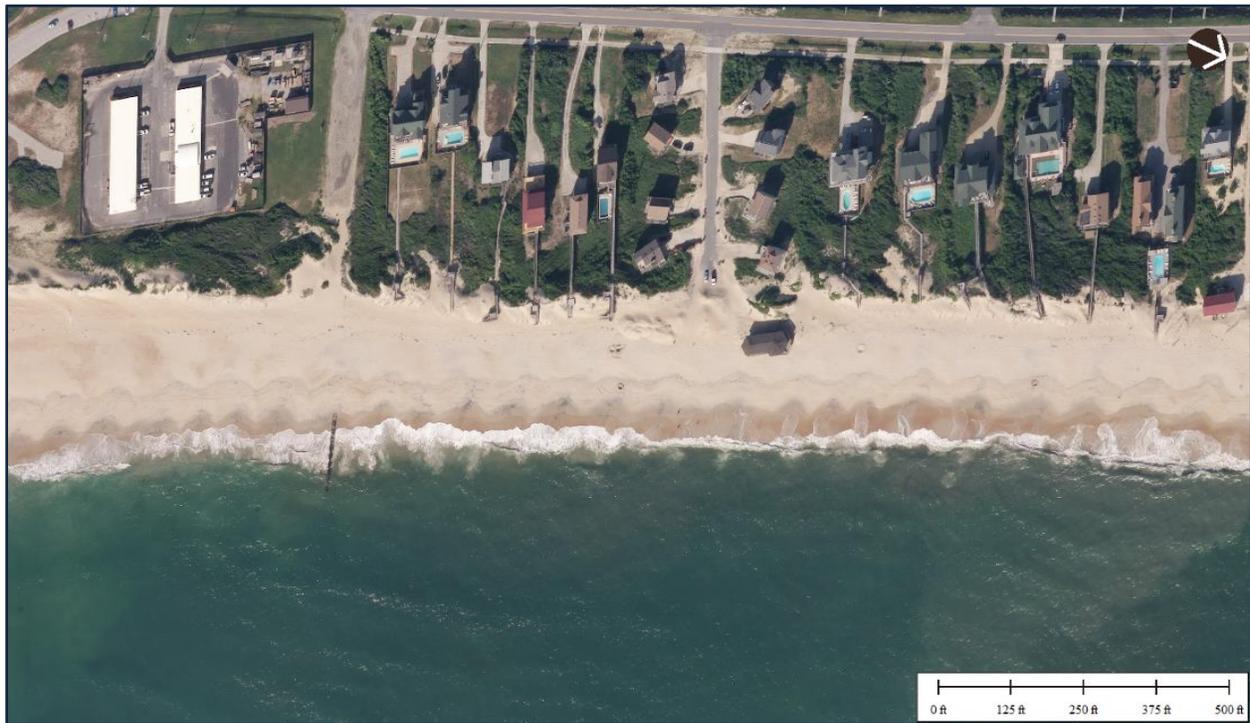
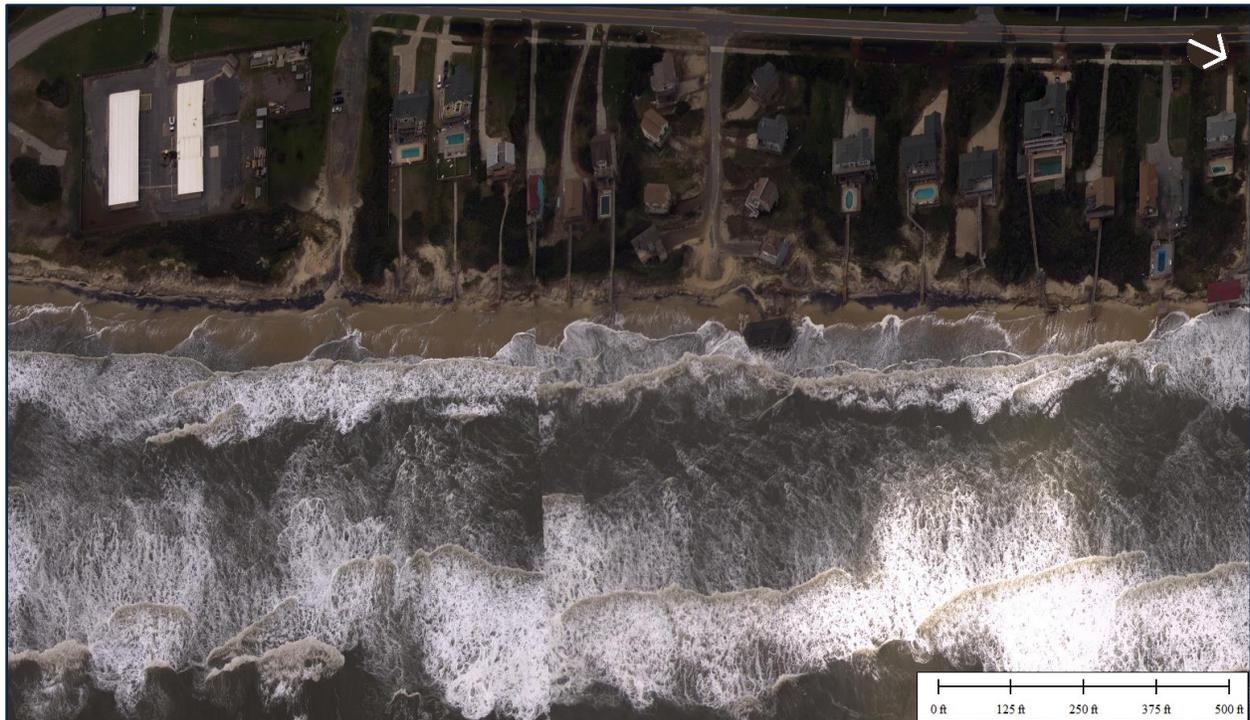
**FIGURE H.** Orthophotos of Town’s south limit before (7 June 2014) and after (10 October 2016) Hurricane *Matthew*.
