S. Nags Head Drainage Infrastructure Maintenance & Repair Projects

Department of Public Works

October 22, 2015

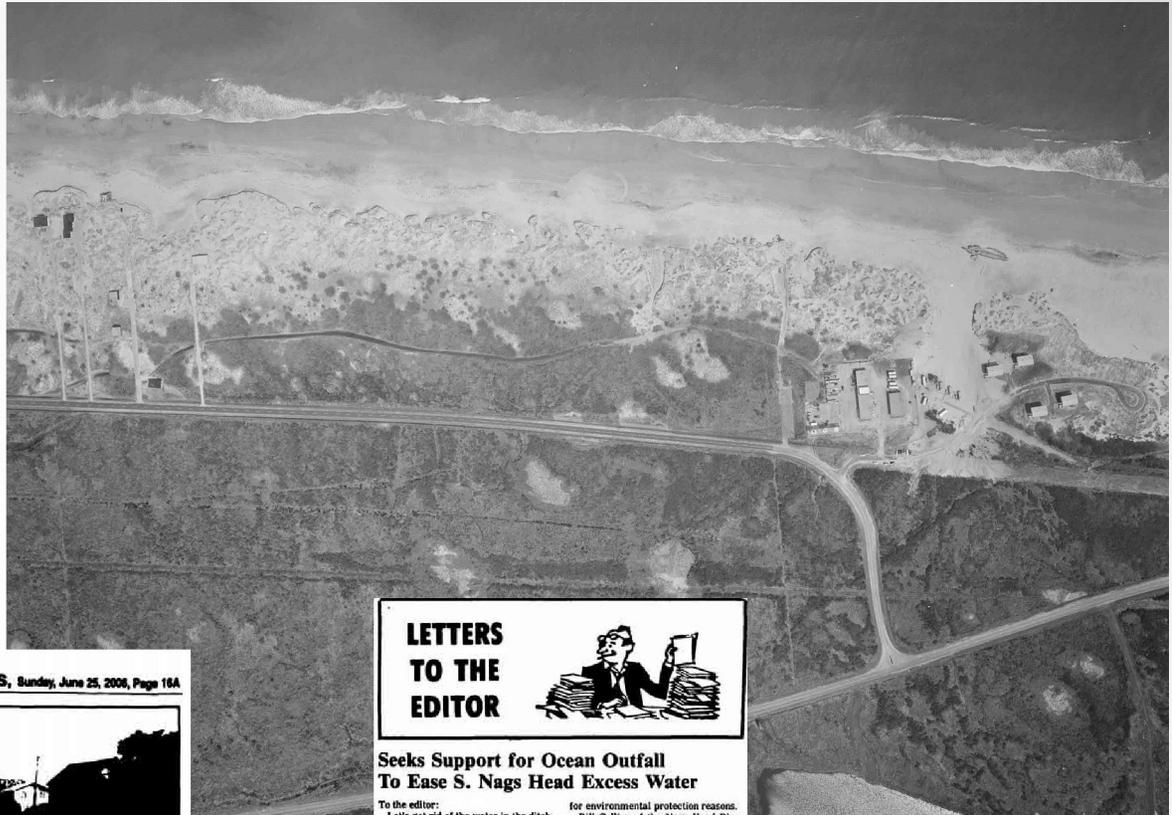
AN APPROXIMATELY one-half mile section of Virginia Dare Trail in Nags Head was flooded with up to five inches of rainwater Friday and over the weekend due to two ocean outfall drainage basins that were stopped up, said Skip Lange, the town's director of public works. State Department of Transportation officials were notified of the situation Monday, and the drains are expected to be cleared because the water had dropped later Monday, Lange said. The drain basins are located near the intersection of Virginia Dare Trail and Conch Street, near Forbes Candy & Gift Shop. Some automobile drivers braved the depths, while others heeded the sign and bypassed the flooded area. (J. Glass photo)

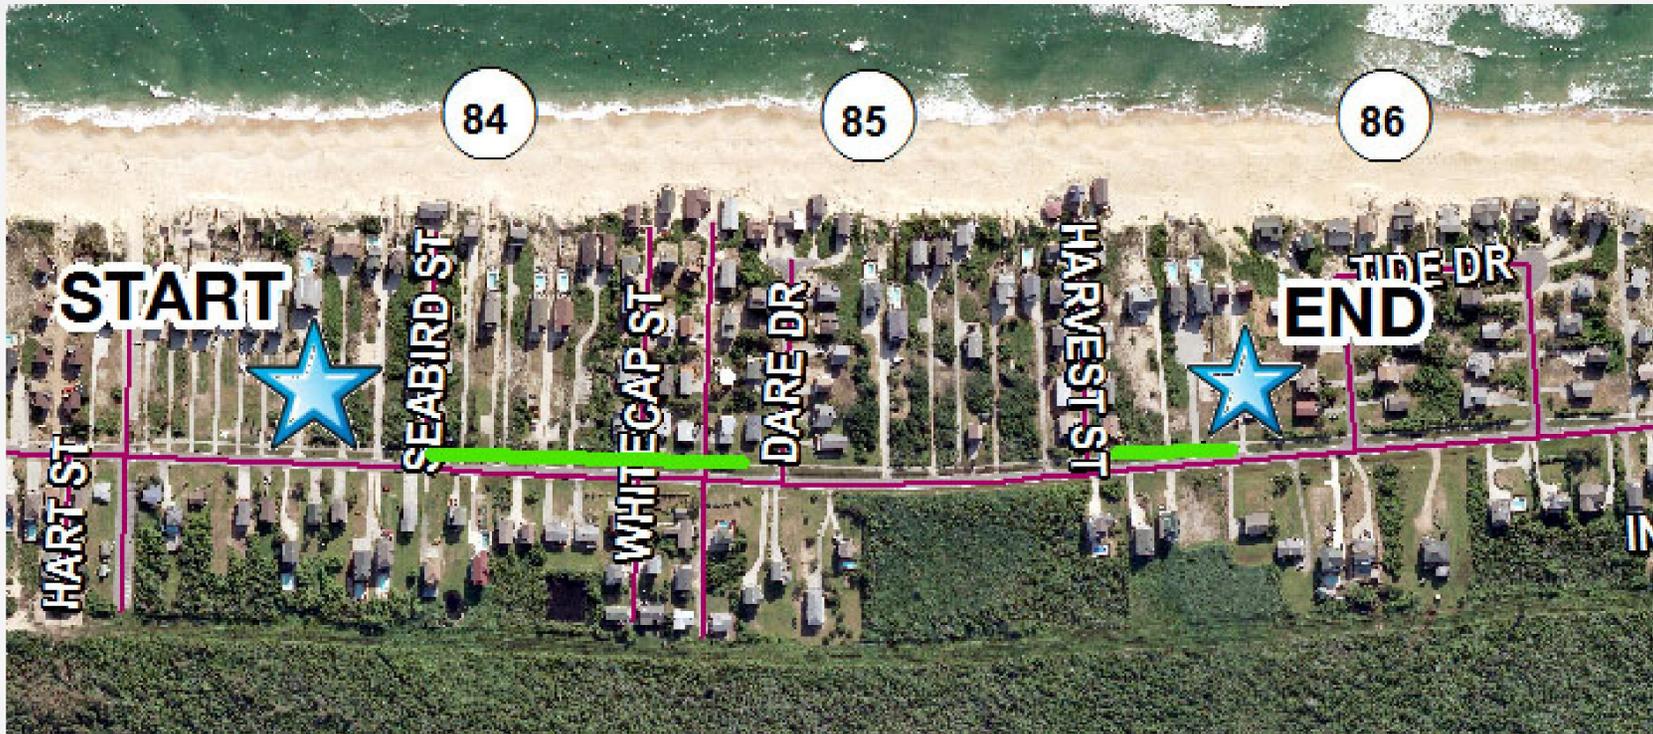
Milepost 18

- Problem
 - Elevated Groundwater conditions and Rainfall Surface Runoff
 - Superelevated roadway curve.
 - Low-lying topography
 - No drainage outlet
 - Regulatory Constraints
 - Underground Utility Conflicts
 - Requires coordinated effort with NCDOT to resolve
- Objectives
 - Improve public safety
 - Reduce amount of standing water on pavement
 - Reduce duration of standing water on pavement
 - Expand areas for enhanced infiltration
 - Time frame for implementation

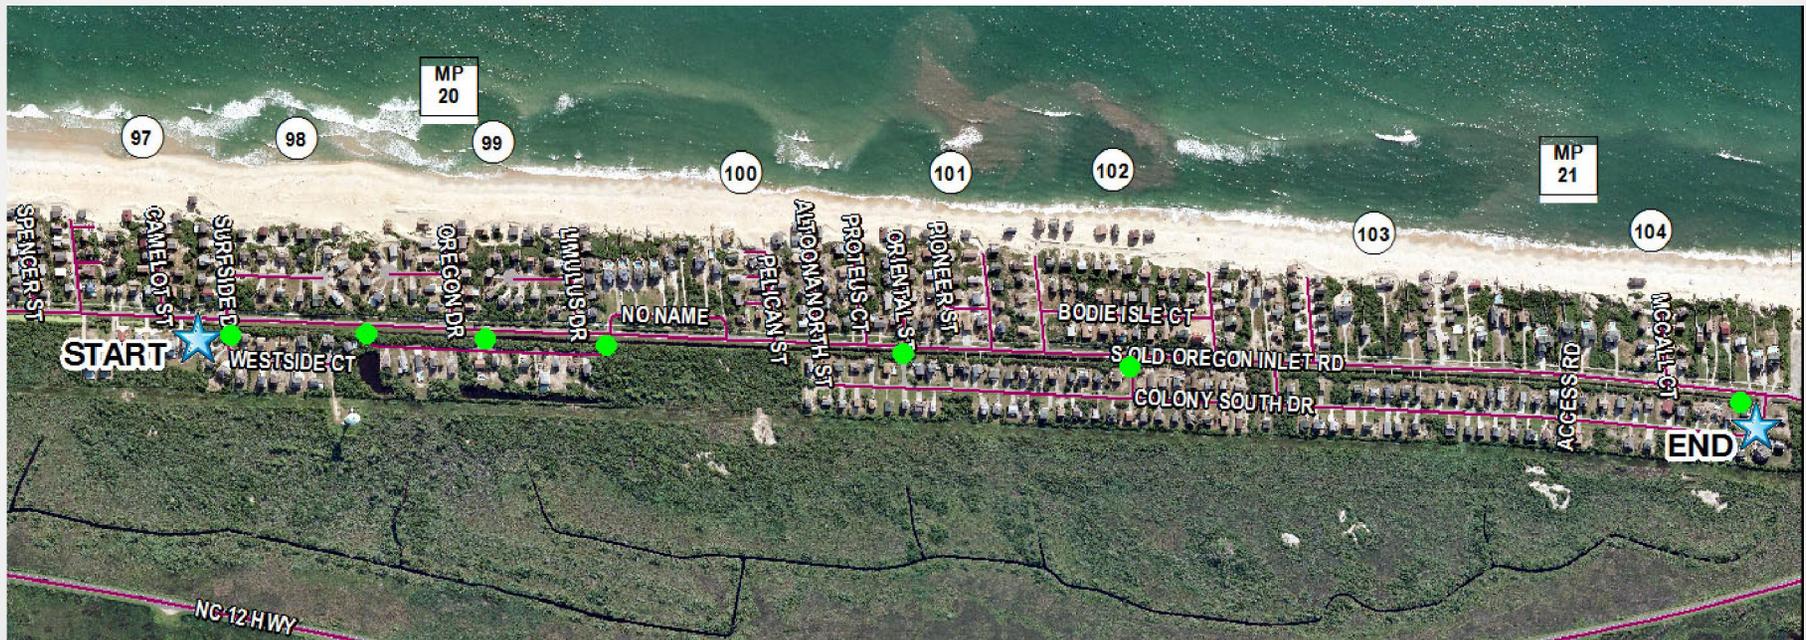
Milepost 20

- Problem
 - Public safety concern of failing pavement sections, (i.e. potholes)
 - Failing drainage infrastructure
 - Clogged or impeded drainage flow
 - Underground utility conflicts
 - Regulatory Constraints
 - Requires coordinated effort with NCDOT
 - Stormwater surface runoff, elevated groundwater conditions and wastewater disposal system impacts
- Objectives
 - Address immediate public safety concern
 - Reduce maintenance requirements
 - Improved flow efficiency through pipes
 - Coordinated pipe installation
 - Time frame for implementation
